▼
**Solvent Cleaning and PE
Joining Procedures**

Prepared by:
Gas Technology Institute
Des Plaines, Illinois

GTI-OTD FINAL REPORT

Solvent Cleaning and PE Joining Procedures

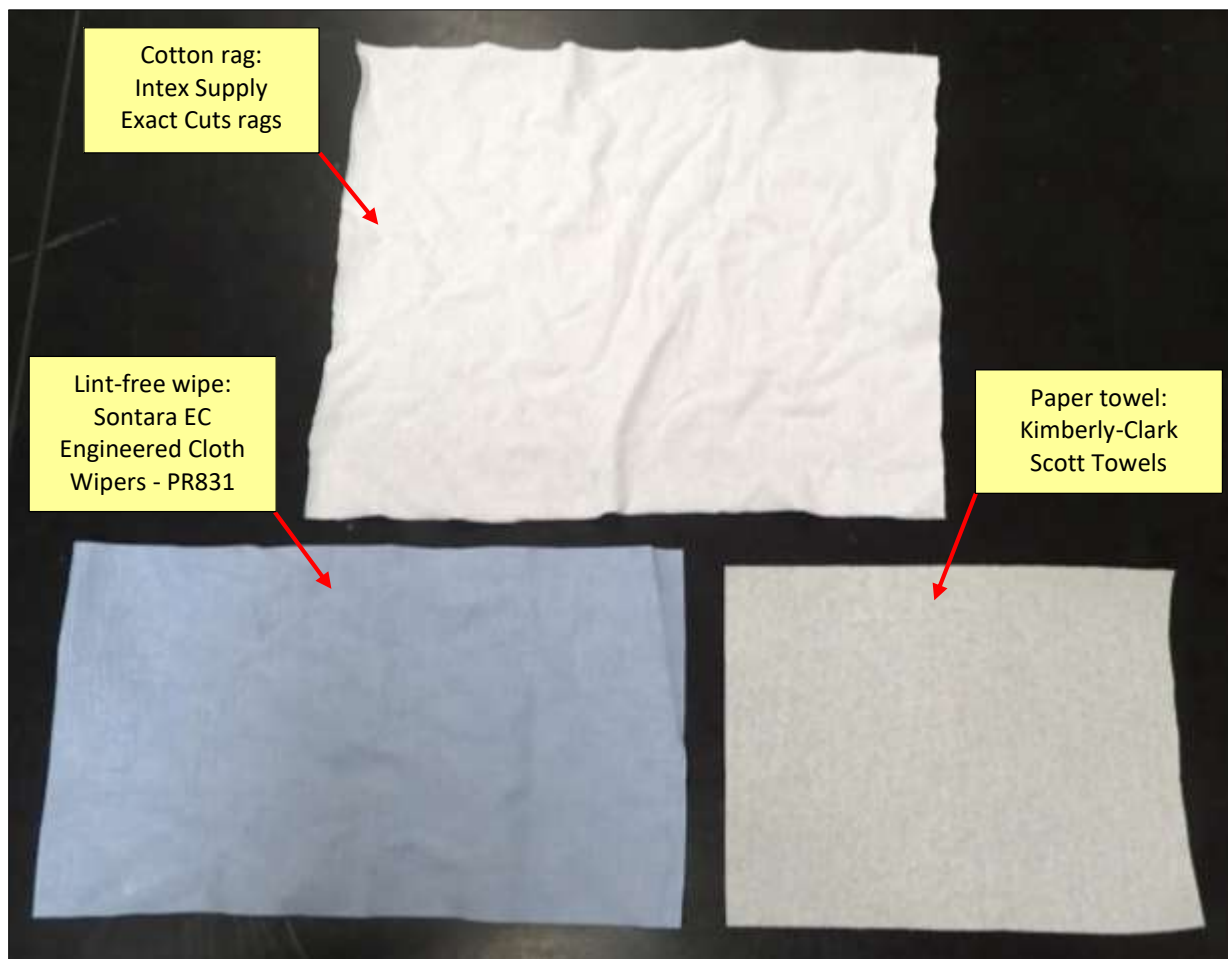
- Lint-free wipe: Sontara EC Engineered Cloth Wipers - PR831
- Cotton rag: Intex Supply Exact Cuts rags
- Paper towel: Kimberly-Clark Scott Towels

Figure 2. Tested cleaning tools

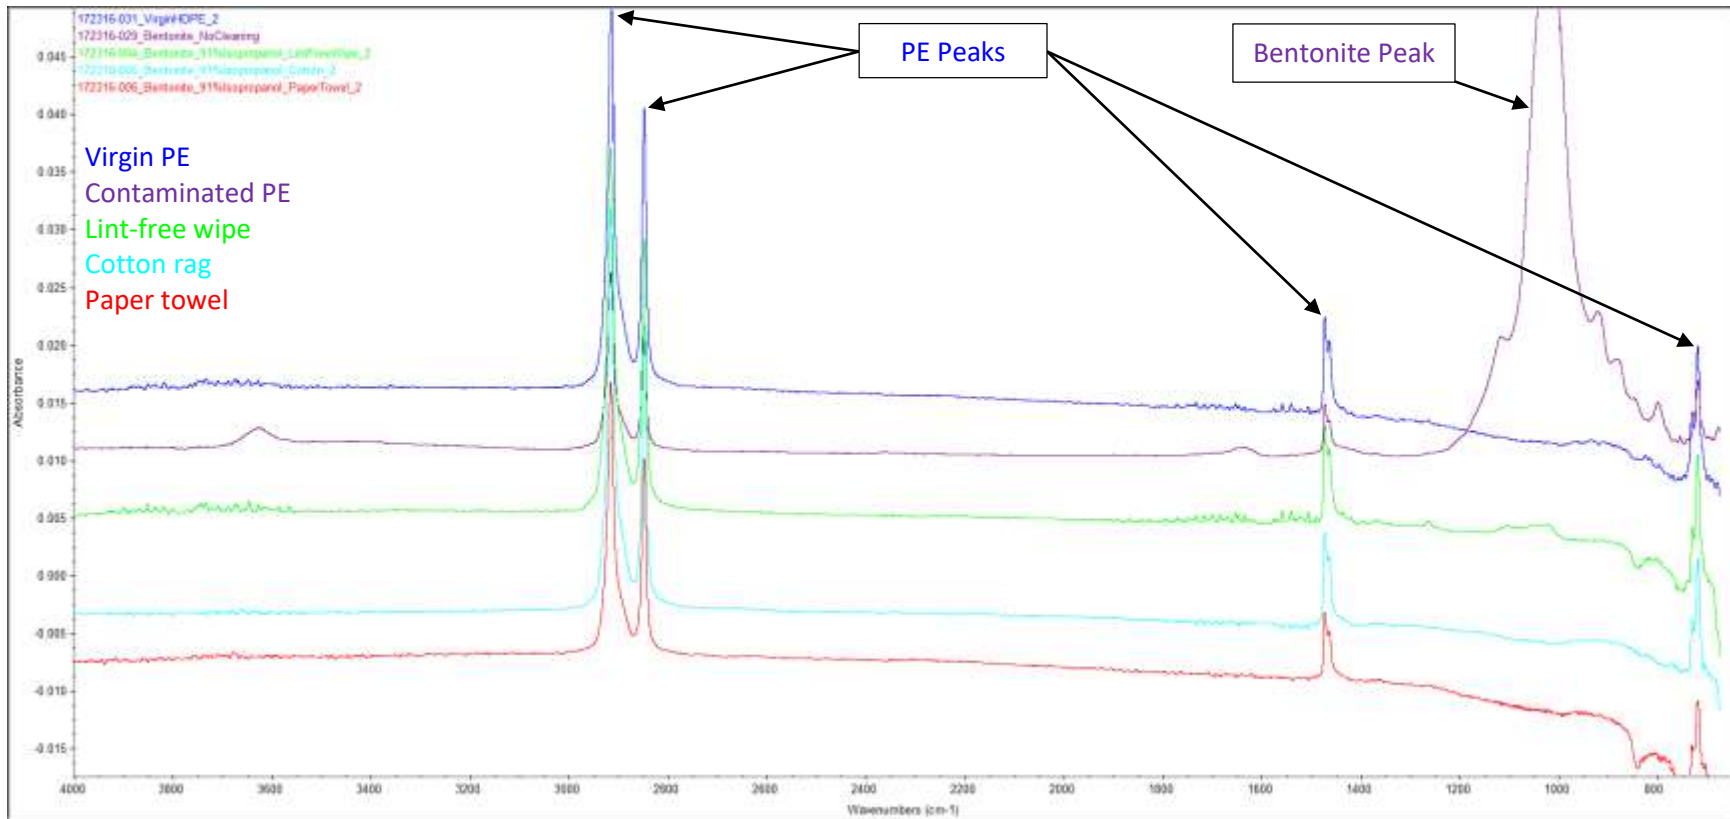
Figure 3. Post-cleaning FTIR spectra, contaminant=bentonite, solvent=91% isopropyl alcohol/9% distilled water

Figure 3 shows that 91% isopropyl alcohol was effective at removing bentonite with all tools. This is seen by the absence of a bentonite peak in the spectra of the samples that were cleaned.

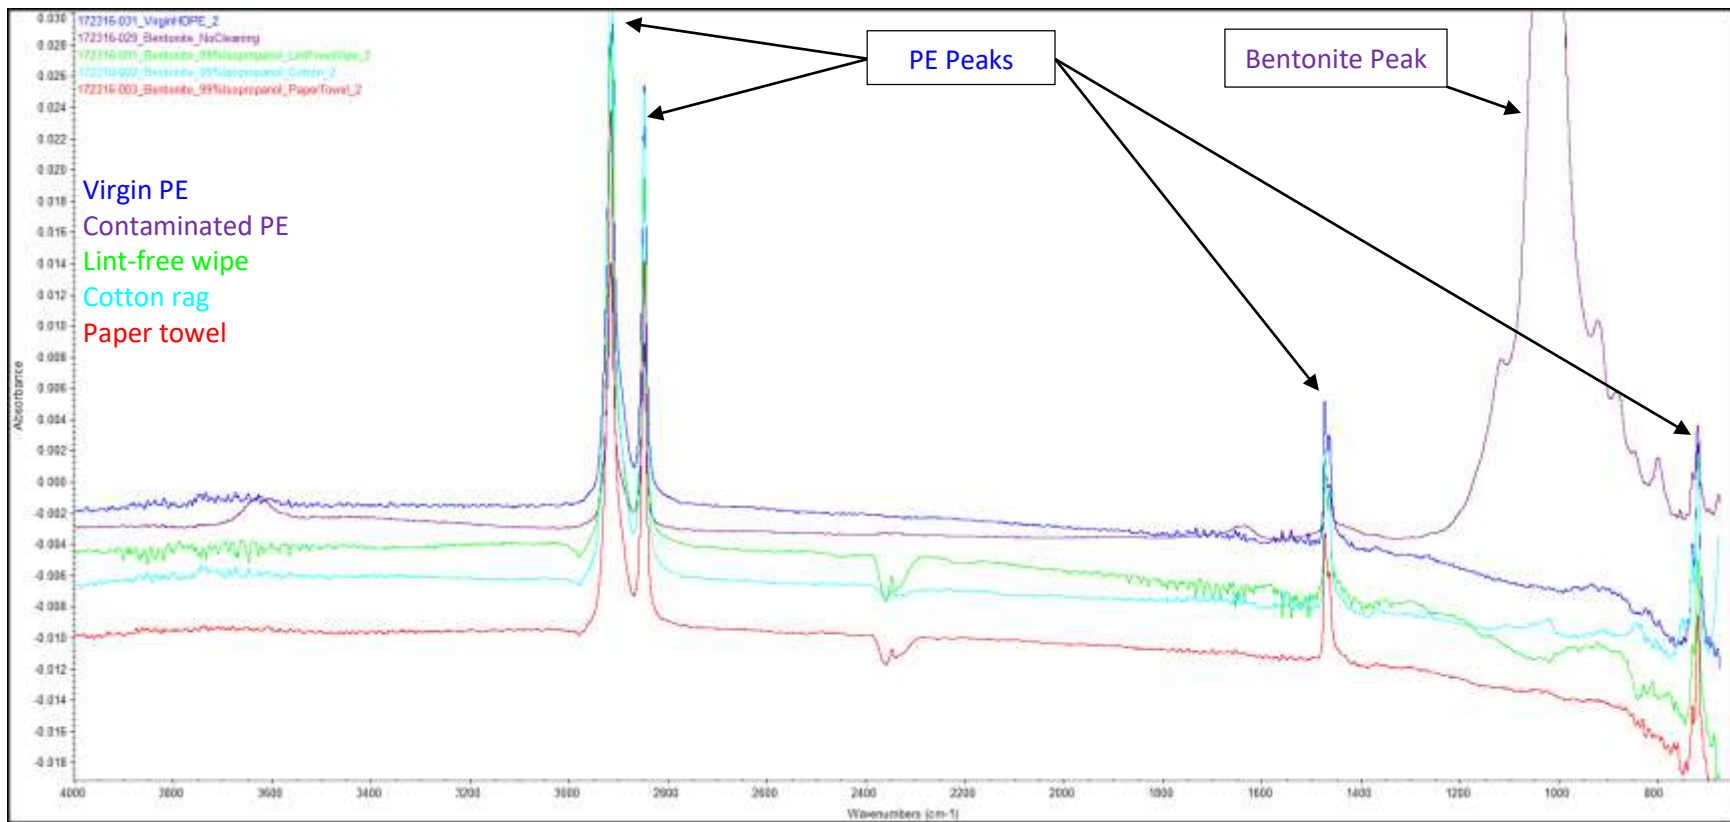
Figure 4. Post-cleaning FTIR spectra, contaminant=bentonite, solvent=99% isopropyl alcohol/1% distilled water

Figure 4 shows that 99% isopropyl alcohol was effective at removing bentonite with all tools.

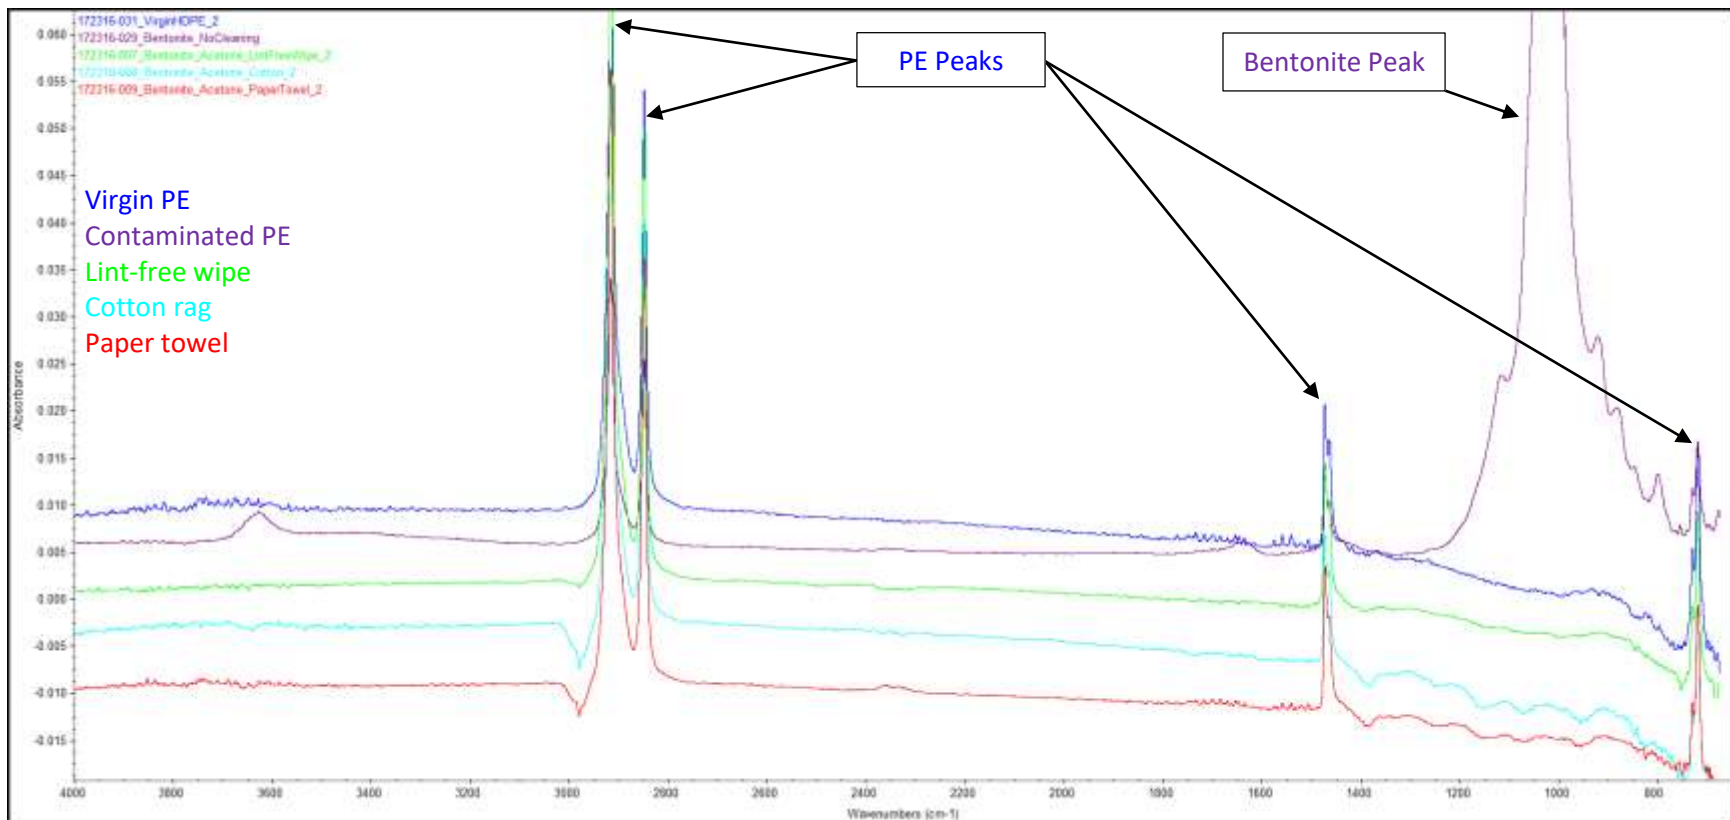
Figure 5. Post-cleaning FTIR spectra, contaminant=bentonite, solvent=acetone

Figure 5 shows that acetone was effective at removing bentonite with all tools.

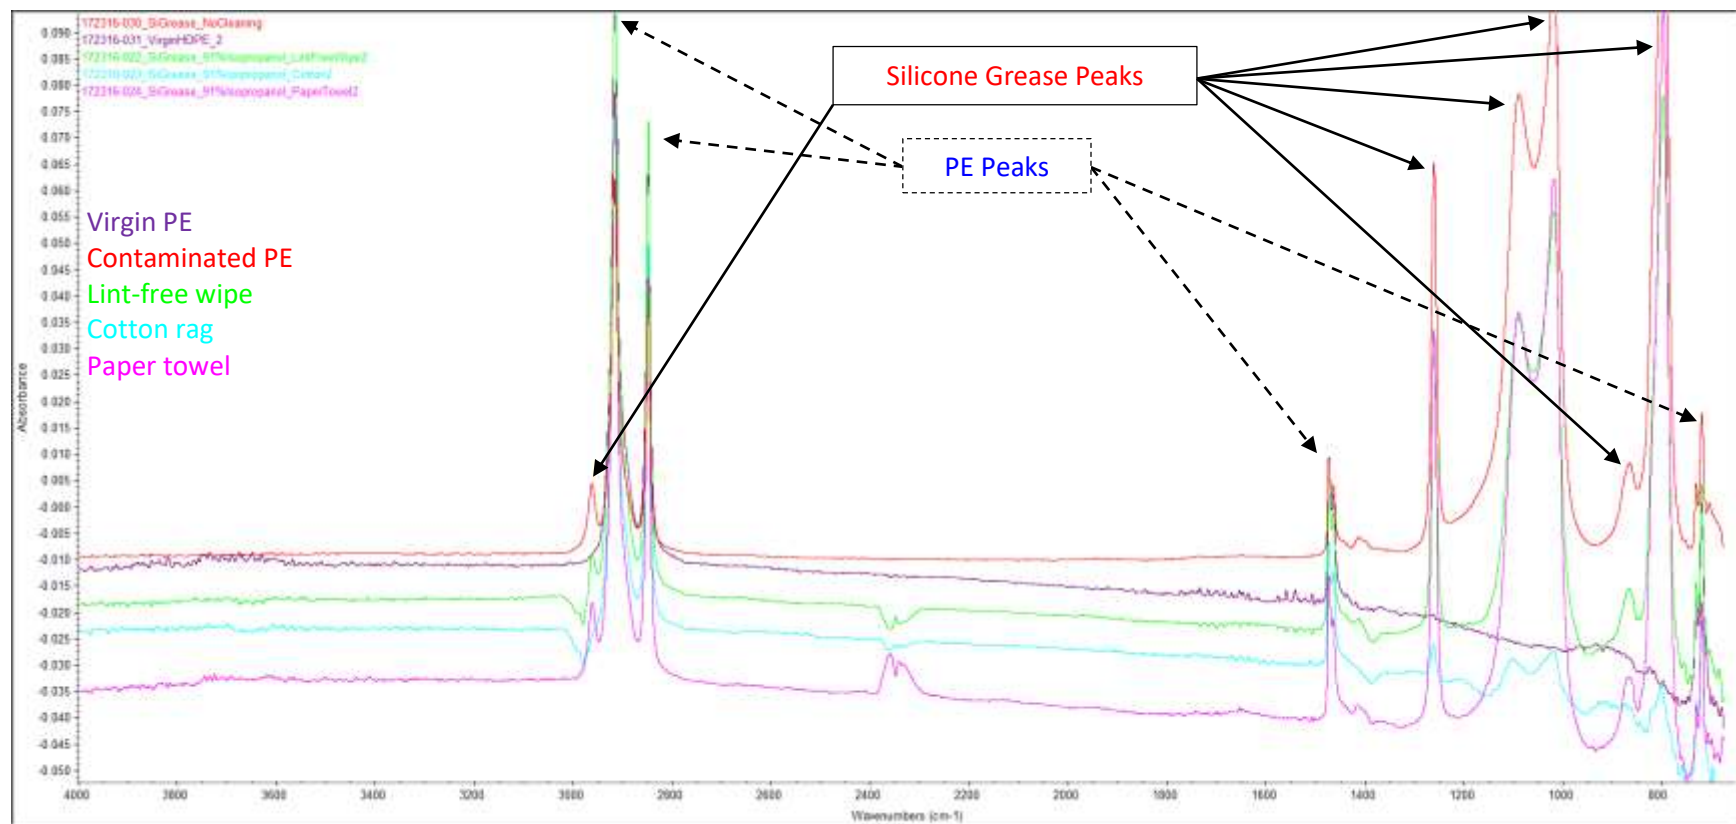
Figure 6. Post-cleaning FTIR spectra, contaminant=silicone grease, solvent=91% isopropyl alcohol/9% distilled water

Figure 6 shows that 91% isopropyl alcohol was not effective at removing silicone grease when used with a lint free wipe or paper towel. The cotton rag was much better than the other tools, but did not completely remove the silicone grease.

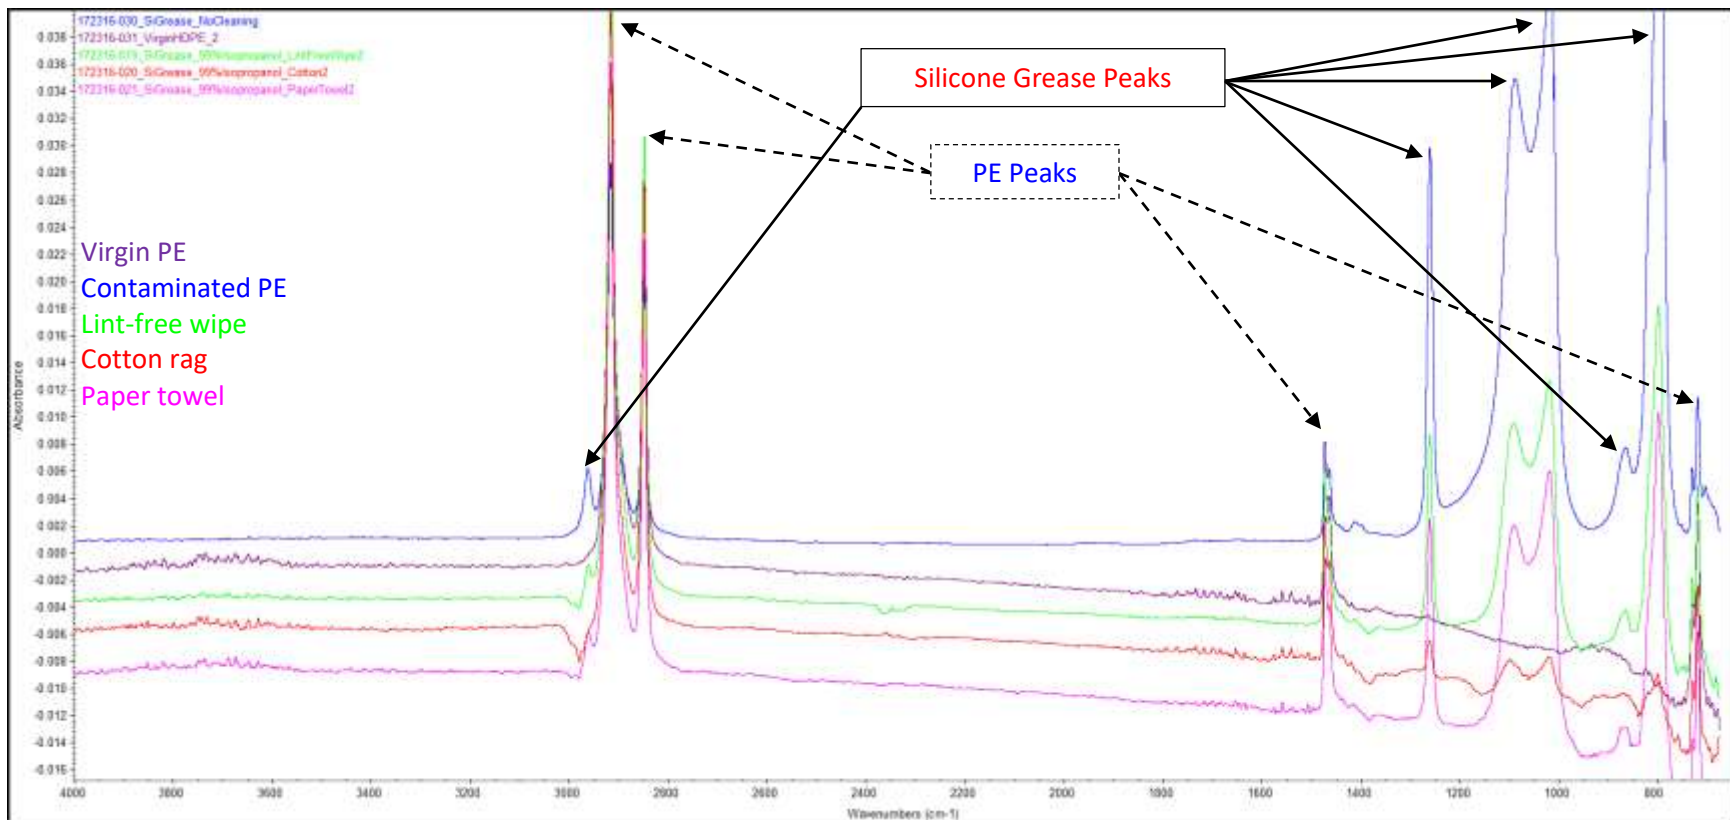
Figure 7. Post-cleaning FTIR spectra, contaminant=silicone grease, solvent=99% isopropyl alcohol/1% distilled water

Figure 7 shows that 99% isopropyl alcohol was not effective at removing silicone grease when used with a lint free wipe or paper towel. The cotton rag was much better than the other tools, but did not completely remove the silicone grease.

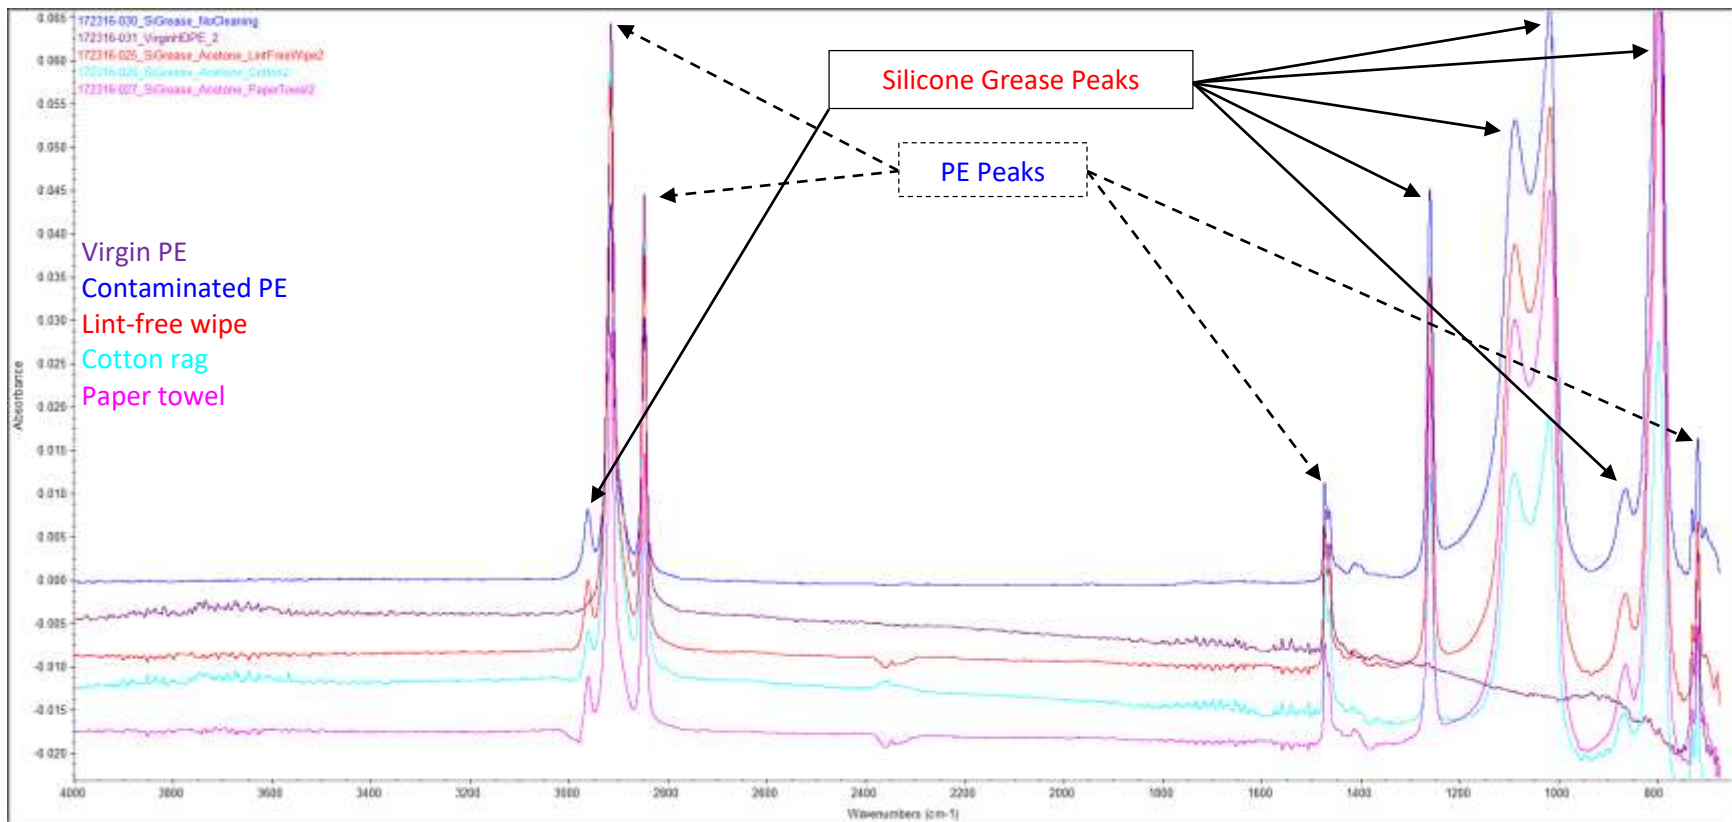
Figure 8. Post-cleaning FTIR spectra, contaminant=silicone grease, solvent=acetone

Figure 8 shows that acetone was not effective at removing silicone grease with any of the tools.

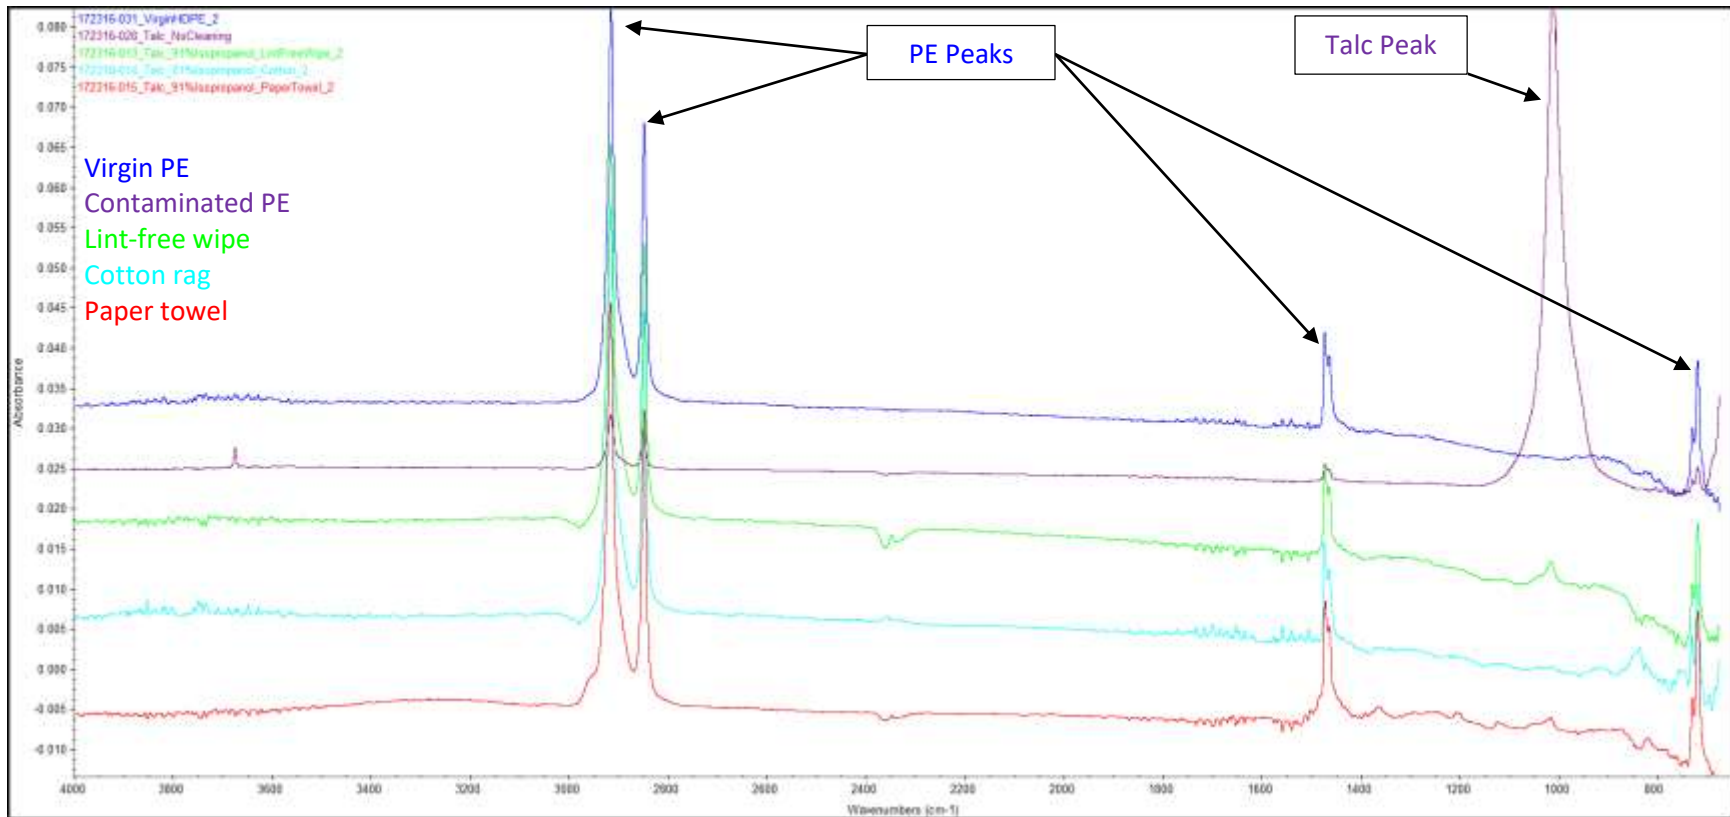
Figure 9. Post-cleaning FTIR spectra, contaminant=talc, solvent=91% isopropyl alcohol/9% distilled water

Figure 9 shows that 91% isopropyl alcohol was effective at removing most of the talc with the lint-free wipe and paper towel, but did not completely remove the talc. With the cotton rag, the talc peak was completely removed.

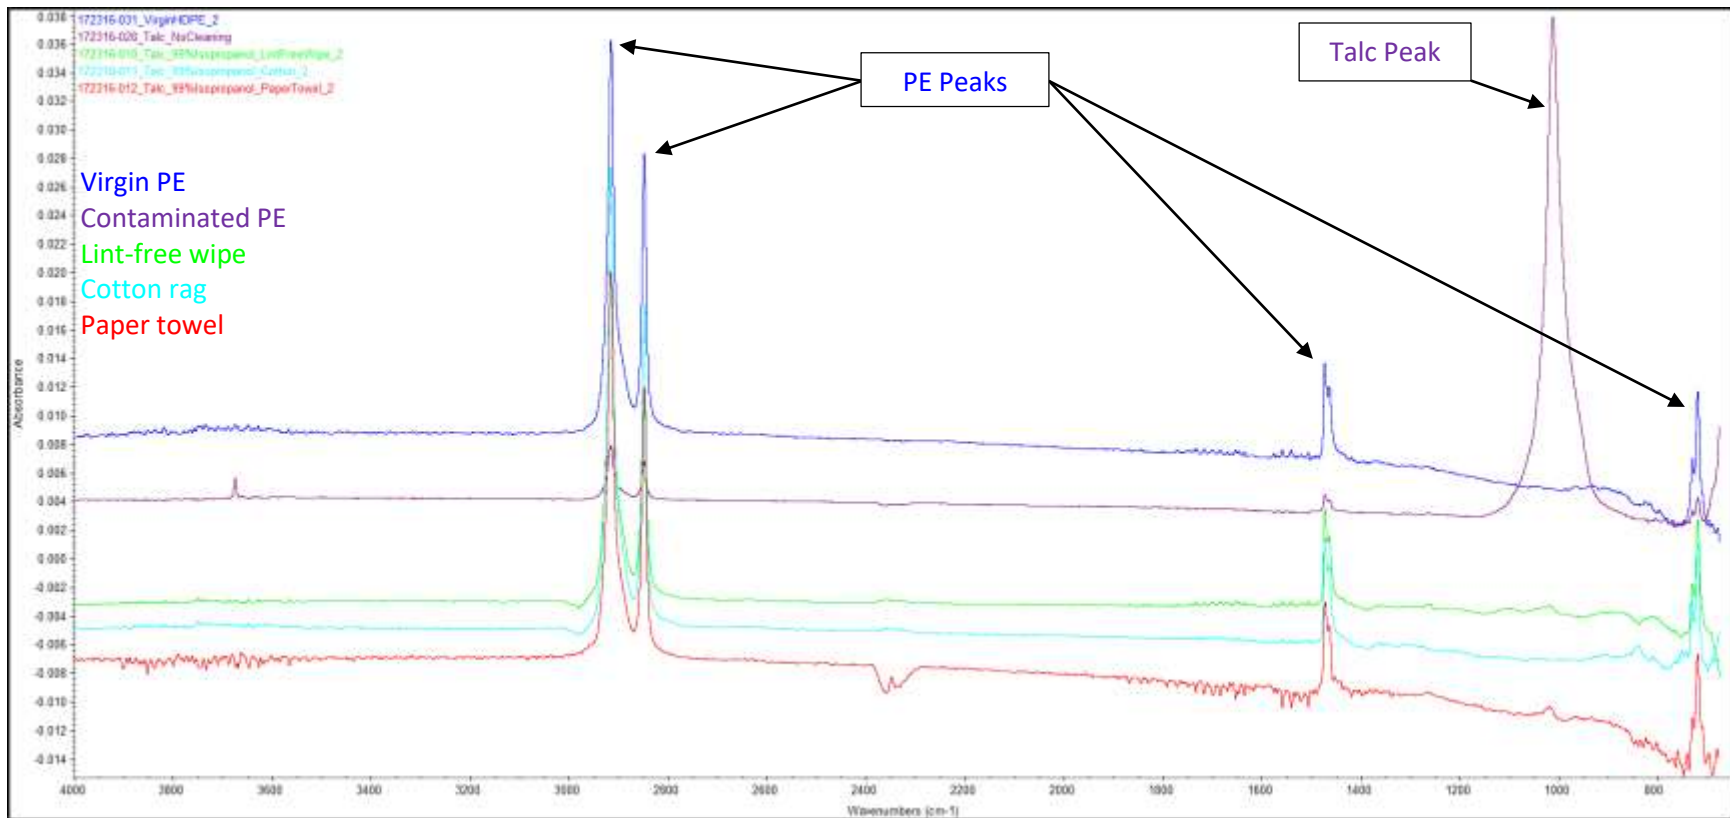
Figure 10. Post-cleaning FTIR spectra, contaminant=talc, solvent=99% isopropyl alcohol/1% distilled water

Figure 10 shows that 99% isopropyl alcohol was effective at removing most of the talc with the lint-free wipe and paper towel, but did not completely remove the talc. With the cotton rag, the talc peak was completely removed.

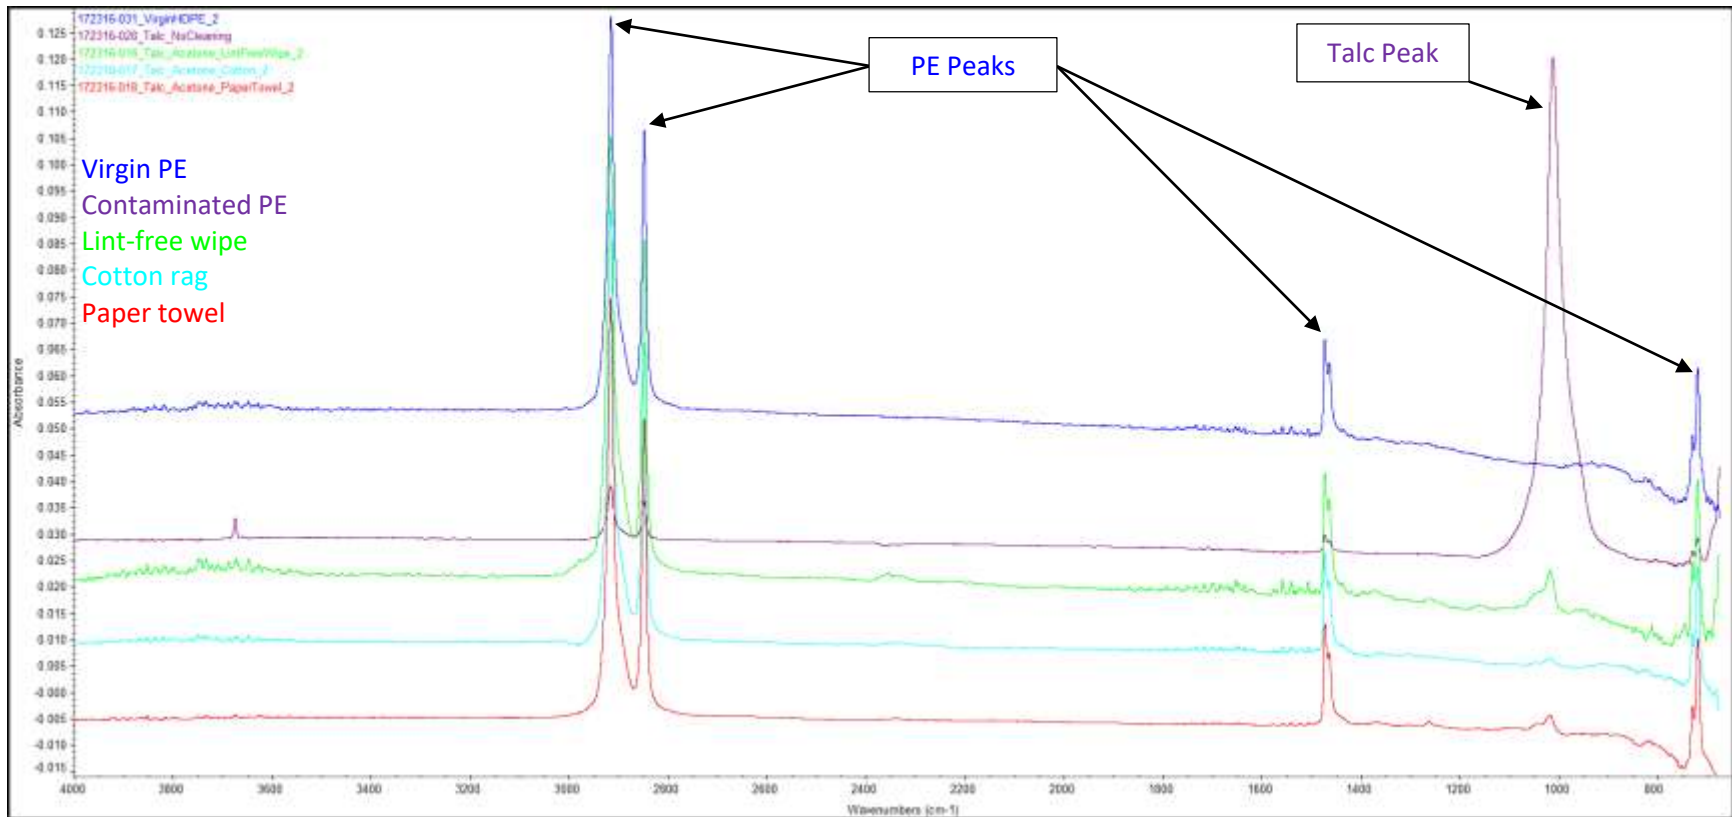
Figure 11. Post-cleaning FTIR spectra, contaminant=talc, solvent=acetone

Figure 11 shows that acetone was effective at removing most of the talc with all tools, but did not completely remove the talc.

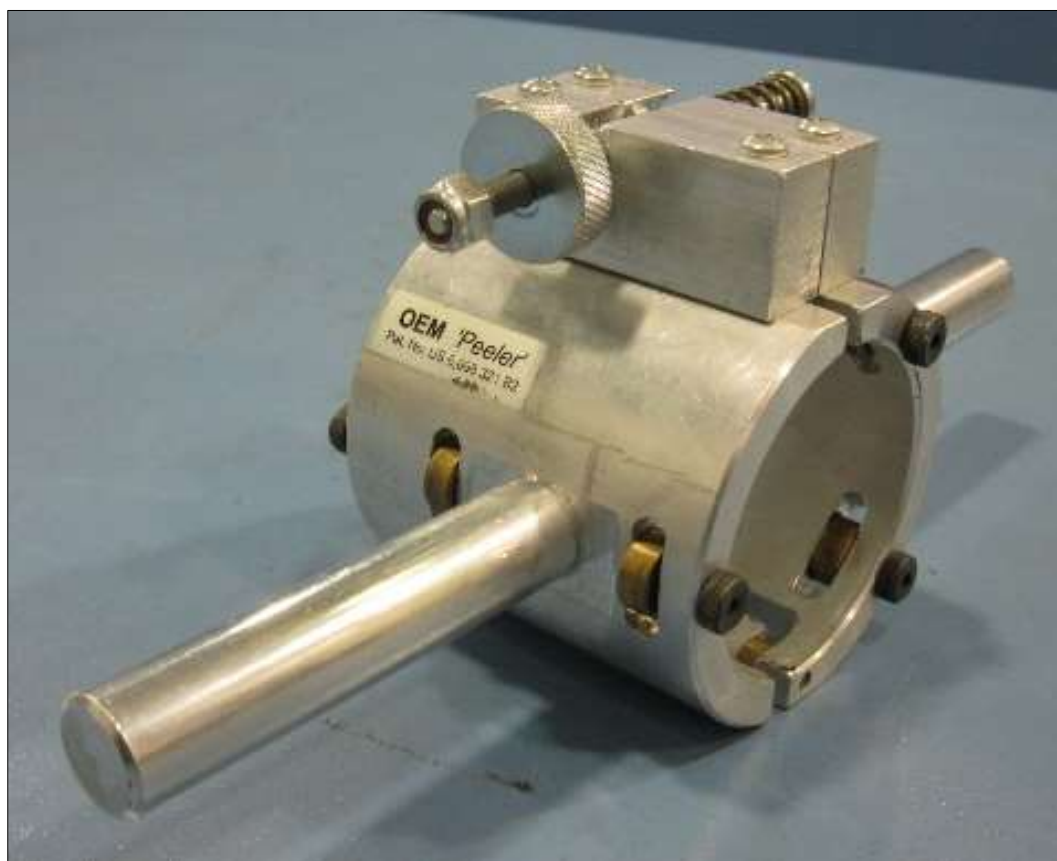
Figure 12. OEM 'Peeler', 2" IPS

1. Scrape the pipe (using OEM 'Peeler', see **Figure 12**),
2. Contaminate the pipe,
3. Wet the tool with the solvent,
4. Make one wiping pass along pipe axis, starting at one end of the scraped zone and moving to its other end, with the wipe fully encircling the pipe (2" IPS),
5. If contaminant was still visible on the fusion zone, repeat Step 3 and Step 4 with a new tool,
6. Wait for pipe to dry,
7. Assemble electrofusion saddle (as soon as pipe is dry) and perform fusion.

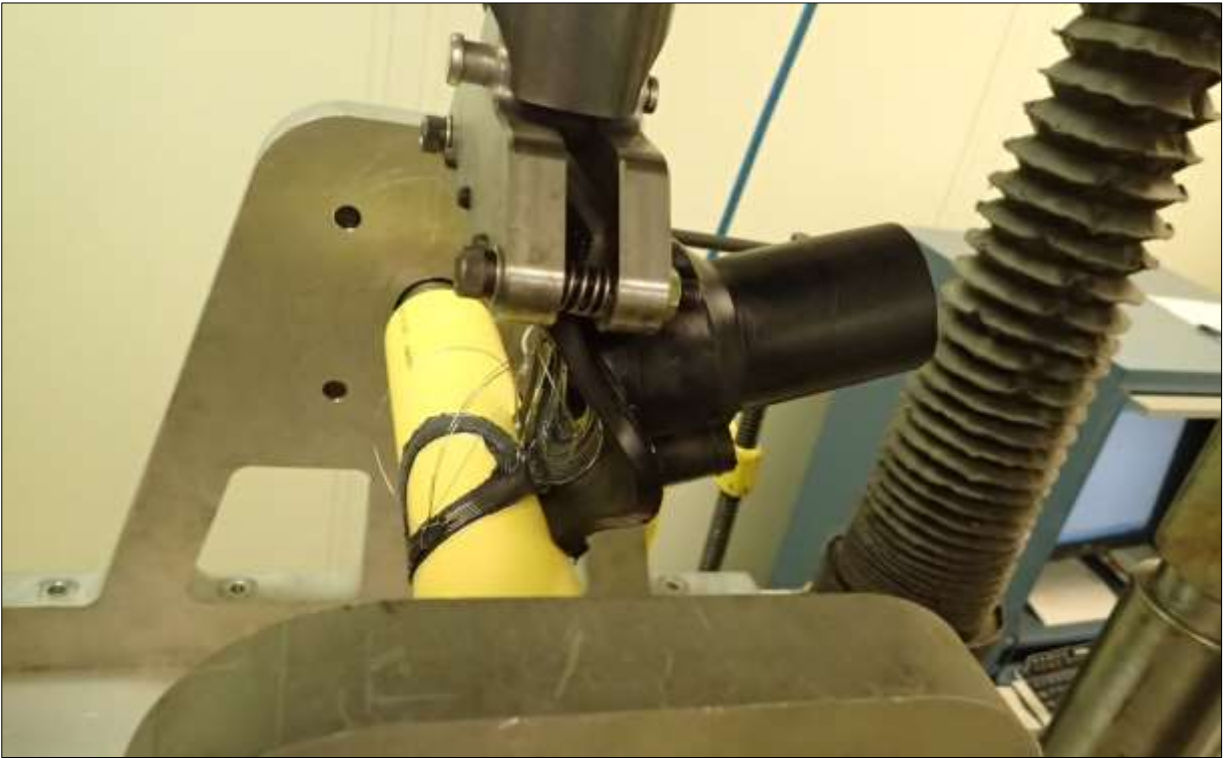
Figure 13. Example of saddle decohesion test

Following the scraping procedure, electrofusion saddles were fused and then peeled off using the ISO 13956 Type A2 decohesion test method (see **Figure 13** and **Figure 14**).

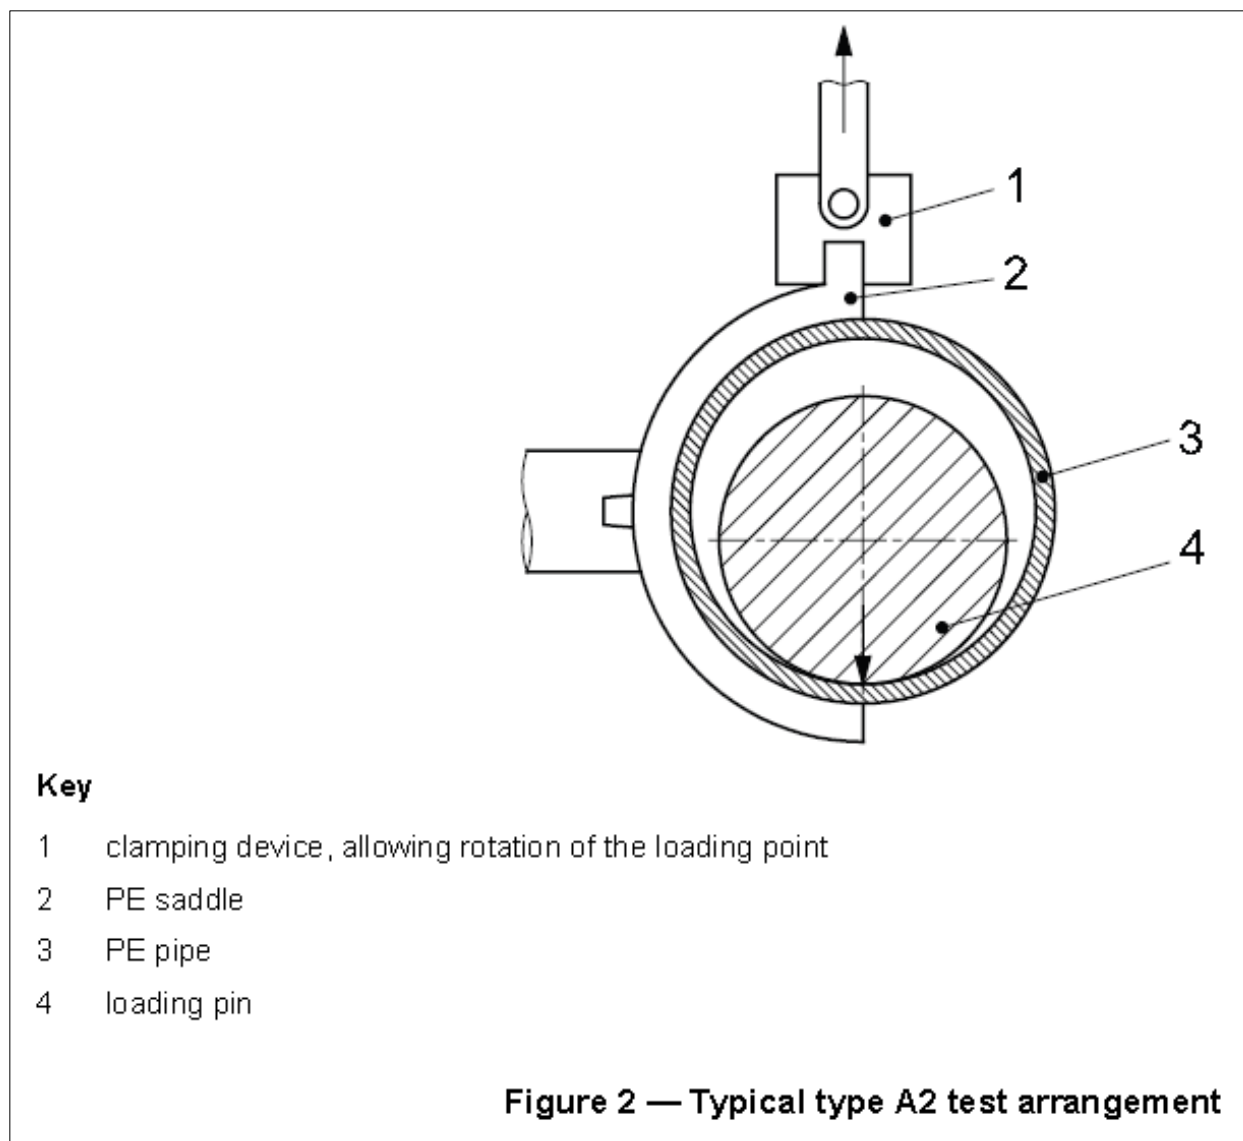
Figure 14. Schematic of ISO 13956 type A2 decohesion test arrangement

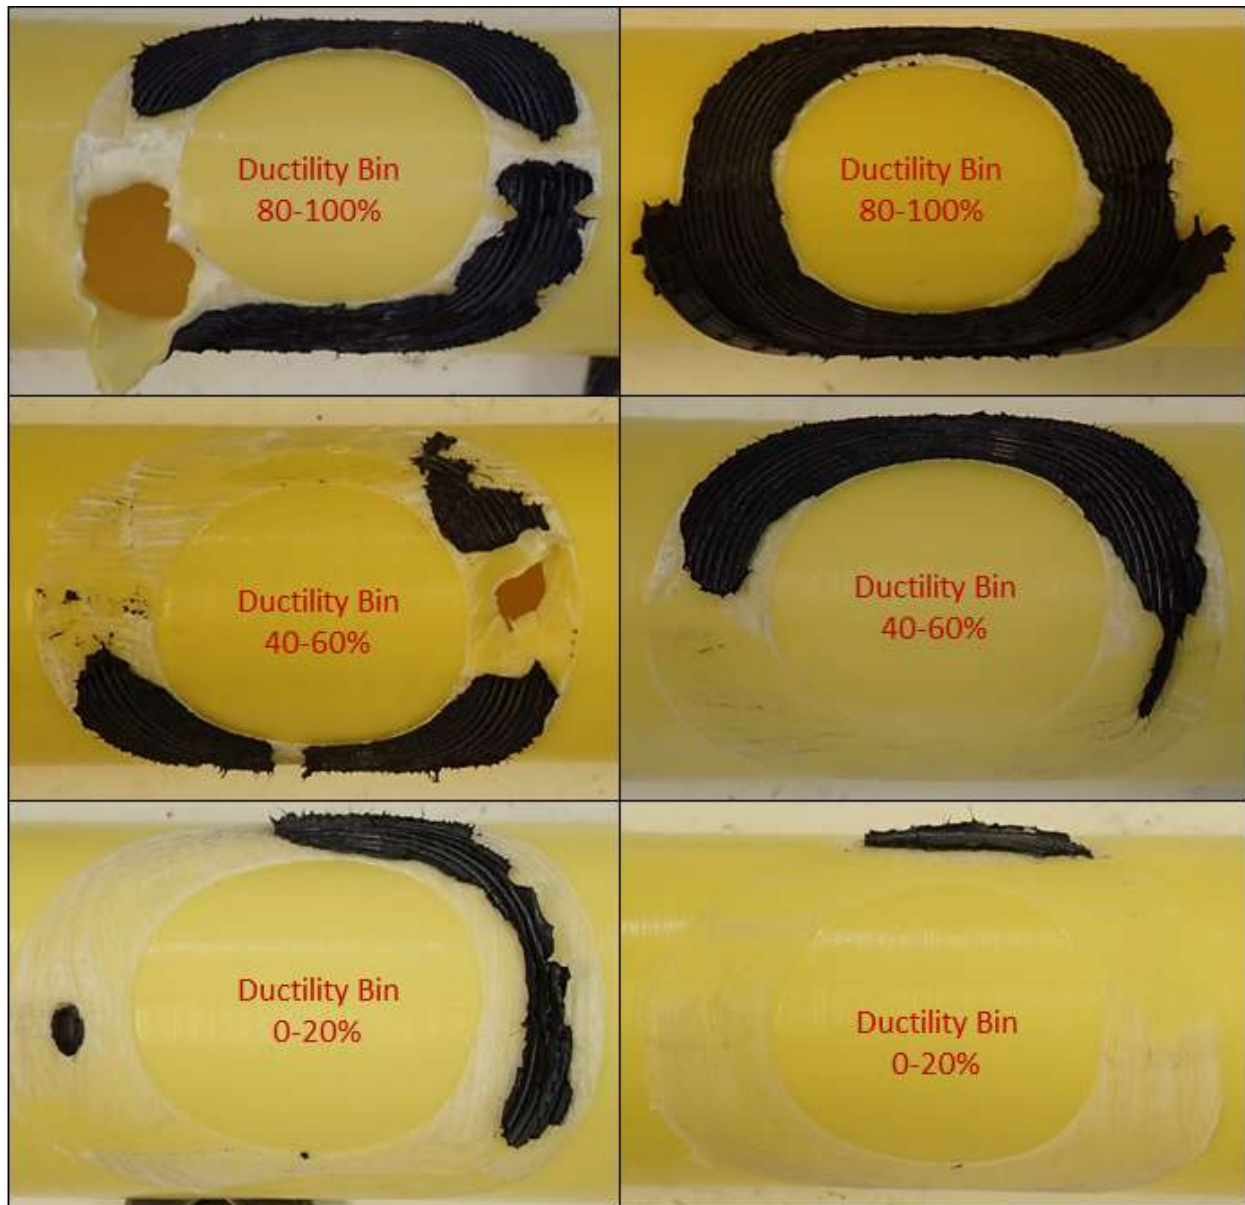
Fusions were scored based on the percent of the fusion zone that exhibited ductile separation¹. The scores were binned in 20% intervals: 0-20%, 21-40%, 41-60%, 61-80%, and 81-100%. Higher ductility scores indicate better removal of the contaminant. For general reference, **Figure 15** shows some examples of results at three different ductility bins.

Figure 15. Examples of saddle decohesion test results with their ductility bin score

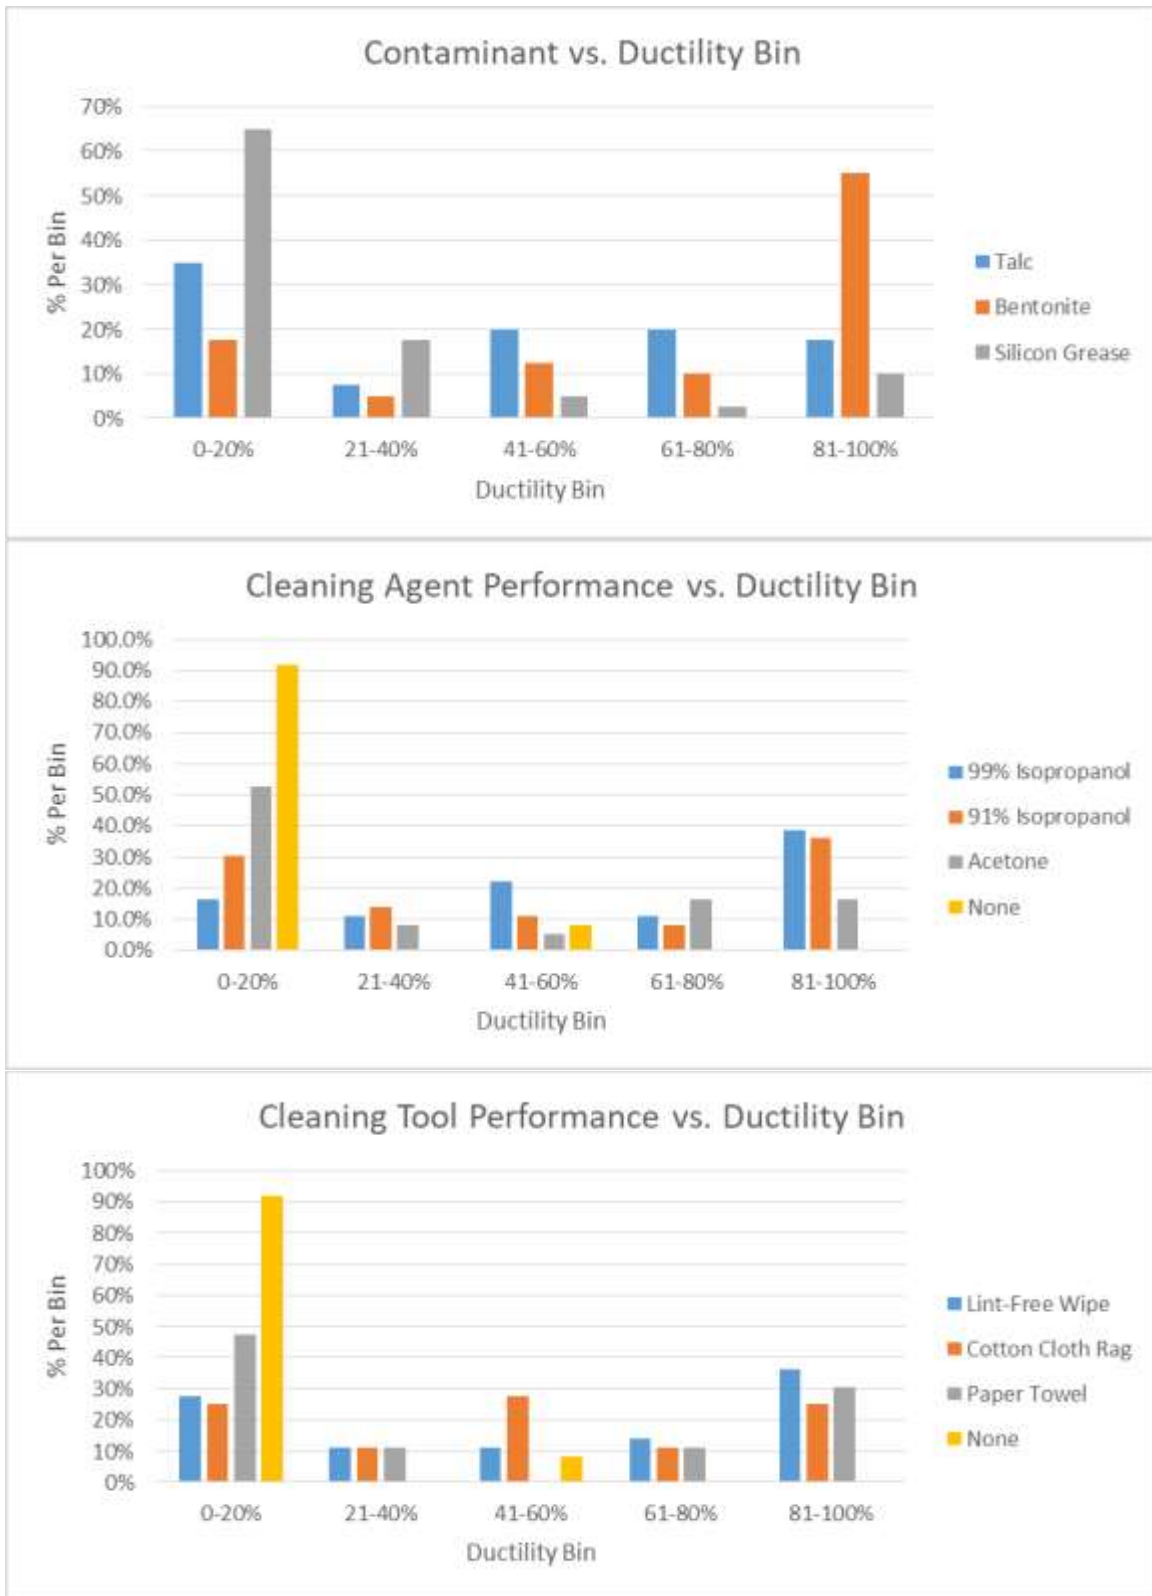
Figure 16. Combined decohesion test results

Figure 16 through **Figure 18** show combined results from the 120-run test matrix. The combined results charts help show general trends per contaminant, agent, and tool. **Figure 19** through **Figure 21** show the detailed results, broken down by the specific contaminant-agent-tool combination.
