▼
**Solvent Cleaning and PE
Joining Procedures**

Prepared by:
Gas Technology Institute
Des Plaines, Illinois

GTI-OTD FINAL REPORT

Solvent Cleaning and PE Joining Procedures

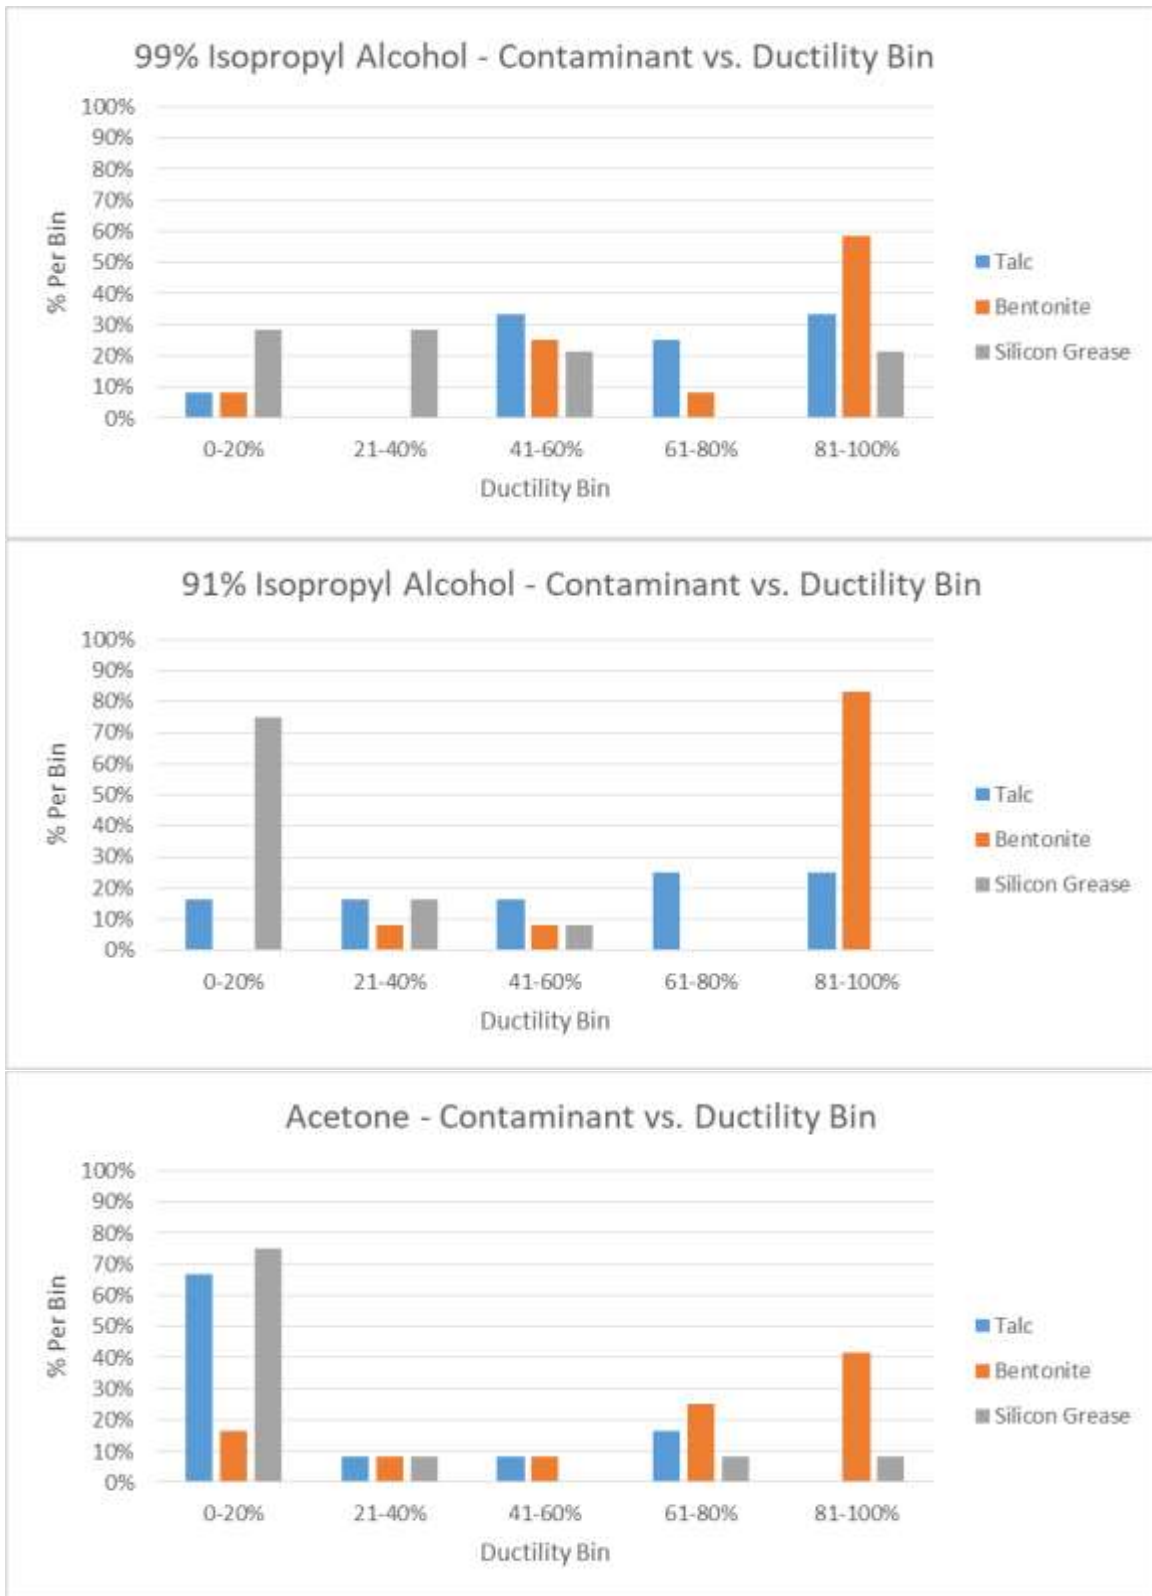
Figure 17. Cleaning agent performance with different contaminants

Figure 16 through **Figure 18** show combined results from the 120-run test matrix. The combined results charts help show general trends per contaminant, agent, and tool. **Figure 19** through **Figure 21** show the detailed results, broken down by the specific contaminant-agent-tool combination.

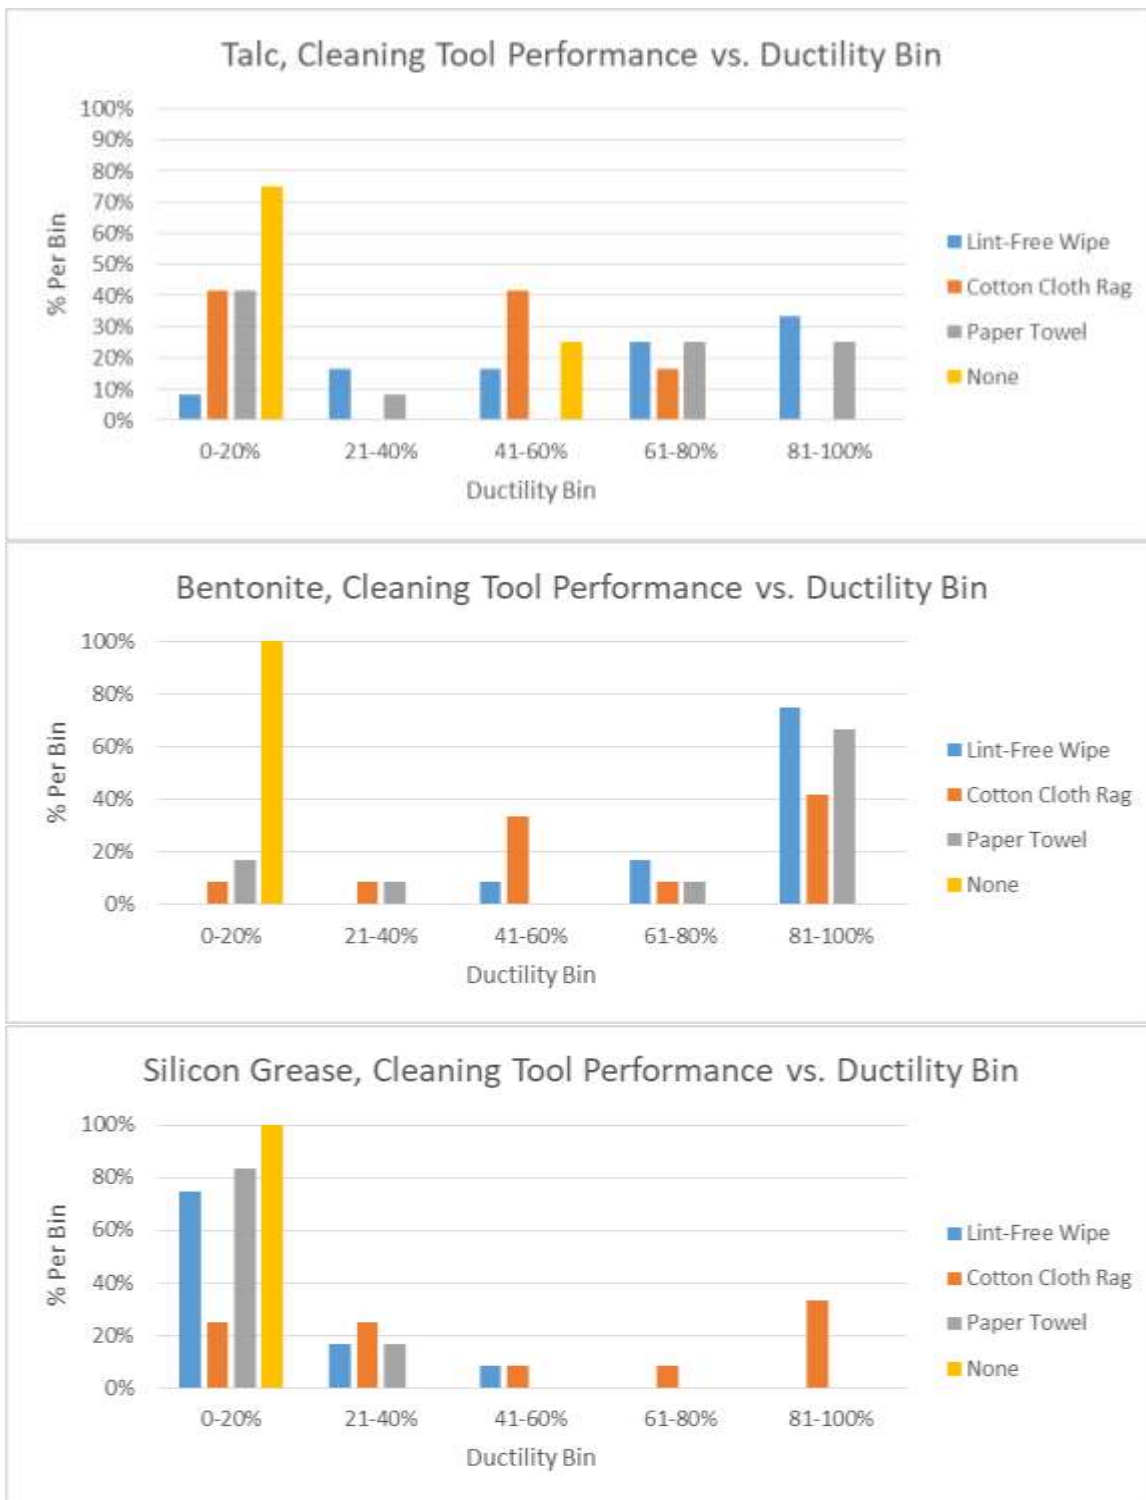
Figure 18. Cleaning tool performance with different contaminants

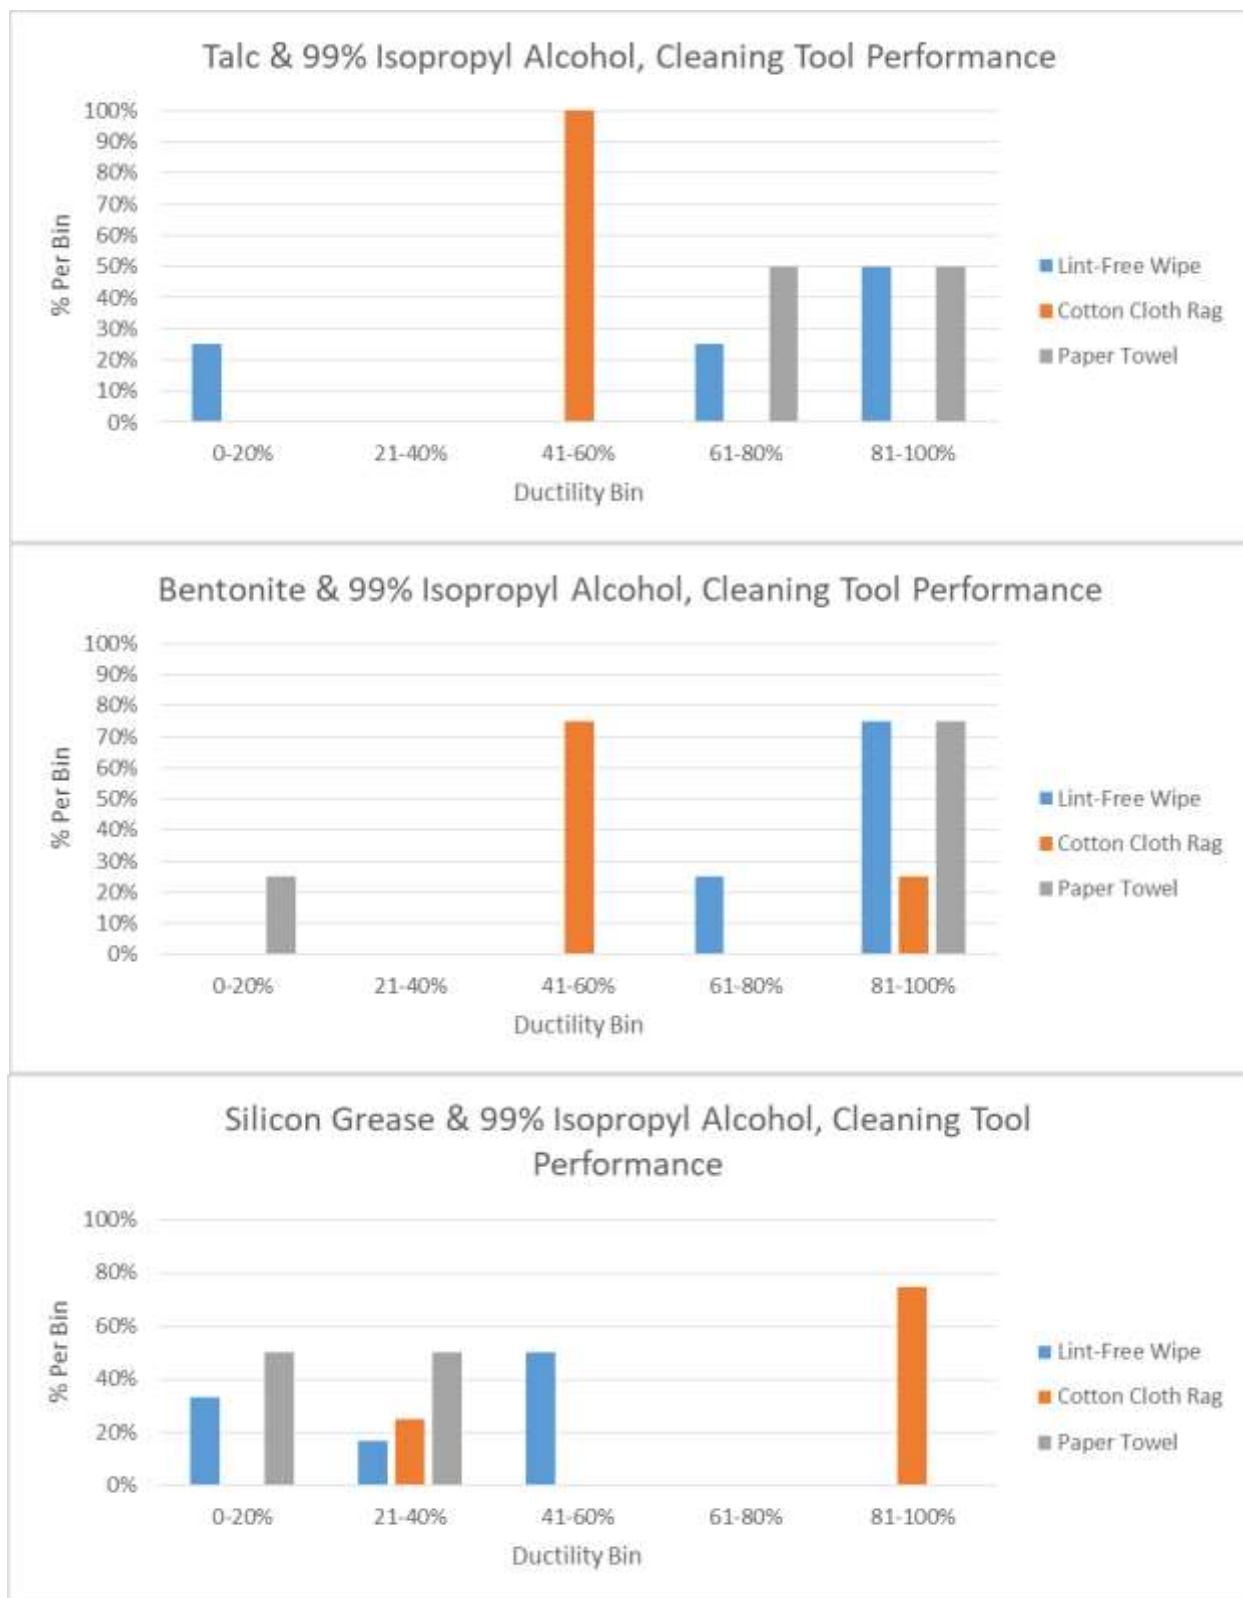
Figure 19. Detailed results, 99% isopropyl alcohol

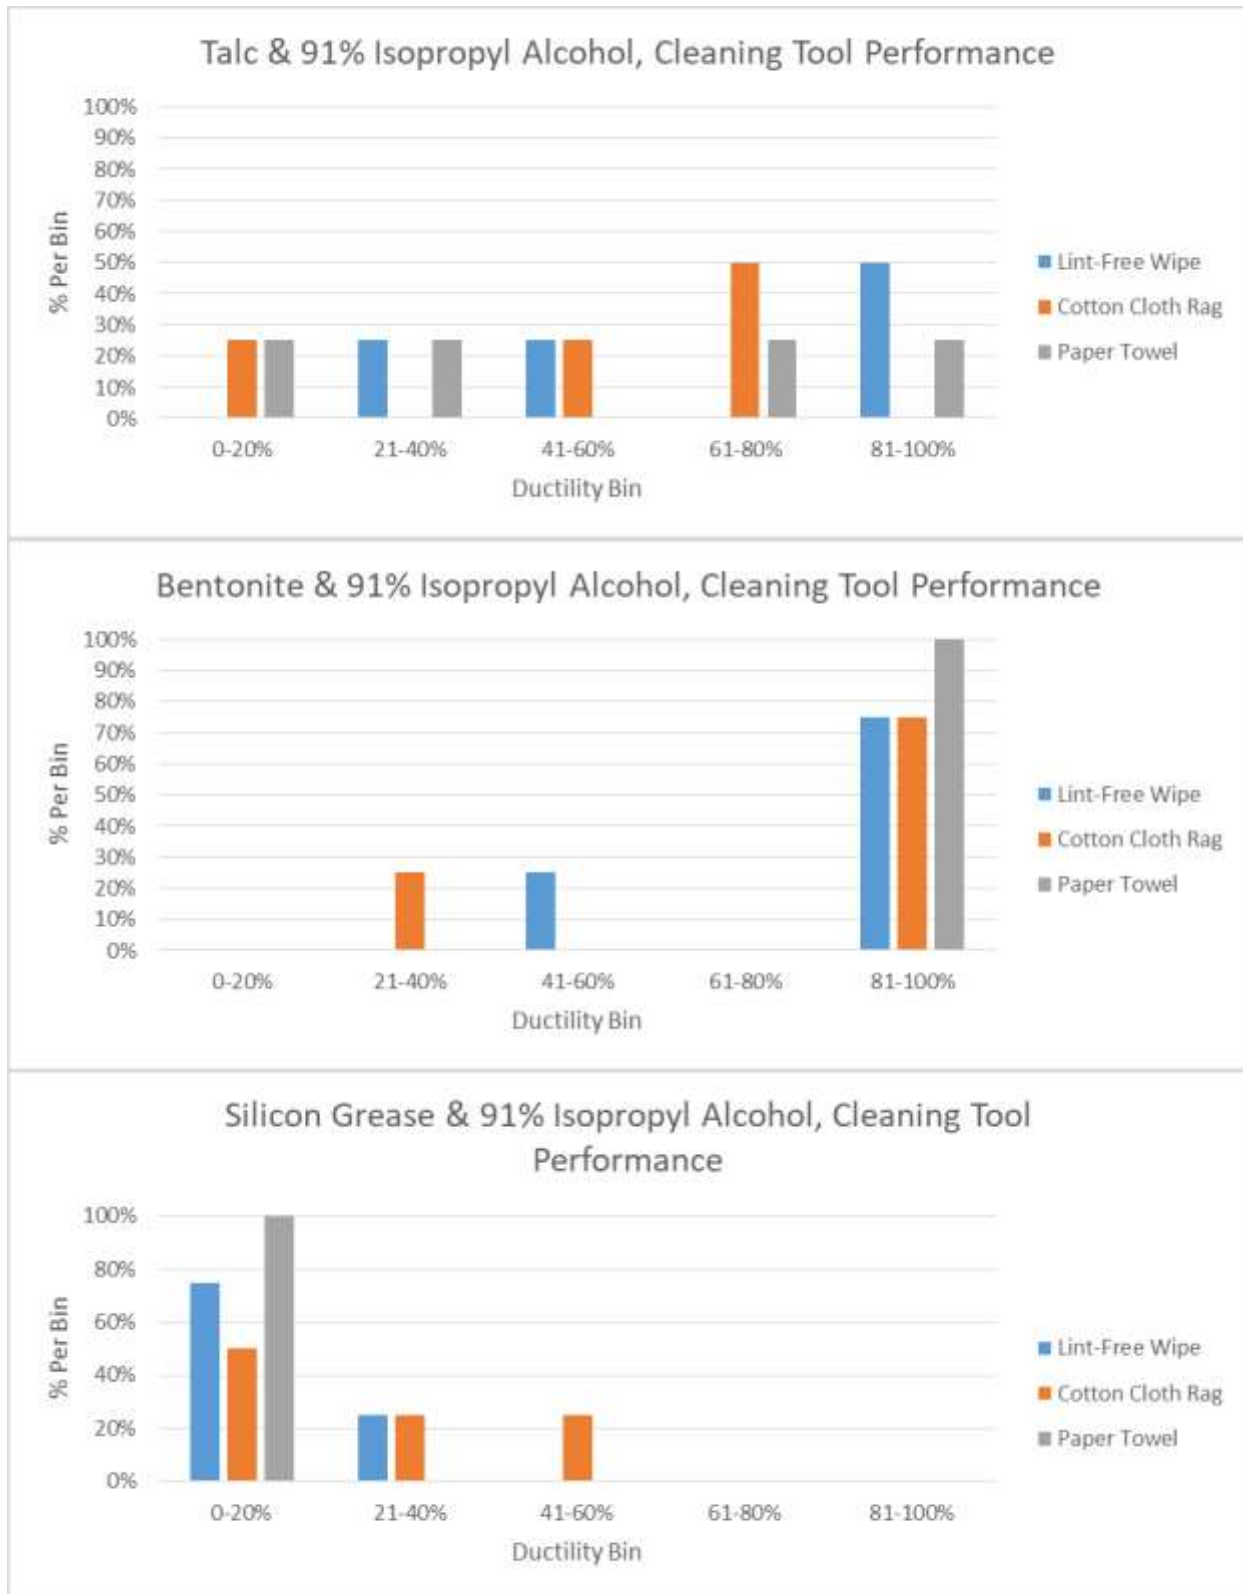
Figure 20. Detailed results, 91% isopropyl alcohol

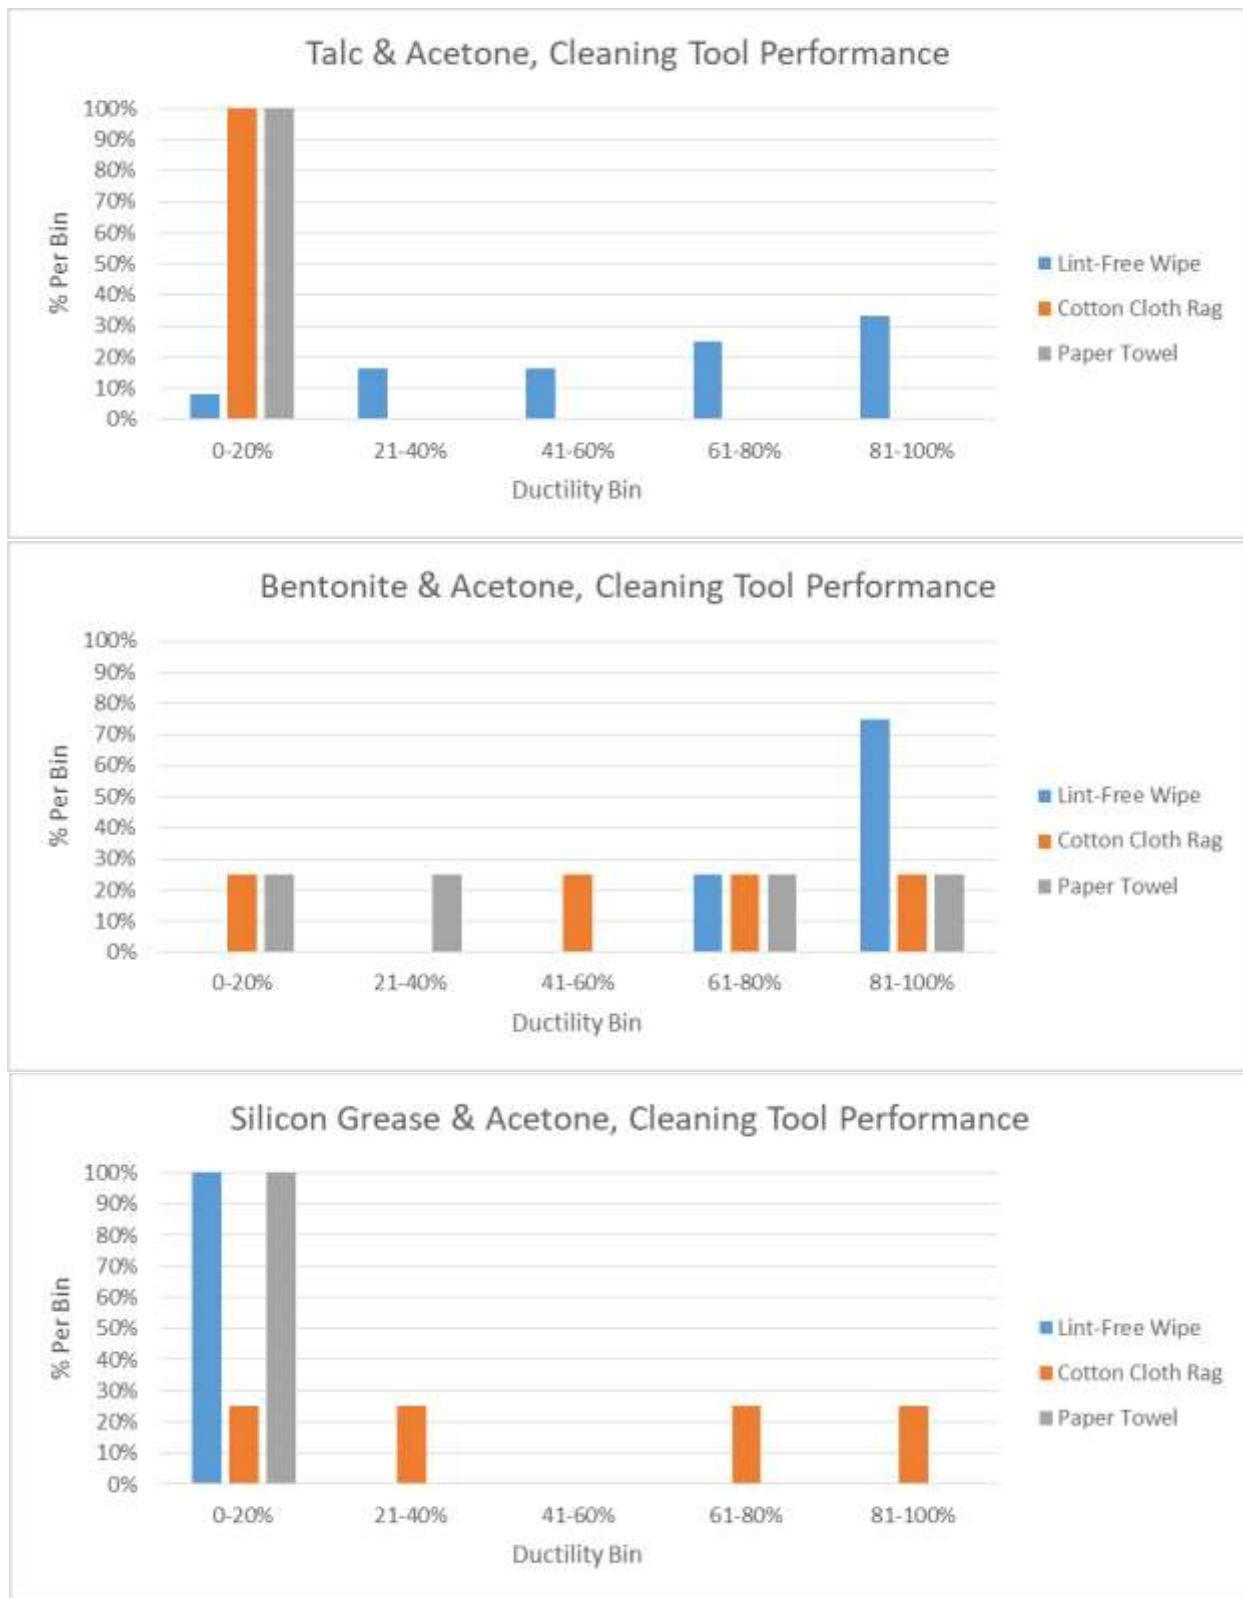
Figure 21. Detailed results, acetone

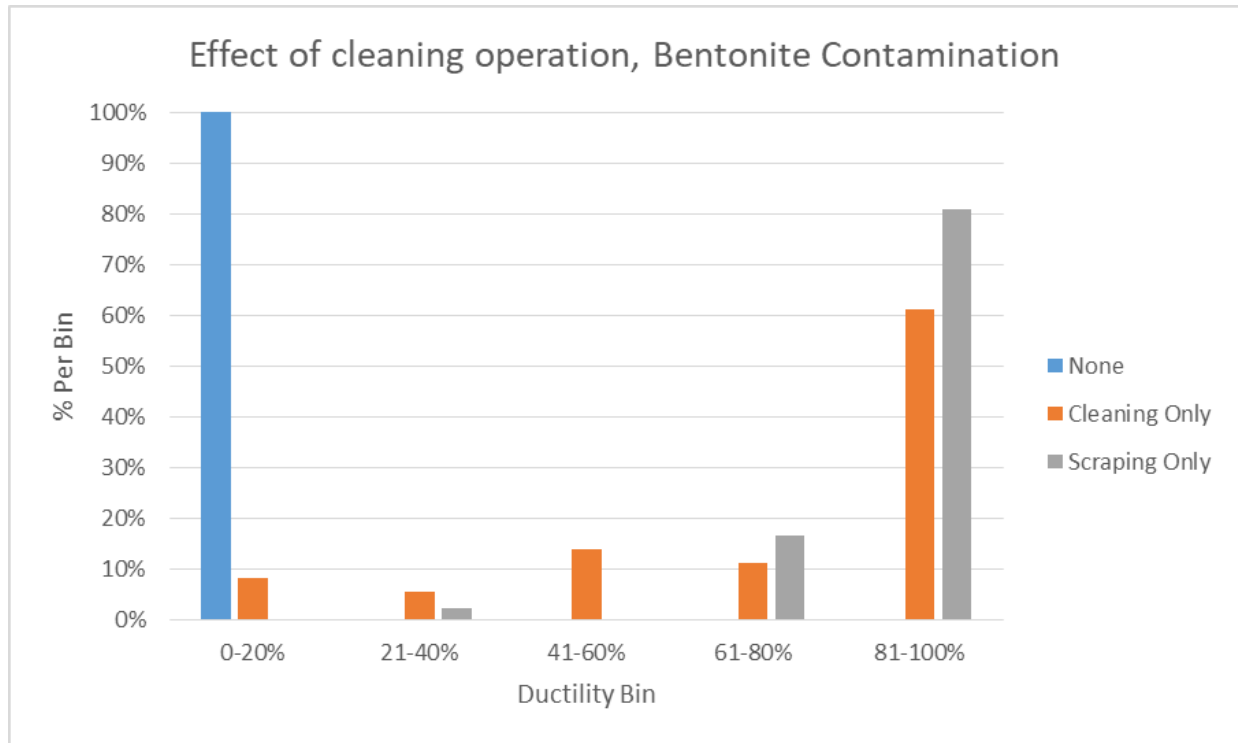
Figure 22 shows a comparison of the overall decohesion test results from pipes contaminated with bentonite. This comparison provides an illustration of the general contribution of solvent cleaning and scraping, where joints fused with no cleaning or scraping consistently fall in the 0-20% ductility bin (as expected), joint fused with solvent cleaning alone fall in all ductility bins, and joints fused with only scraping predominantly fall in the top two ductility bins. This suggests that both solvent cleaning and scraping must be used to consistently achieve 100% ductility by using the solvent cleaning to remove loose dirt and then scraping to remove the outer layer of the pipe together with any contaminant that may be adhering to or embedded in it.

Figure 22. Comparison of cleaning operations with bentonite contamination, overall decohesion results

- Solvent cleaning should be used to remove loose dirt and the bulk of surface contaminants before scraping.
 - This is further supported by the scraping-only test results from OTD Project 2.14.e *Guidelines/Best Practices for Scraping PE Pipe and Fittings*, shown in **Figure 22**.
- More than a single wiping pass should be required due to the variability in contamination removal of any single pass.
 - Each subsequent wiping pass should be within the area of the preceding wiping pass to avoid reintroduction of contamination from outside of the first wiping pass area.
- Any wiping pass should be made with a new cleaning tool to avoid reintroduction of contamination from a used cleaning tool.
- Any wiping pass should be made in the same single direction to avoid or minimize spreading of contamination that does not get removed by the current or previous pass.

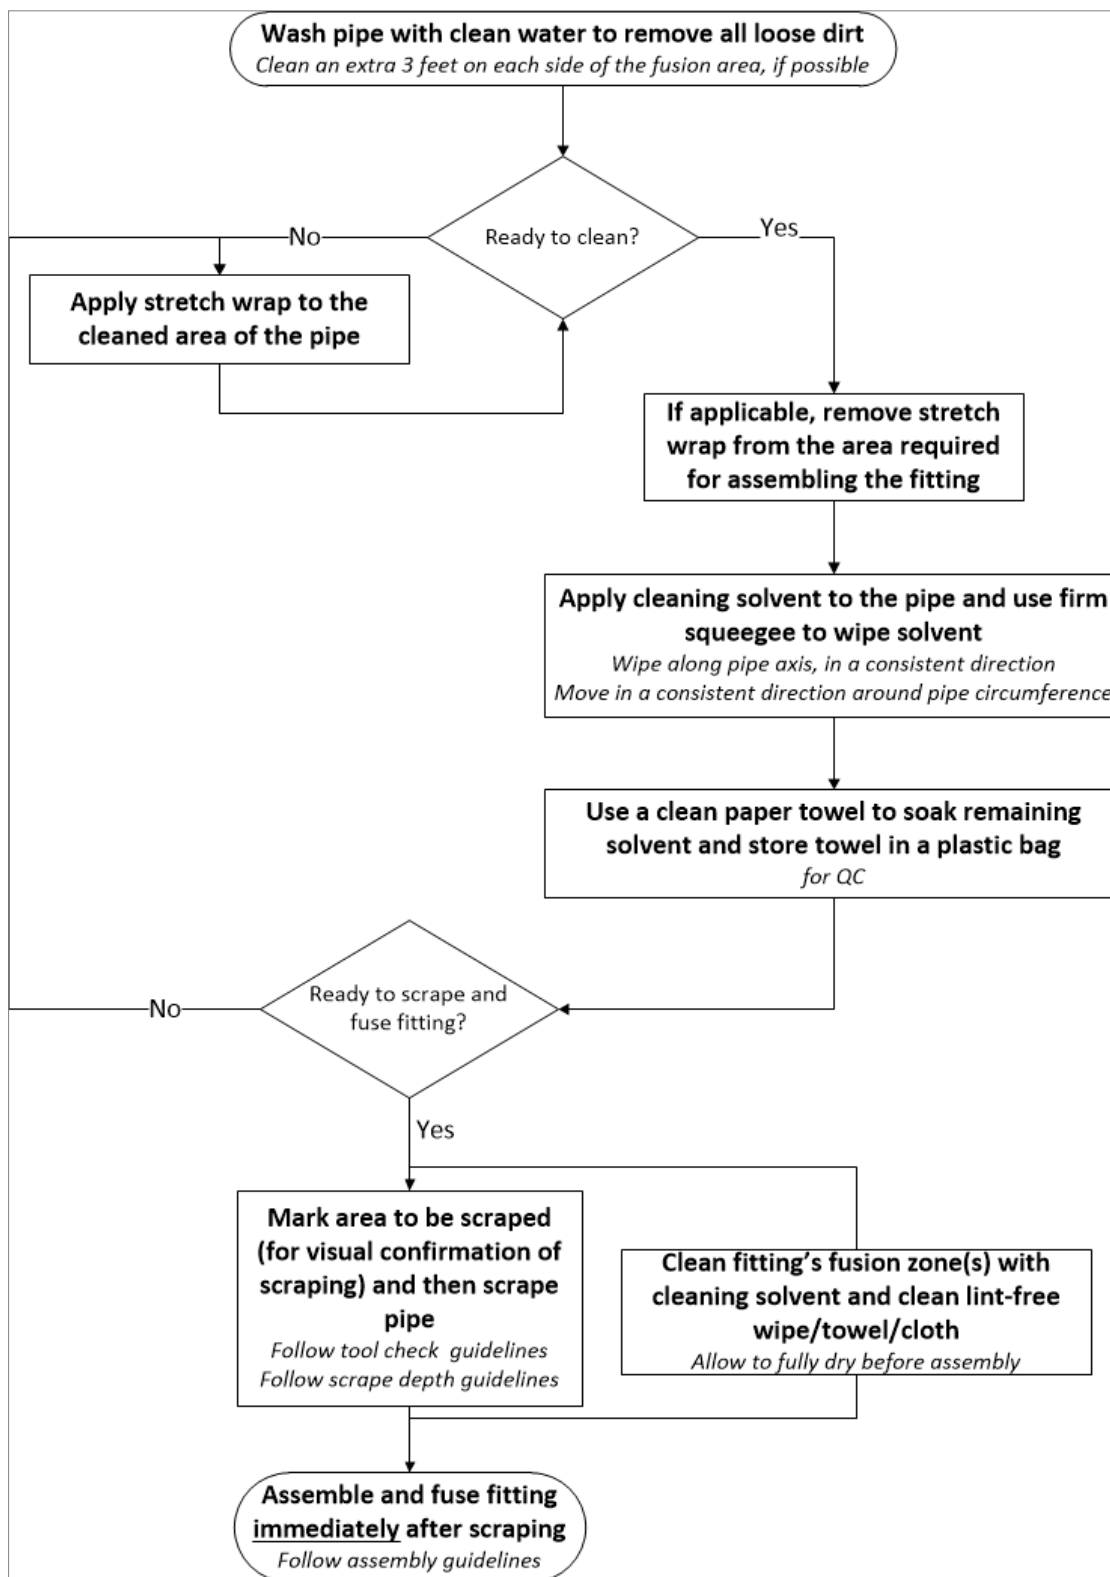
Figure 23 shows a top-level generic scraping procedure guideline incorporating the lessons learned during this project, addressing contamination prevention in particular. The rationale behind this procedure is that all contamination will be removed prior to scraping and then minimizing the chances of the scraped pipe getting contaminated. The critical contamination avoidance aspects of the proposed procedure are (in chronological order):

Figure 23. Top-level generic scraping procedure incorporating best-practices

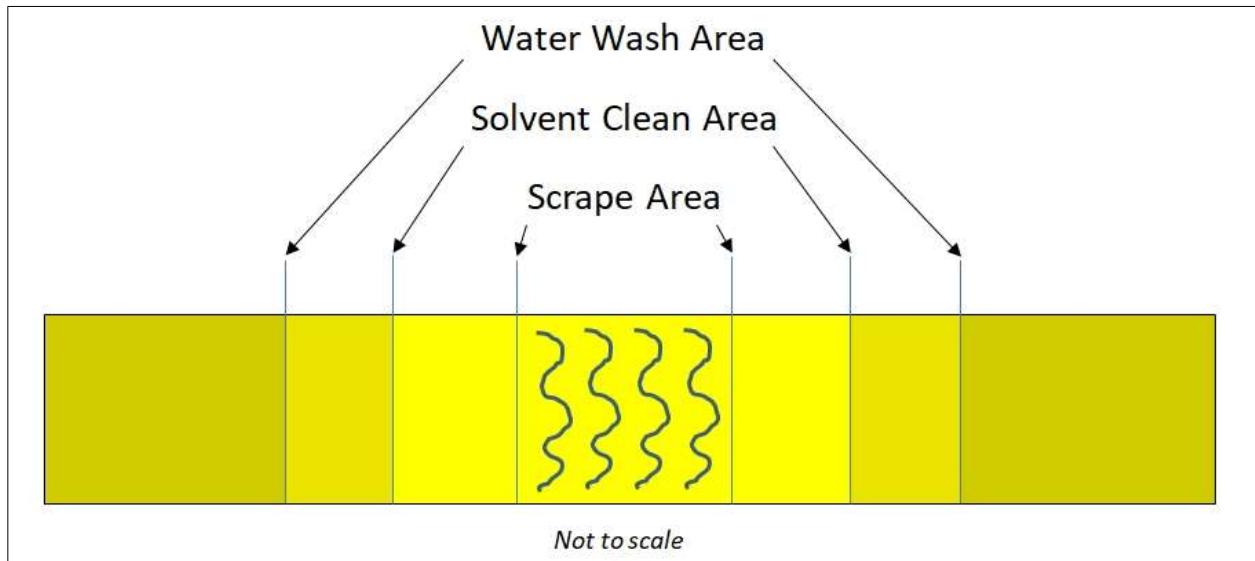
Figure 24. Schematic of cleaned areas for a saddle fitting

Figure 24 and **Figure 25** show schematics of the cleaned areas for saddle and coupling fittings, respectively.

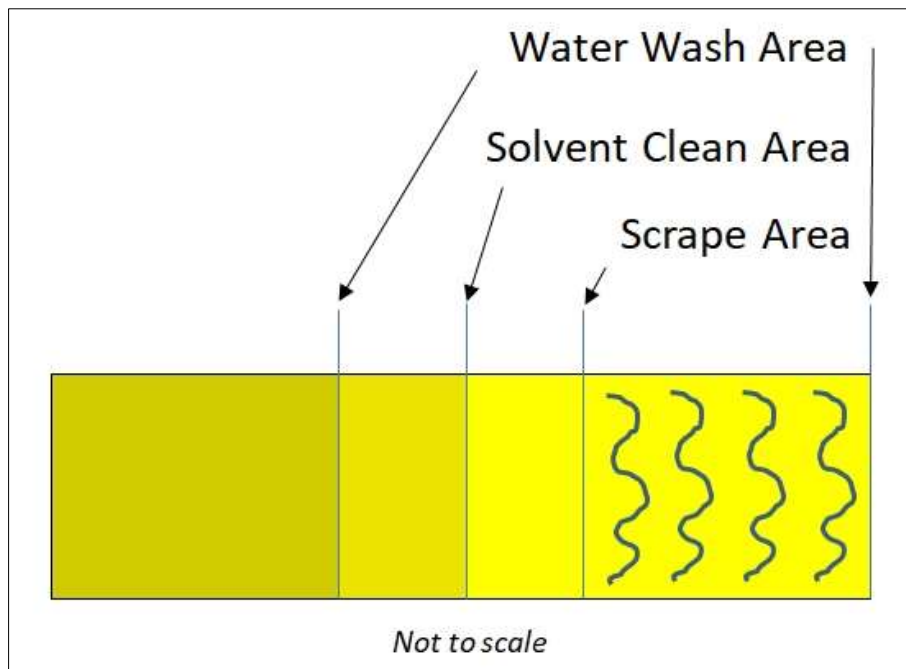
Figure 25. Schematic of cleaned areas for a coupling fitting

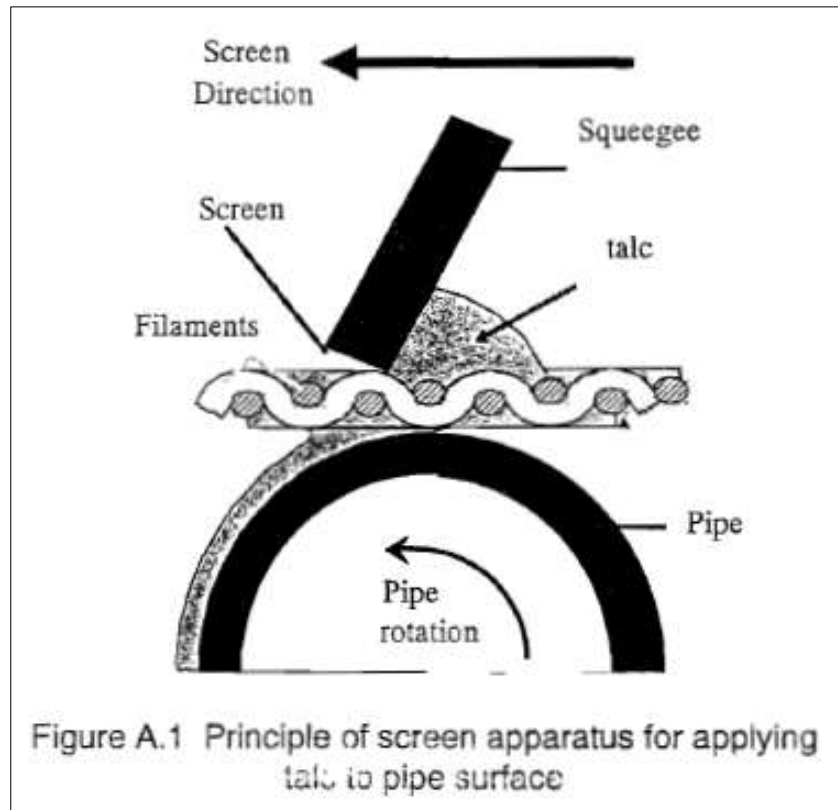
The pipe contamination apparatus was constructed in order to contaminate pipe in a consistent manner with a fine powder (talc, bentonite). The apparatus was built to meet the specifications given in the UK standard WIS-32-4-08 *Specification for the Fusion Jointing of Polyethylene Pressure Pipeline Systems Using PE80 and PE100 Materials* (see **Figure 26**).

Figure 26. Figure A.1 from WIS-32-4-08

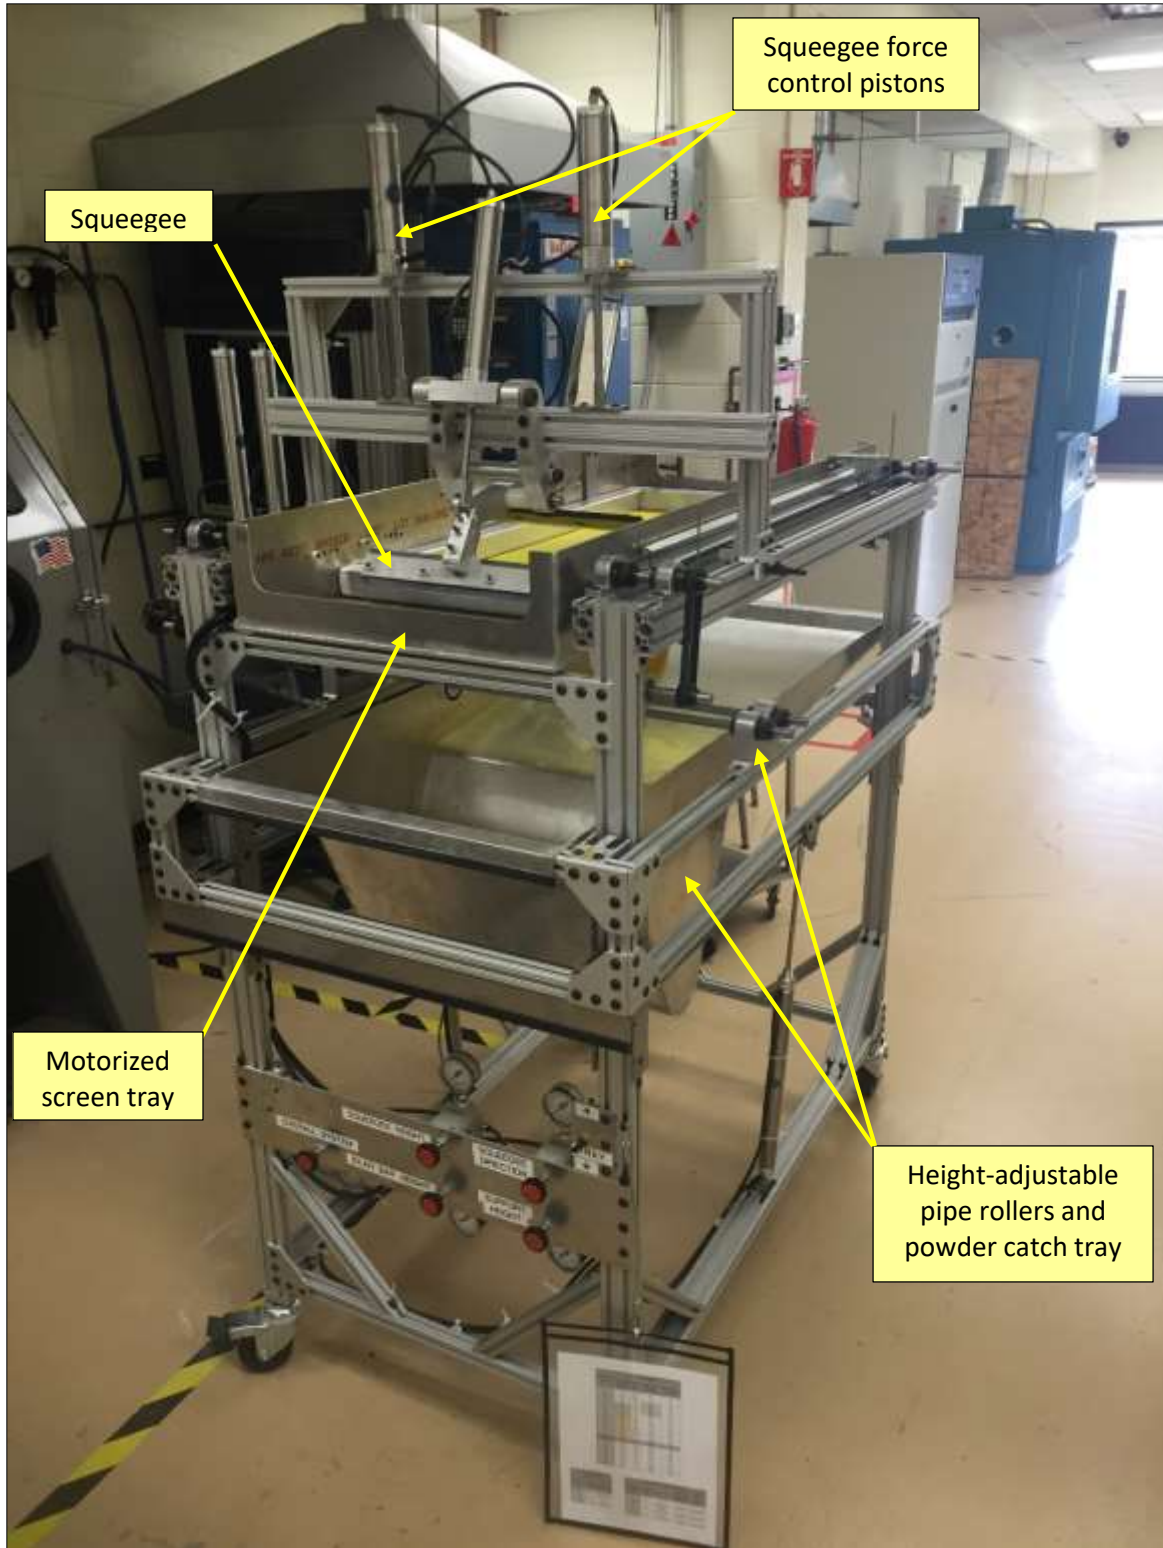
The apparatus has a computer controlled, electrically driven screen tray and a pneumatically actuated squeegee. Tray speed and movement distance are programmable, and squeegee force and manually adjustable via precision air pressure regulators. The pipe underneath the strainer is rotated synchronously with the motion of the tray. The apparatus is also adjustable to accommodate a range of pipe samples from 1/2" CTS to 8" IPS.

Figure 27. Pipe contamination apparatus

Figure 27 through **Figure 30** show details of the pipe contamination apparatus.

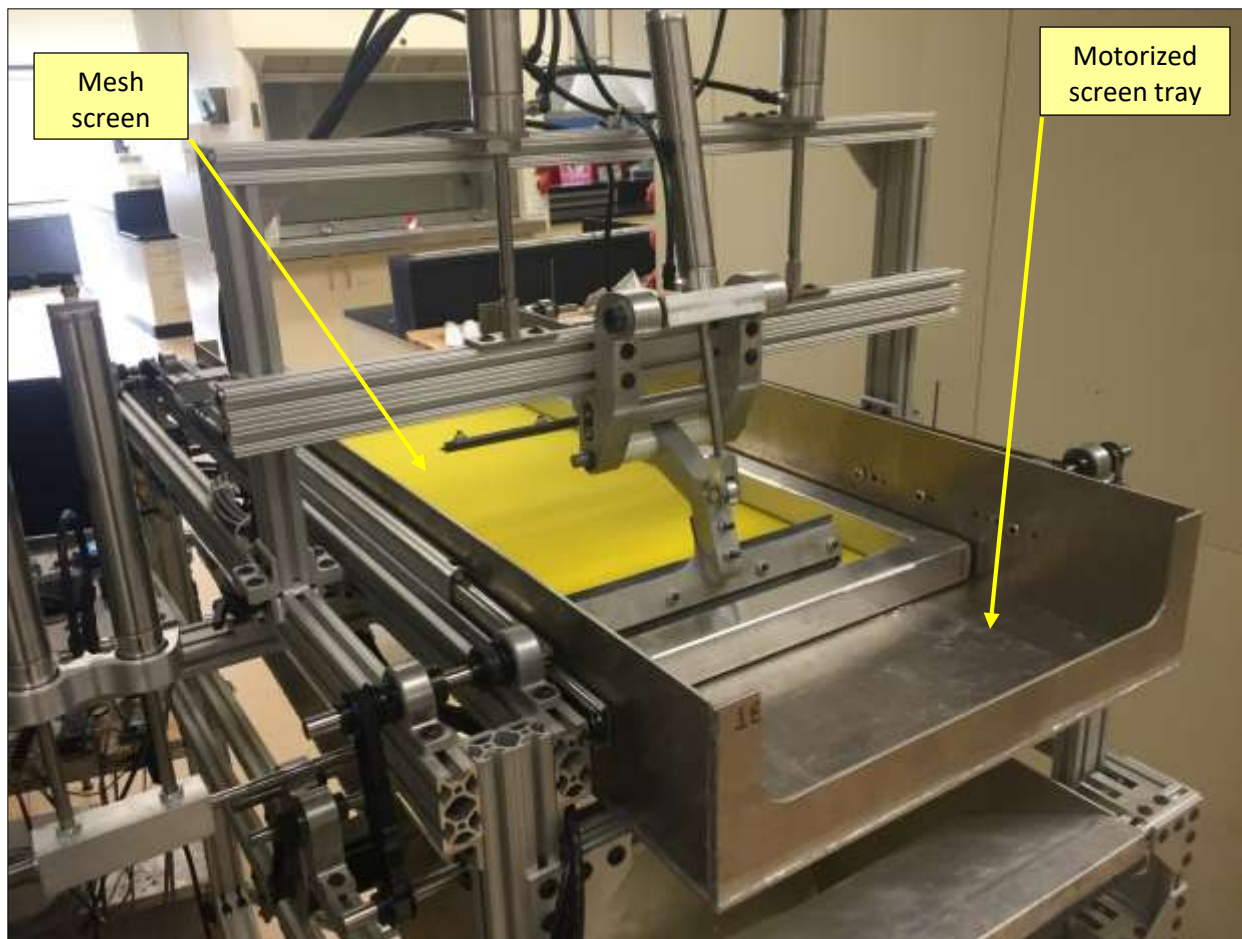
Figure 28. View of motorized strainer carriage, squeegee lowered onto strainer

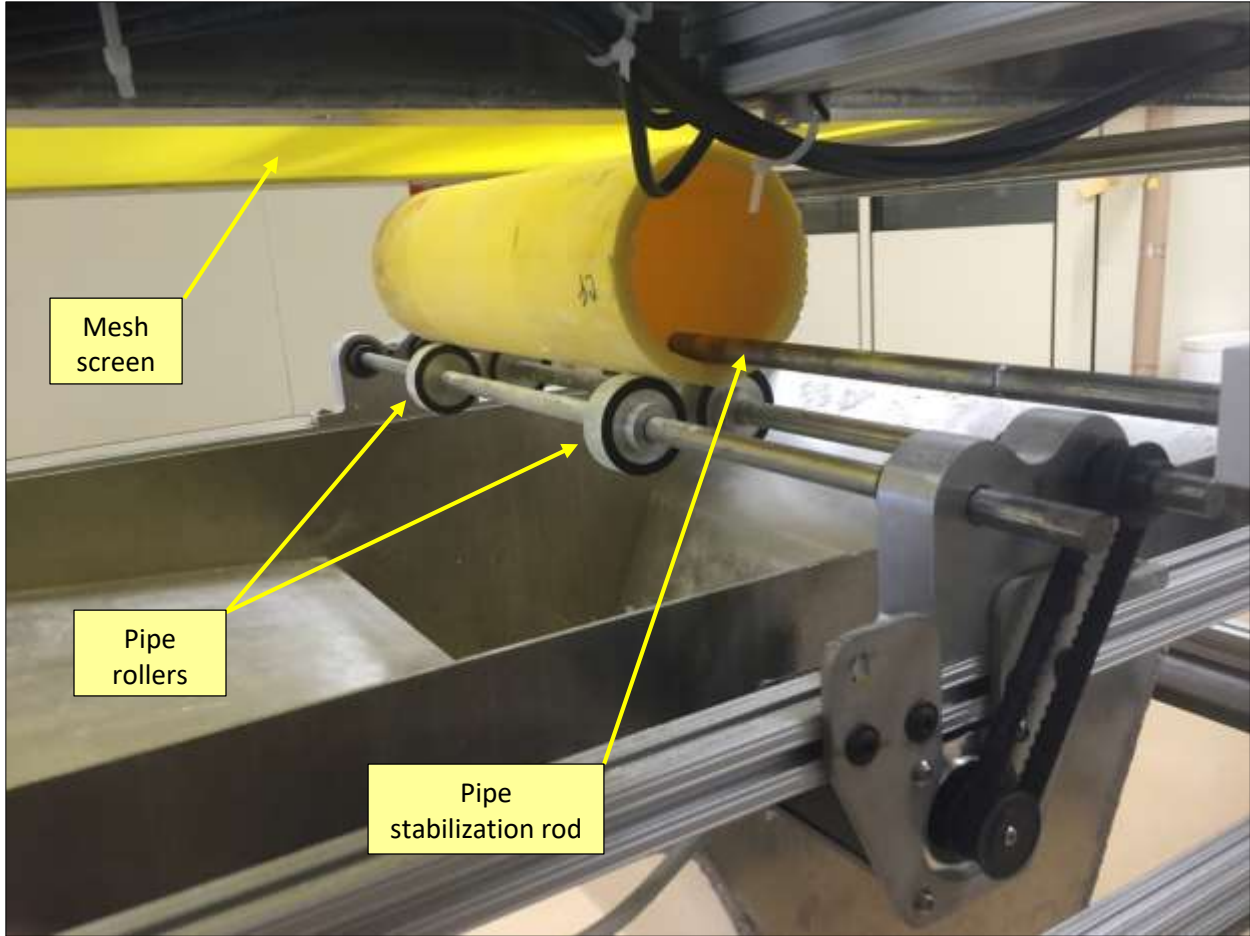
Figure 29. 2" IPS pipe sample in place for contamination

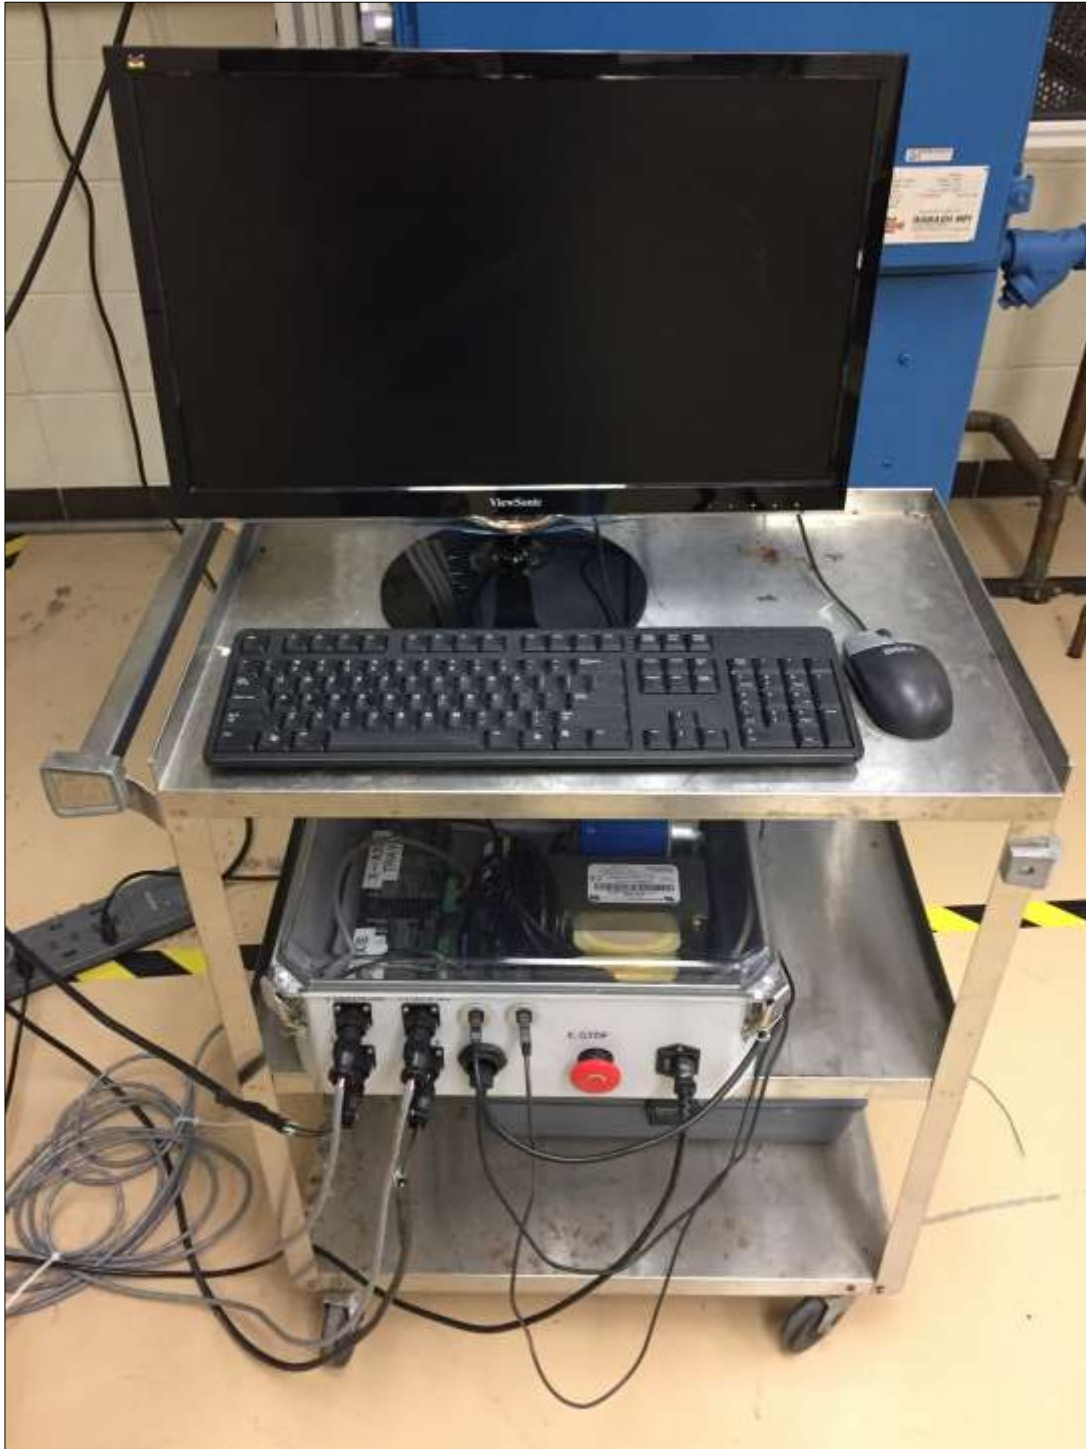
Figure 30. Pipe contaminator control console and electronics box

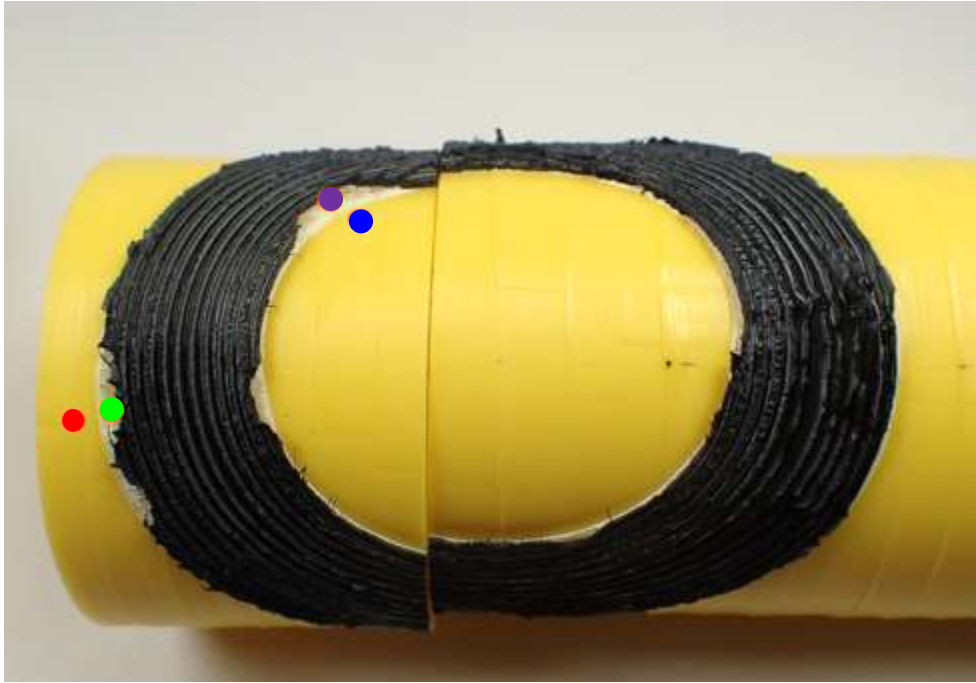
172318-001	172395-001	Talc	99% Isopropanol	Lint-Free Wipe
------------	------------	------	-----------------	----------------

Figure 31. Sample 172318-001, decohesion test result

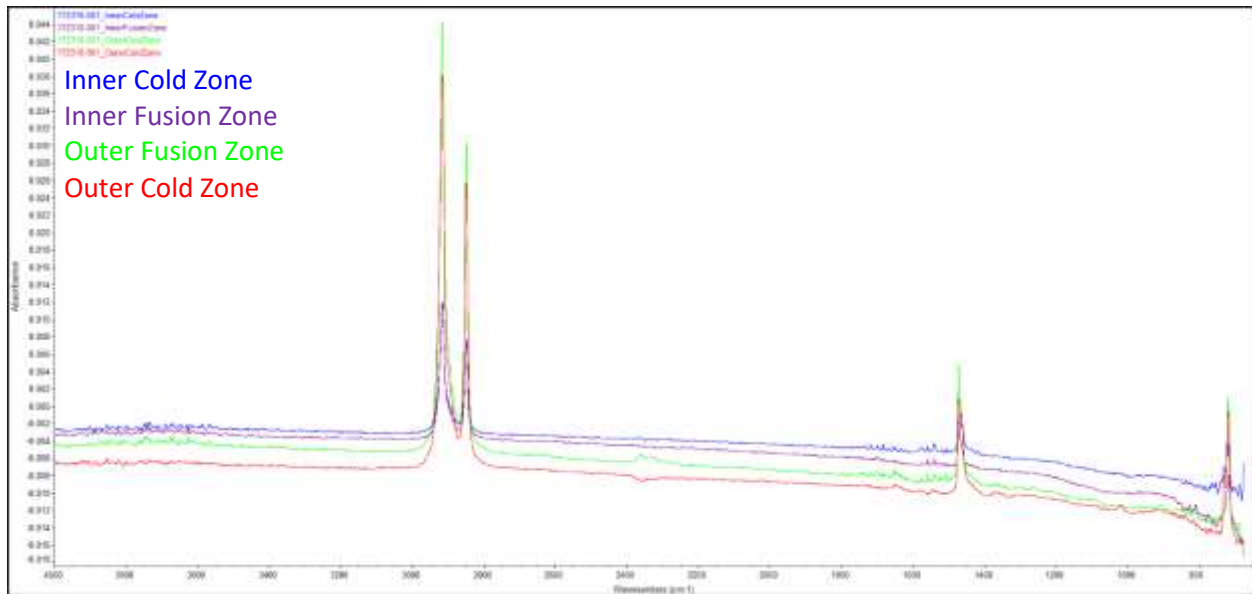
Figure 32. Sample 172318-001, FTIR spectra from decohesion test result
