▼
**Solvent Cleaning and PE
Joining Procedures**

Prepared by:
Gas Technology Institute
Des Plaines, Illinois

GTI-OTD FINAL REPORT

Solvent Cleaning and PE Joining Procedures

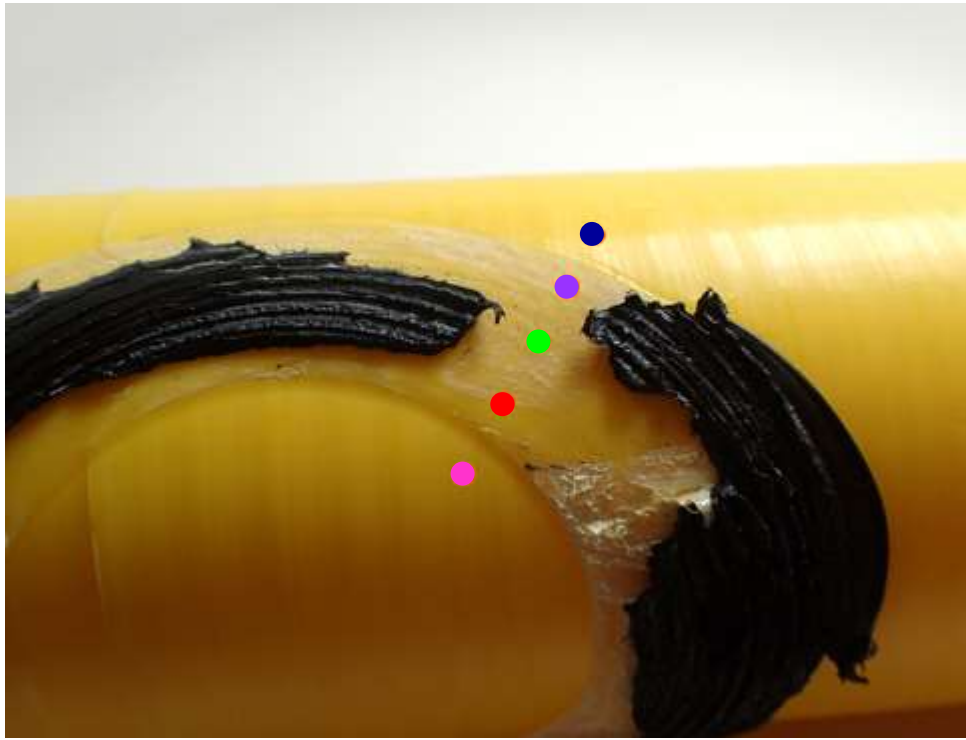
172318-002	172395-002	Talc	99% Isopropanol	Cotton Cloth Rag
------------	------------	------	-----------------	------------------

Figure 33. Sample 172318-002, decohesion test result

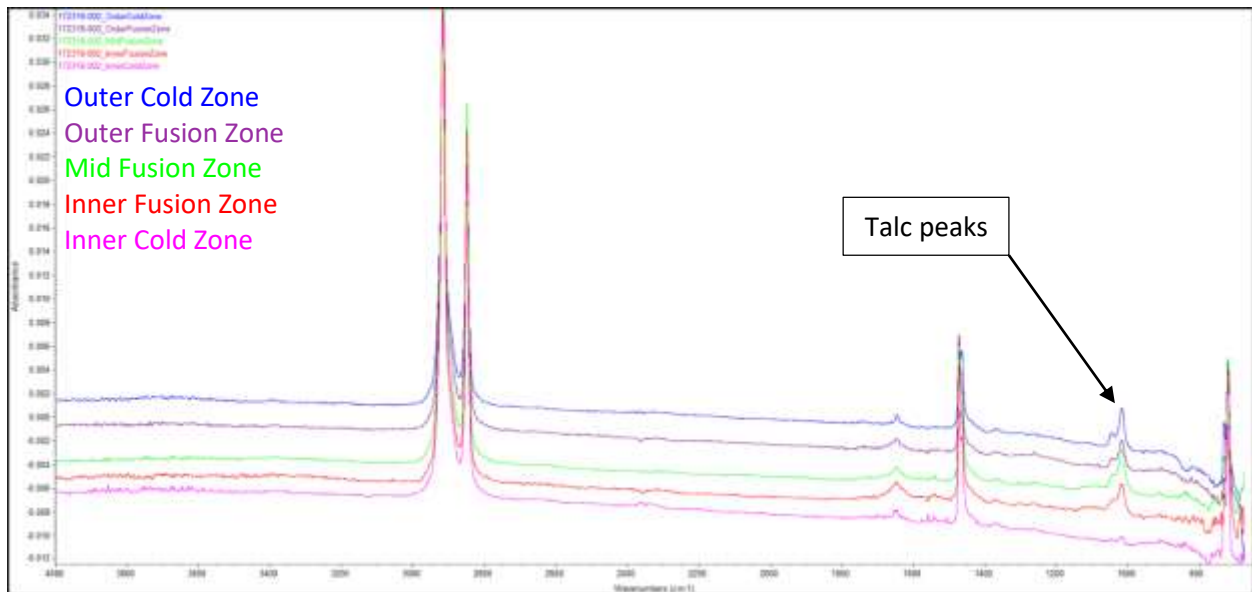
Figure 34. Sample 172318-002, FTIR spectra from decohesion test result

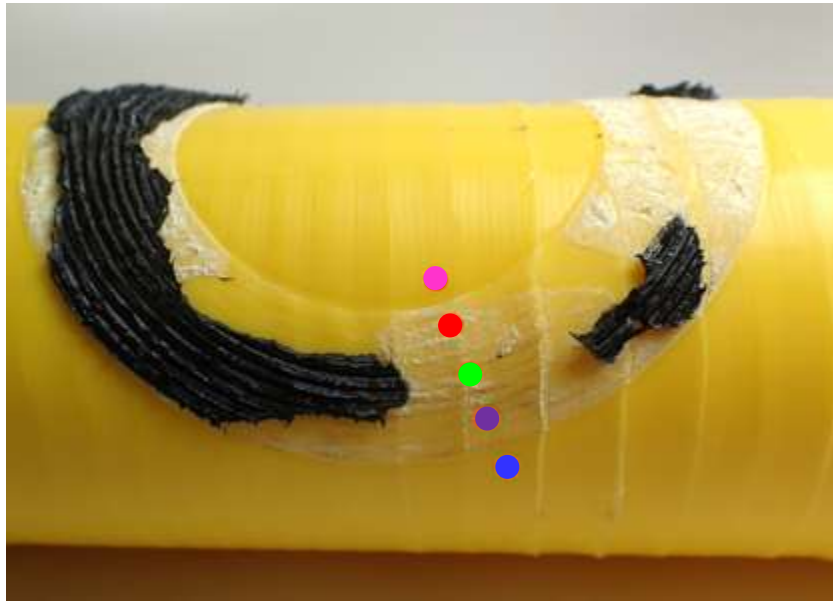
172318-003	172395-003	Talc	91% Isopropanol	Lint-Free Wipe
------------	------------	------	-----------------	----------------

Figure 35. Sample 172318-003, decohesion test result

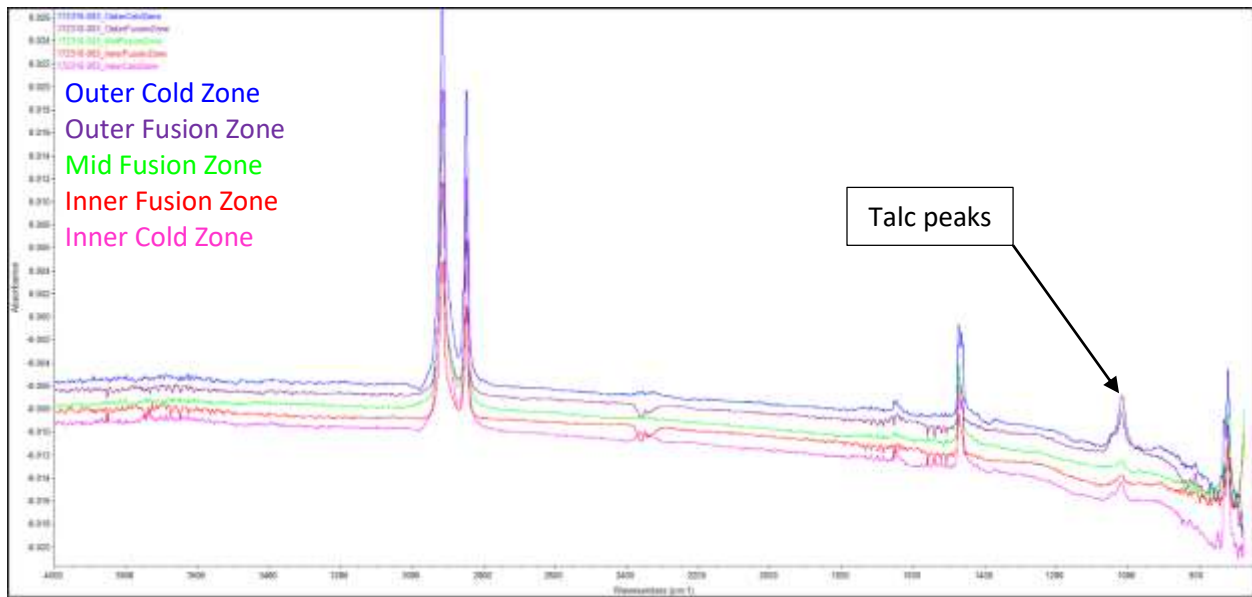
Figure 36. Sample 172318-003, FTIR spectra from decohesion test result

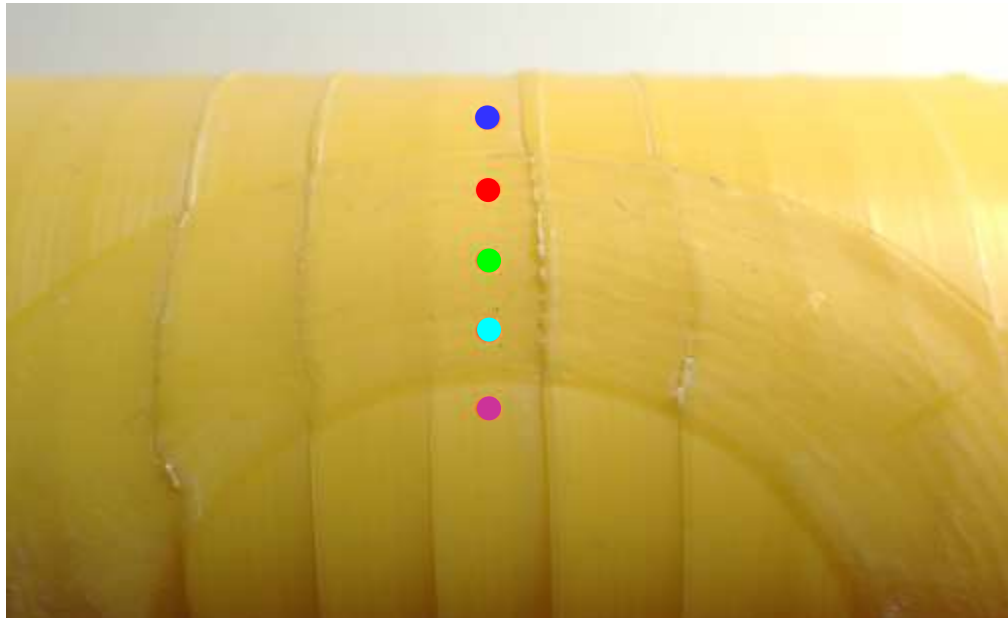
172318-004	172395-004	Talc	91% Isopropanol	Cotton Cloth Rag
------------	------------	------	-----------------	------------------

Figure 37. Sample 172318-004, decohesion test result

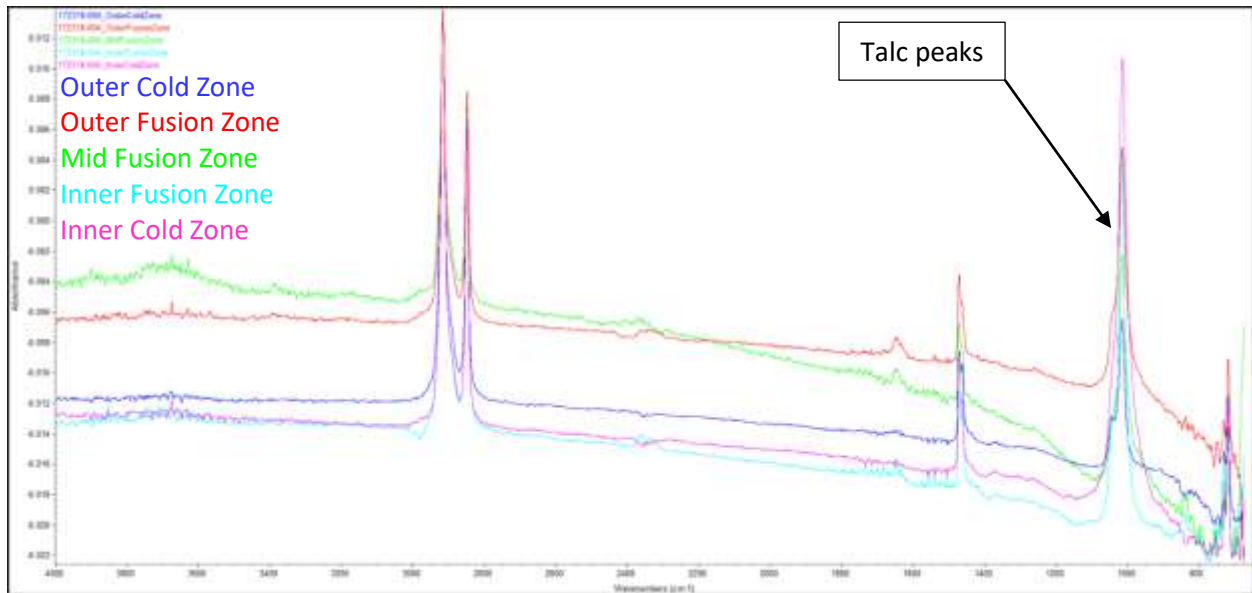
Figure 38. Sample 172318-004, FTIR spectra from decohesion test result

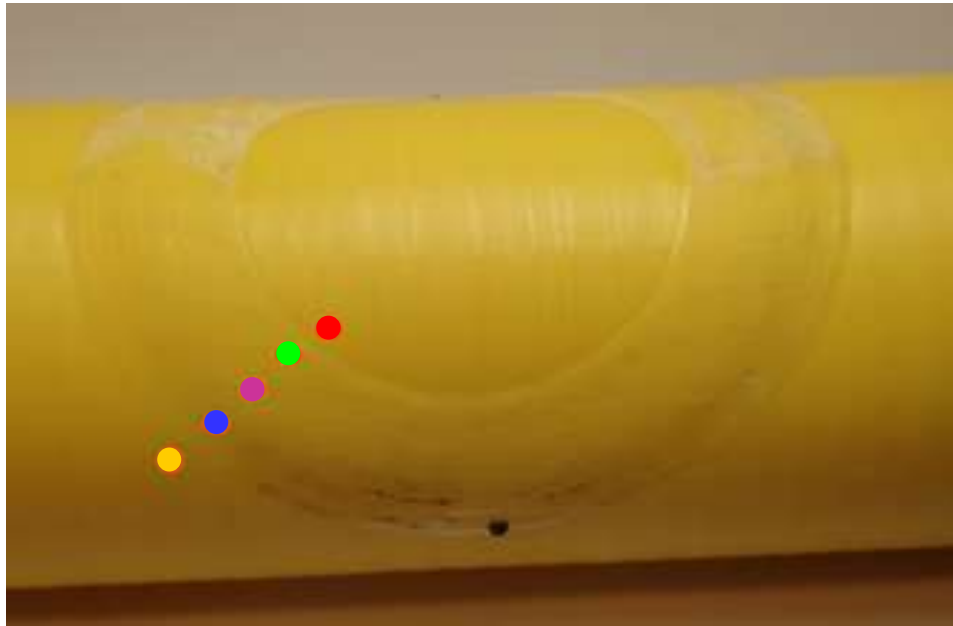
172318-005	172395-005	Talc	99% Isopropanol	Lint-Free Wipe
------------	------------	------	-----------------	----------------

Figure 39. Sample 172318-005, decohesion test result

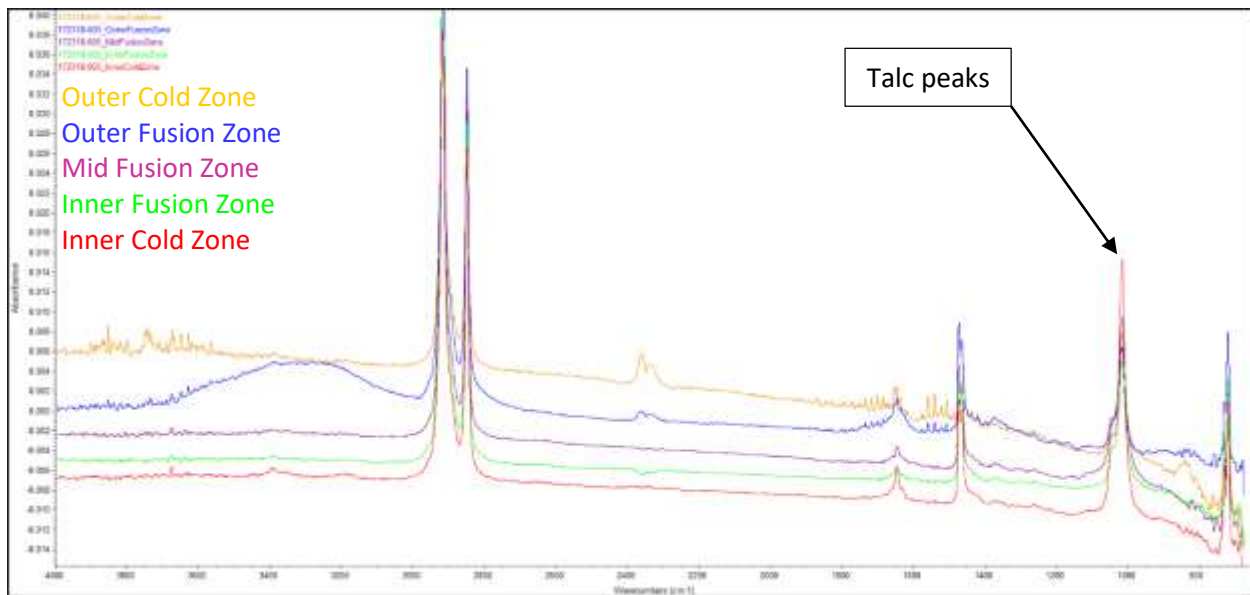
Figure 40. Sample 172318-005, FTIR spectra from decohesion test result

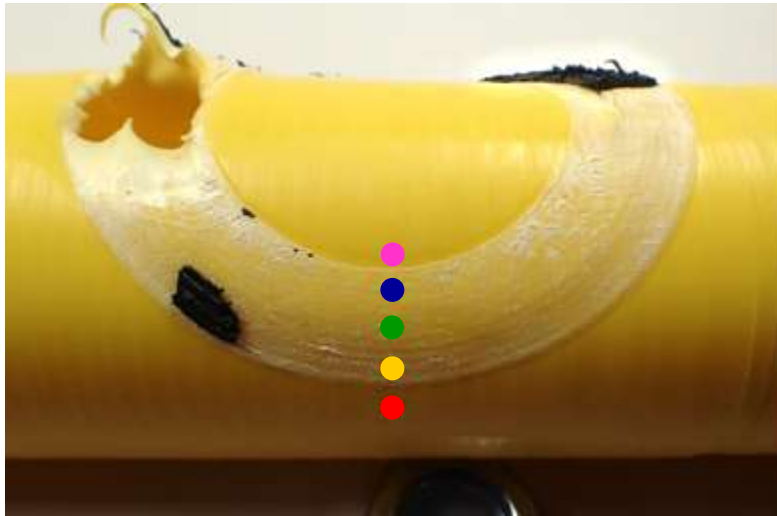
172318-006	172395-006	Talc	99% Isopropanol	Cotton Cloth Rag
------------	------------	------	-----------------	------------------

Figure 41. Sample 172318-006, decohesion test result

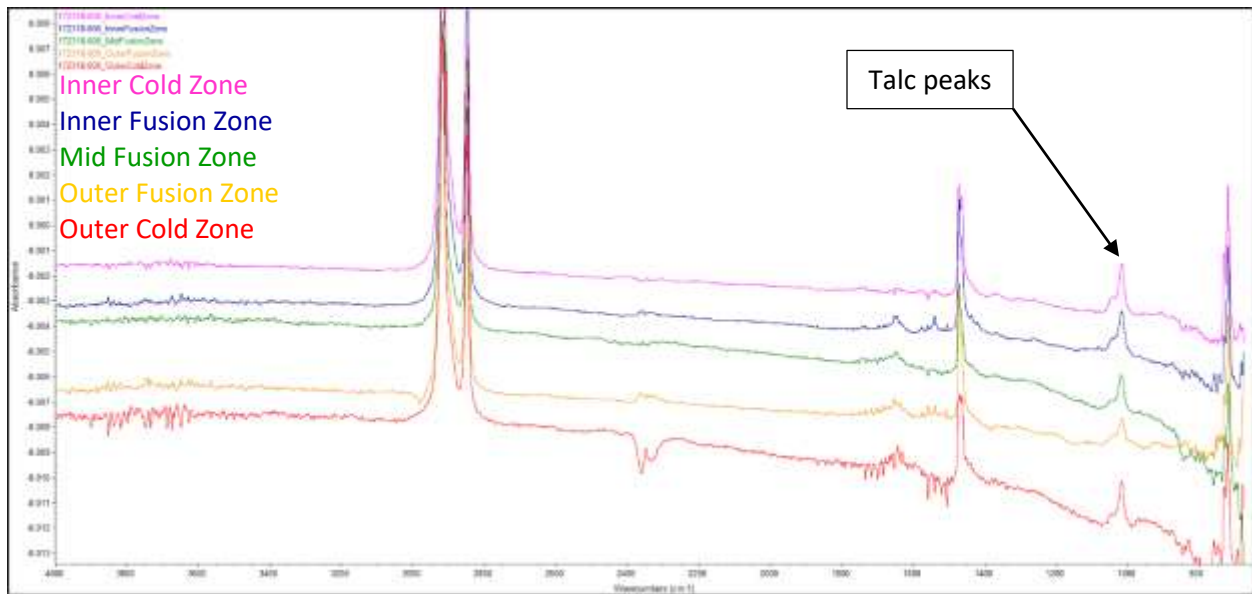
Figure 42. Sample 172318-006, FTIR spectra from decohesion test result

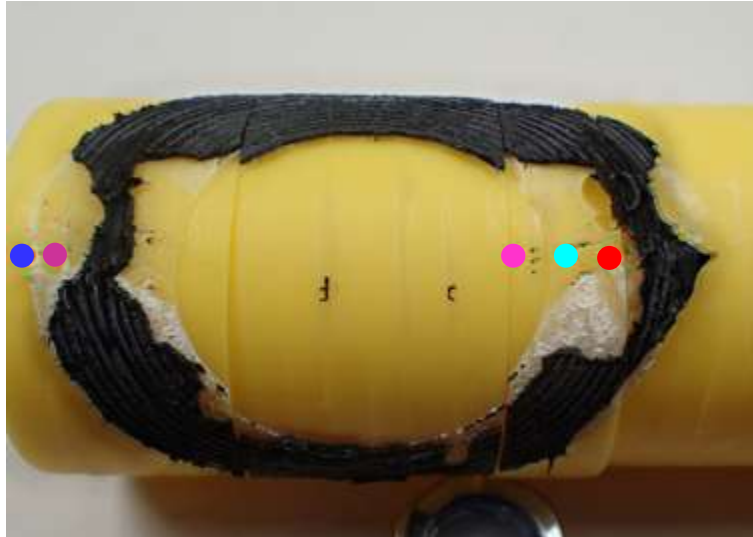
172318-007	172395-007	Talc	99% Isopropanol	Paper Towel
------------	------------	------	-----------------	-------------

Figure 43. Sample 172318-007, decohesion test result

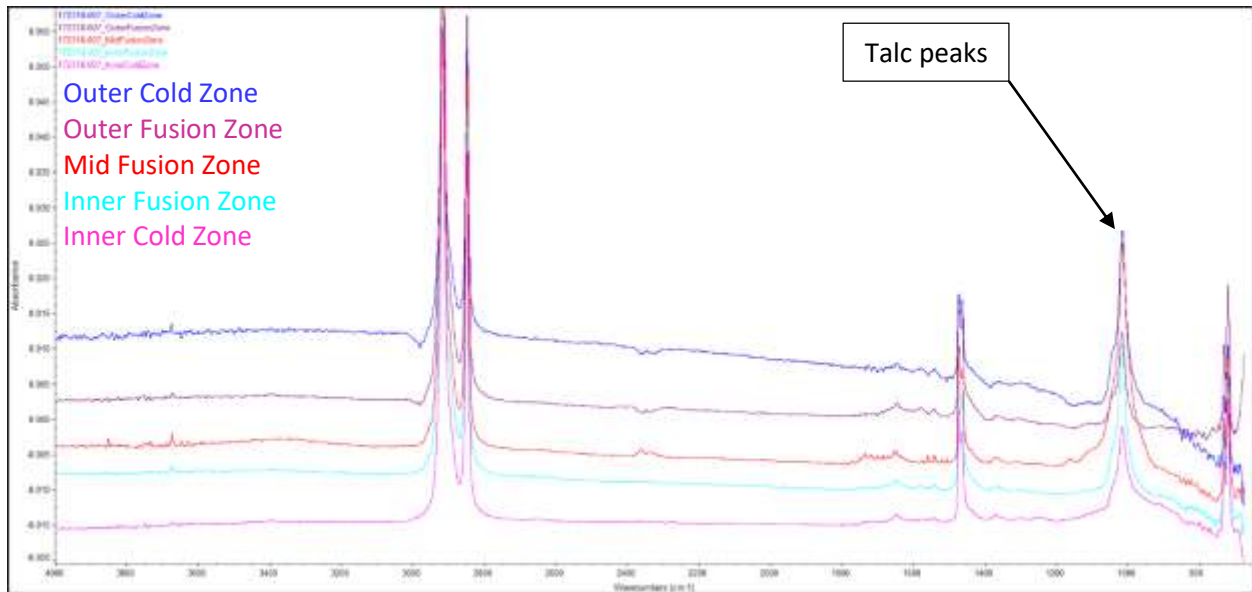
Figure 44. Sample 172318-007, FTIR spectra from decohesion test result

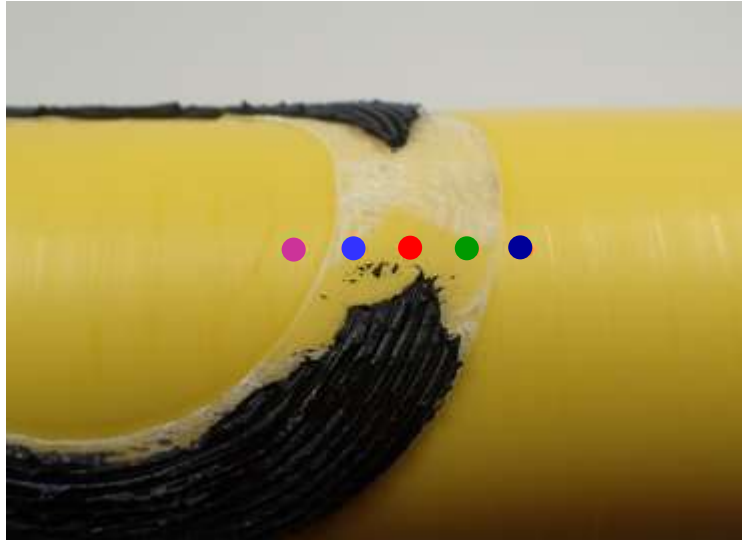
172318-008	172395-008	Talc	99% Isopropanol	Paper Towel
------------	------------	------	-----------------	-------------

Figure 45. Sample 172318-008, decohesion test result

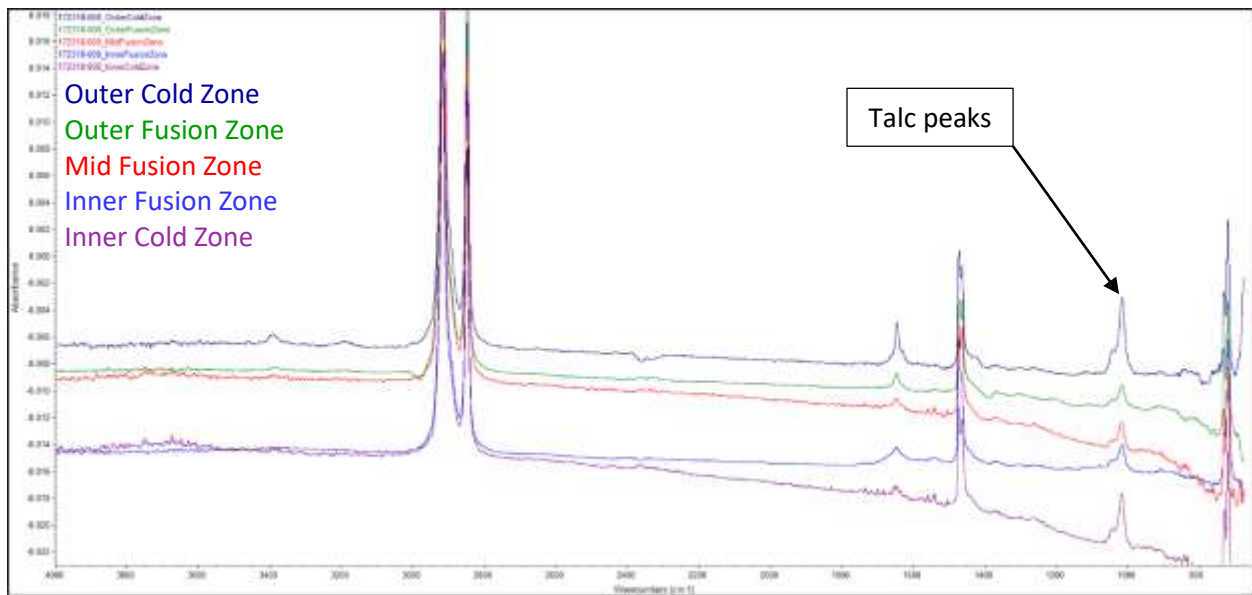
Figure 46. Sample 172318-008, FTIR spectra from decohesion test result

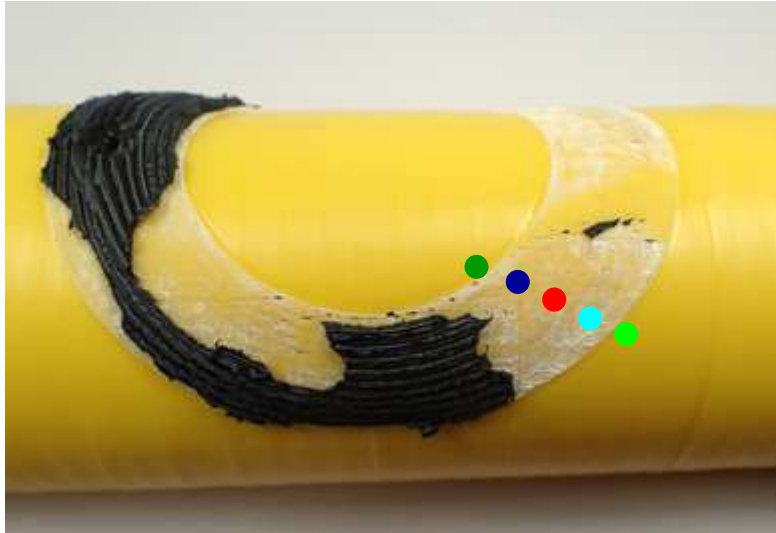
172318-009	172395-009	Talc	91% Isopropanol	Paper Towel
------------	------------	------	-----------------	-------------

Figure 47. Sample 172318-009, decohesion test result

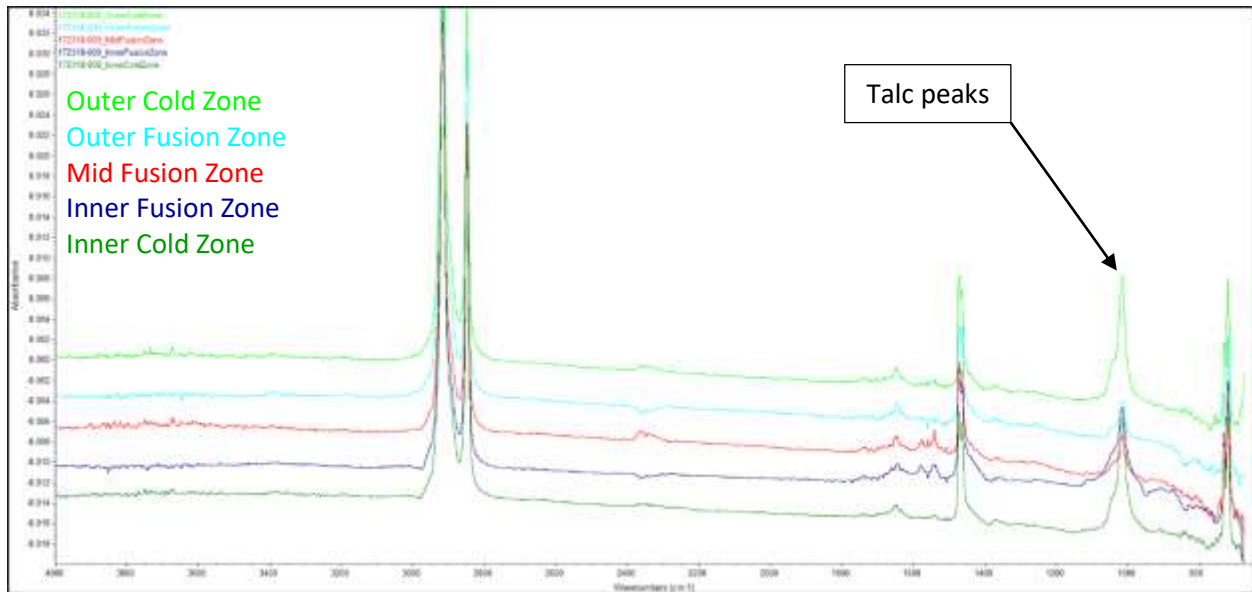
Figure 48. Sample 172318-009, FTIR spectra from decohesion test result

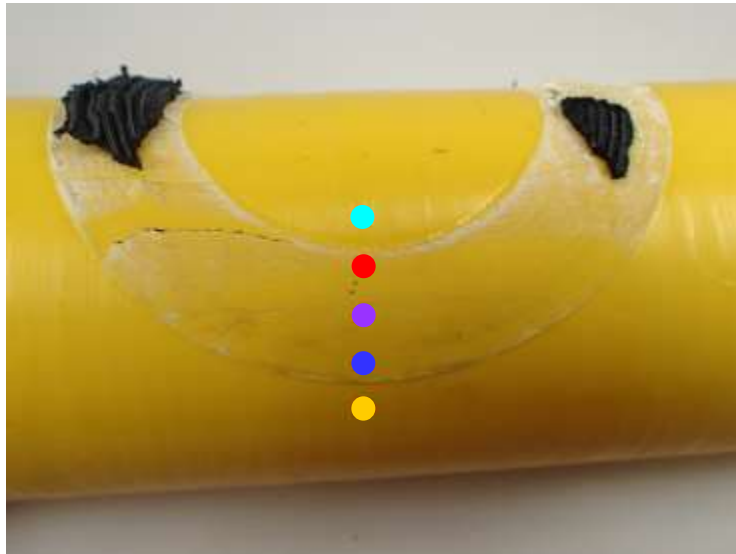
172318-010	172395-010	Talc	91% Isopropanol	Paper Towel
------------	------------	------	-----------------	-------------

Figure 49. Sample 172318-010, decohesion test result

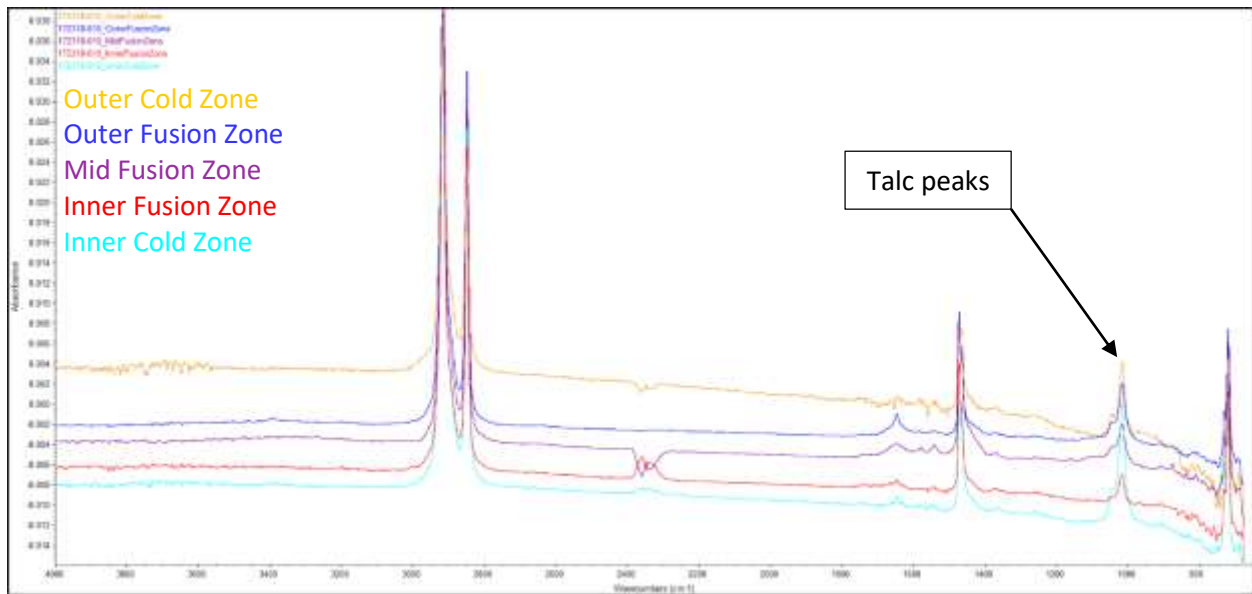
Figure 50. Sample 172318-010, FTIR spectra from decohesion test result

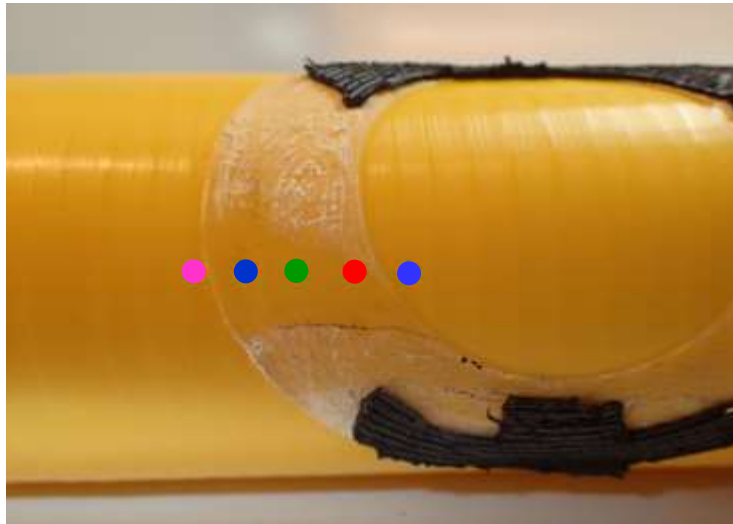
172318-011	172395-013	Talc	91% Isopropanol	Lint-Free Wipe
------------	------------	------	-----------------	----------------

Figure 51. Sample 172318-011, decohesion test result

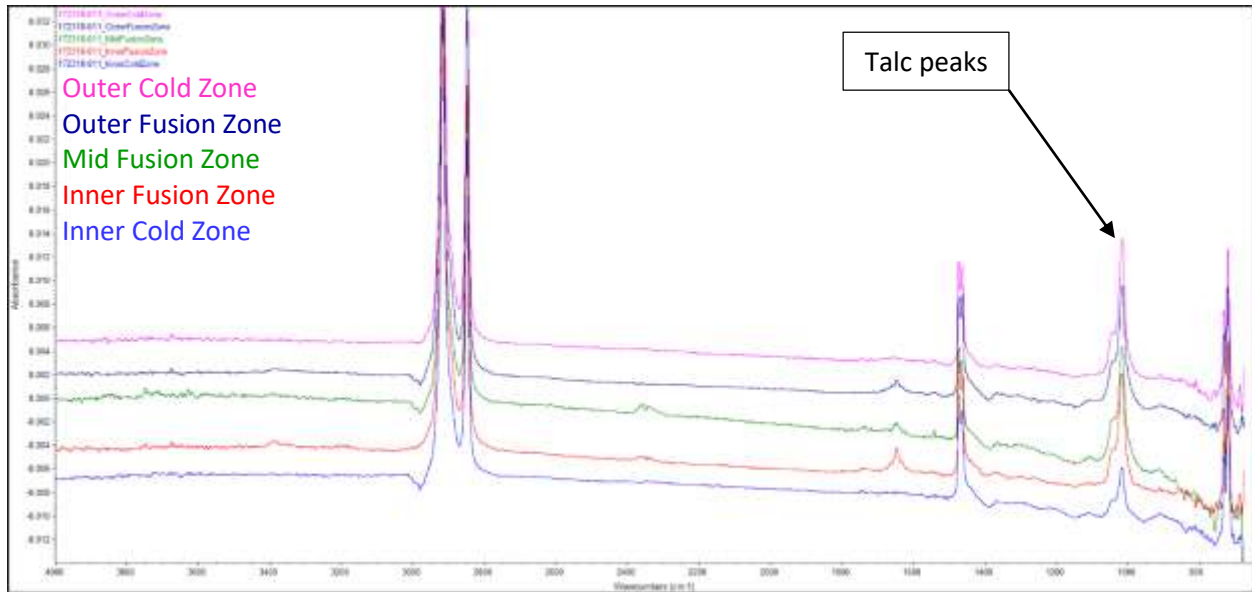
Figure 52. Sample 172318-011, FTIR spectra from decohesion test result

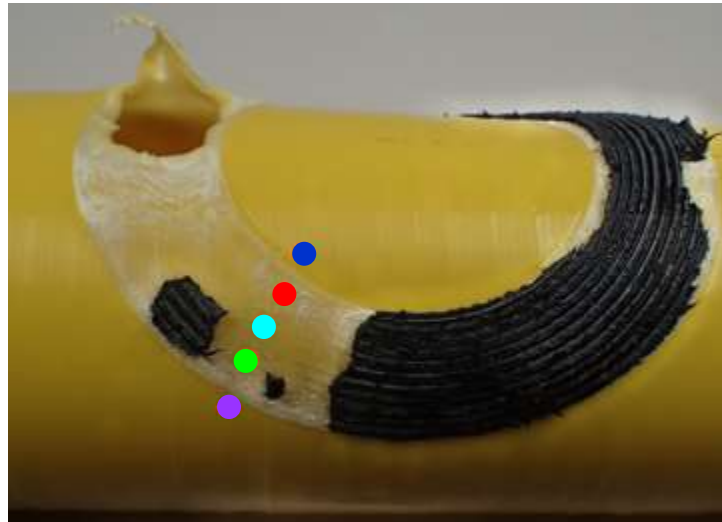
172318-012	172395-022	Talc	91% Isopropanol	Cotton Cloth Rag
------------	------------	------	-----------------	------------------

Figure 53. Sample 172318-012, decohesion test result

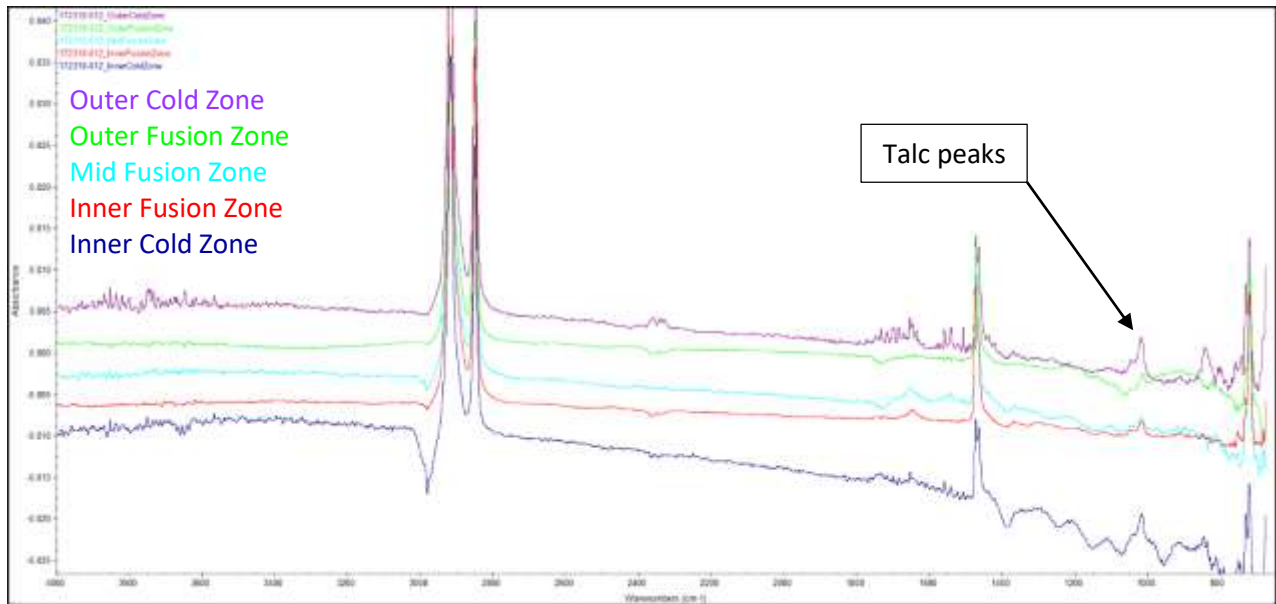
Figure 54. Sample 172318-012, FTIR spectra from decohesion test result

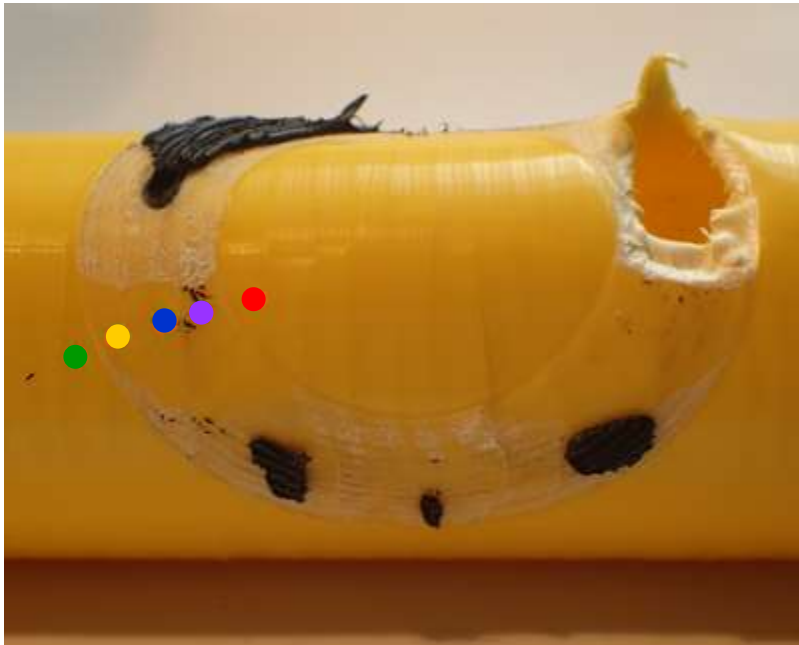
172318-013	172395-025	Talc	Acetone	Lint-Free Wipe
------------	------------	------	---------	----------------

Figure 55. Sample 172318-013, decohesion test result

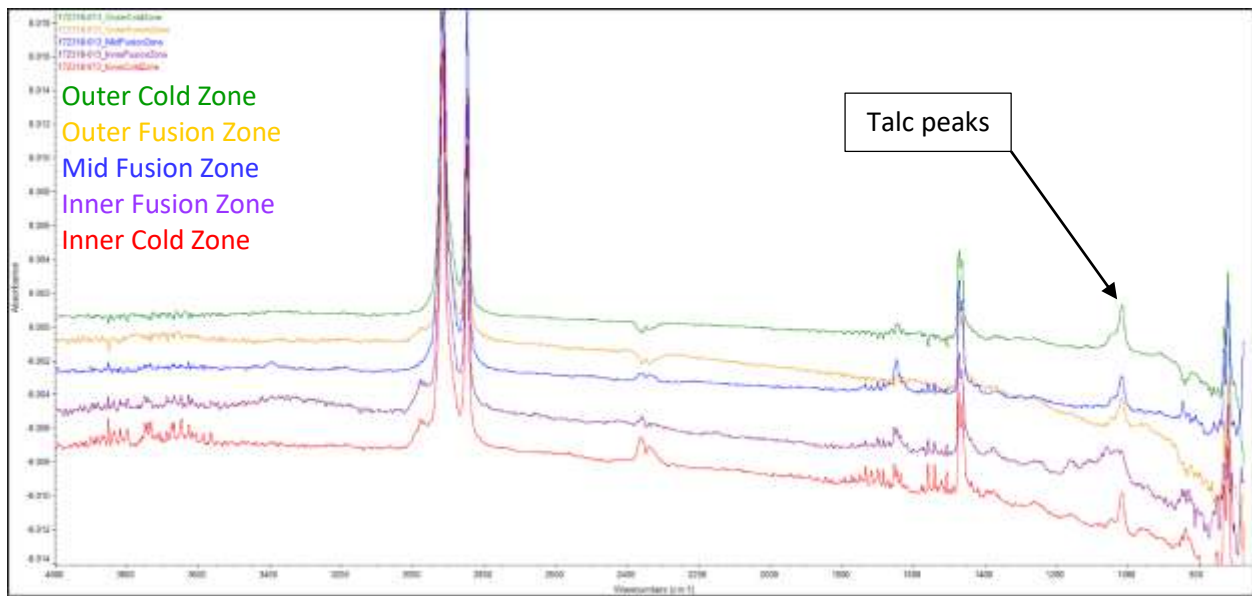
Figure 56. Sample 172318-013, FTIR spectra from decohesion test result

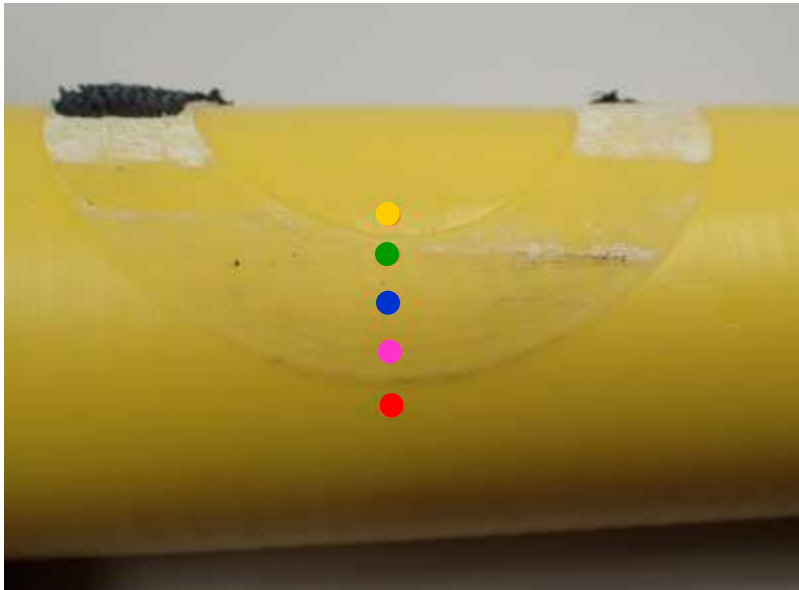
172318-014	172395-026	Talc	Acetone	Lint-Free Wipe
------------	------------	------	---------	----------------

Figure 57. Sample 172318-014, decohesion test result

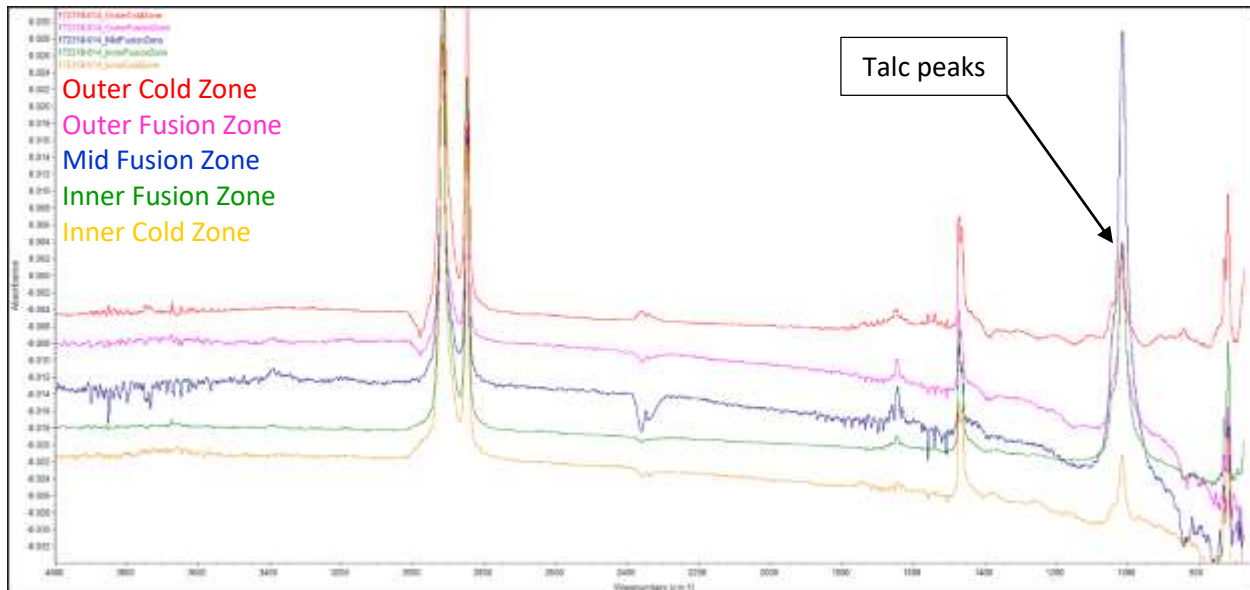
Figure 58. Sample 172318-014, FTIR spectra from decohesion test result

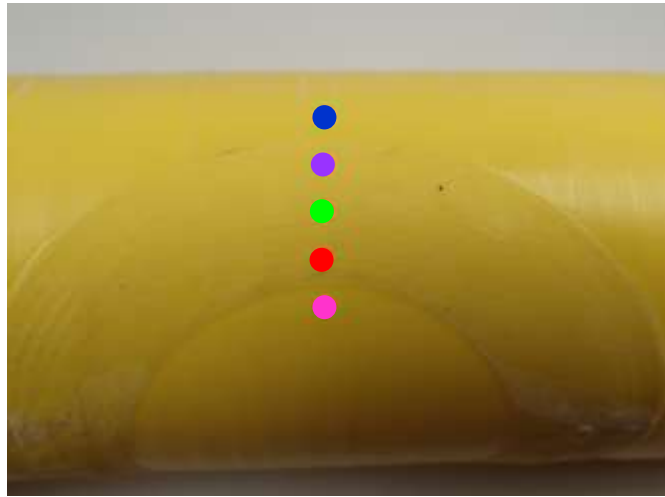
172318-015	172395-029	Talc	Acetone	Cotton Cloth Rag
------------	------------	------	---------	------------------

Figure 59. Sample 172318-015, decohesion test result

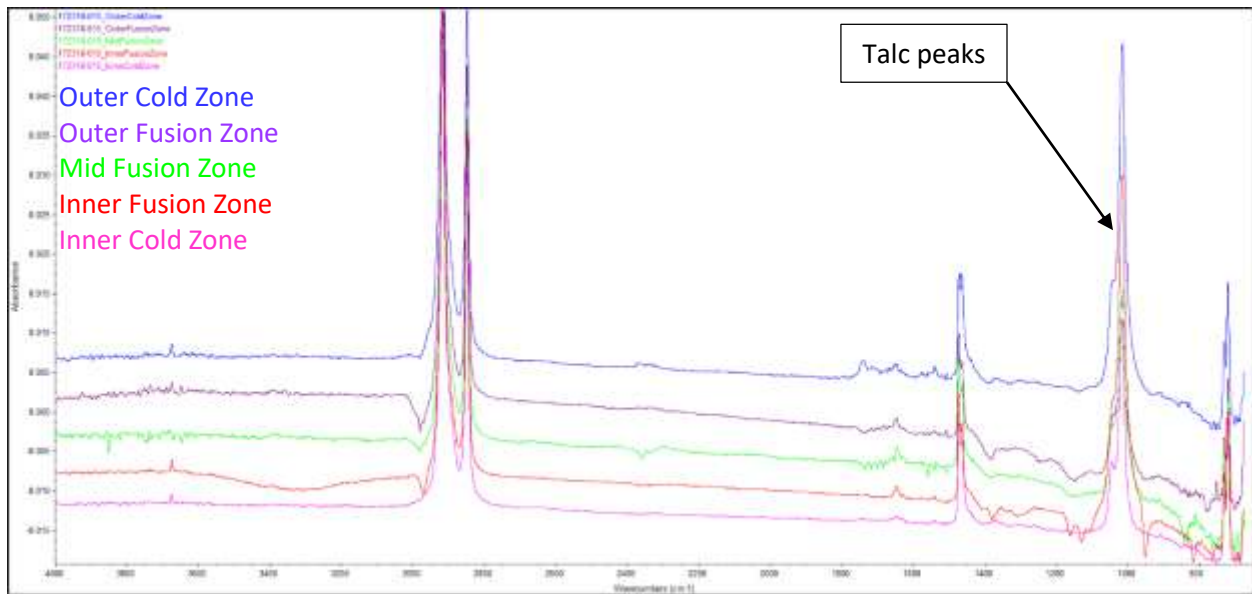
Figure 60. Sample 172318-015, FTIR spectra from decohesion test result

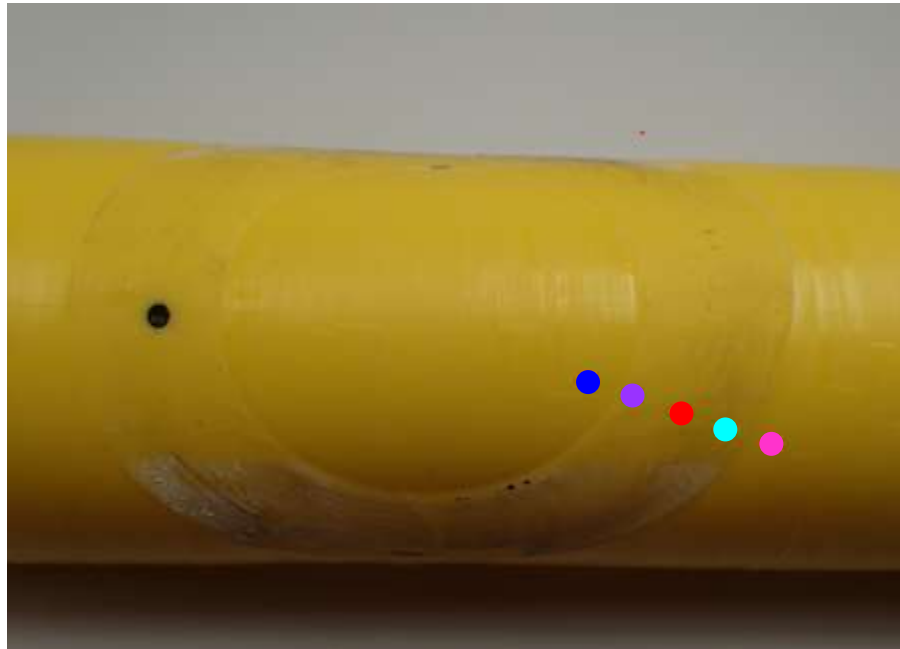
172318-016	172395-030	Talc	Acetone	Cotton Cloth Rag
------------	------------	------	---------	------------------

Figure 61. Sample 172318-016, decohesion test result

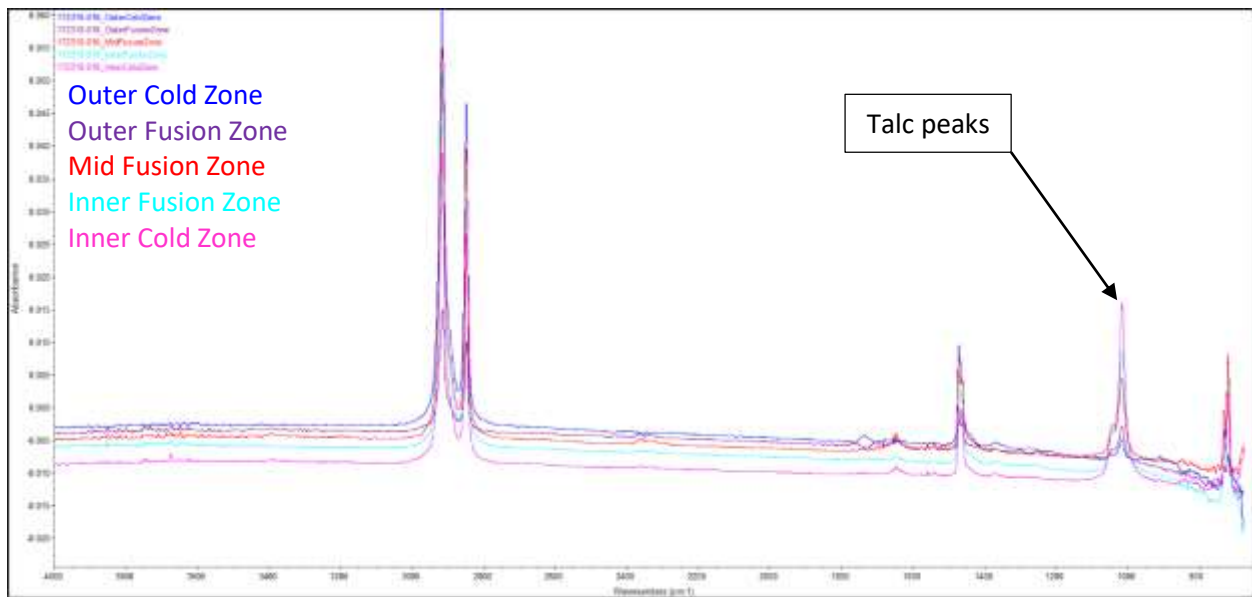
Figure 62. Sample 172318-016, FTIR spectra from decohesion test result

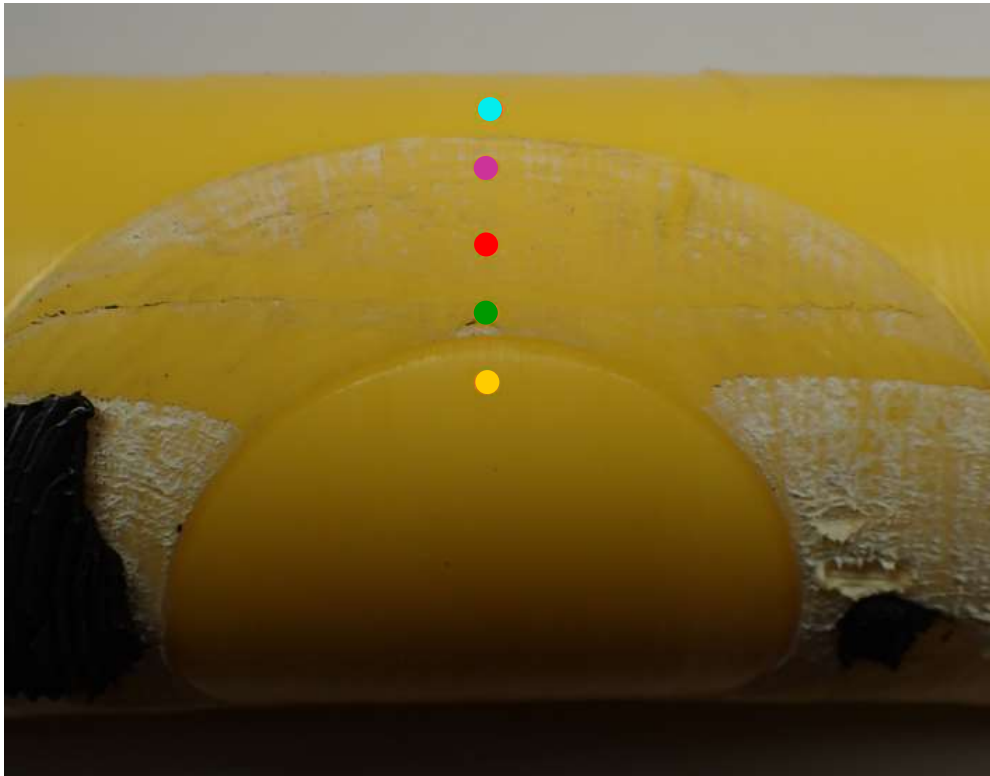
172318-017	172395-033	Talc	Acetone	Paper Towel
------------	------------	------	---------	-------------

Figure 63. Sample 172318-017, decohesion test result

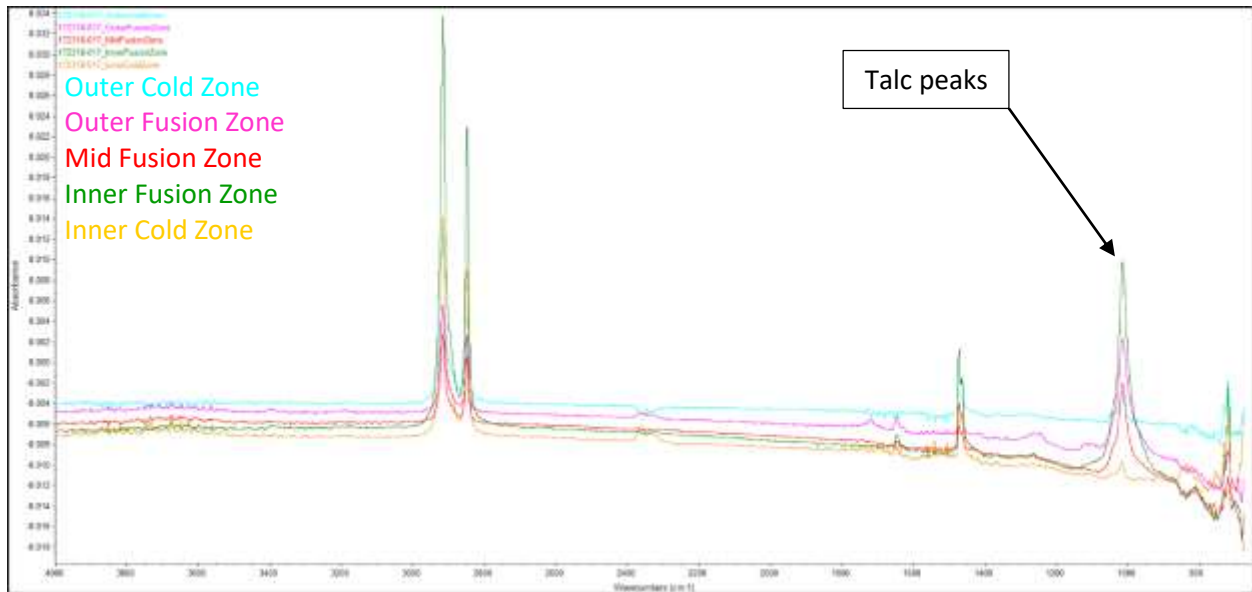
Figure 64. Sample 172318-017, FTIR spectra from decohesion test result

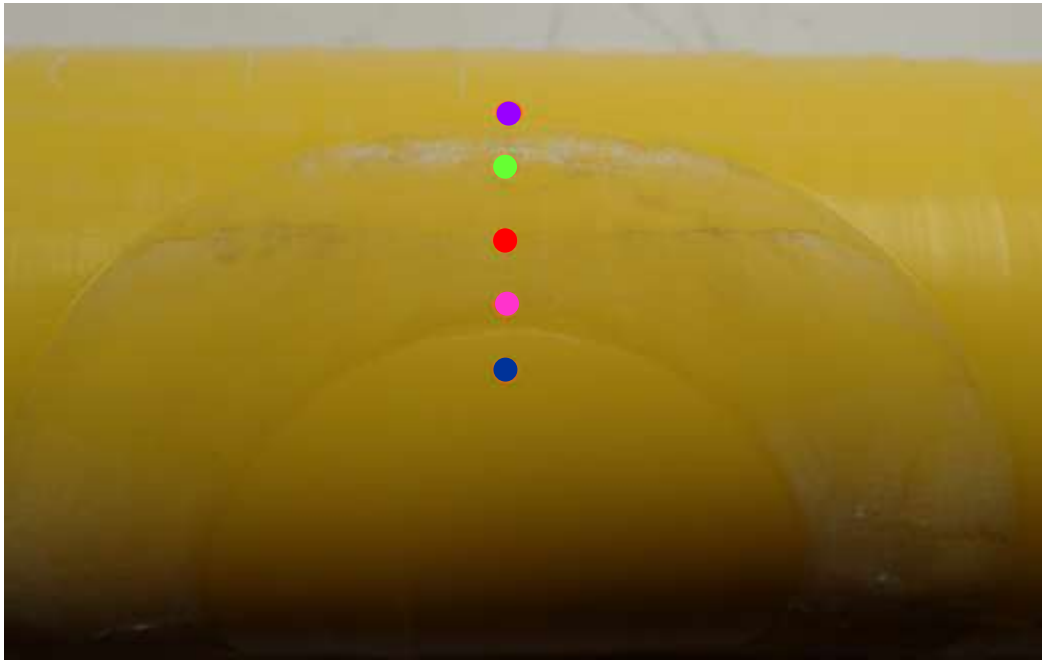
172318-018	172395-034	Talc	Acetone	Paper Towel
------------	------------	------	---------	-------------

Figure 65. Sample 172318-018, decohesion test result

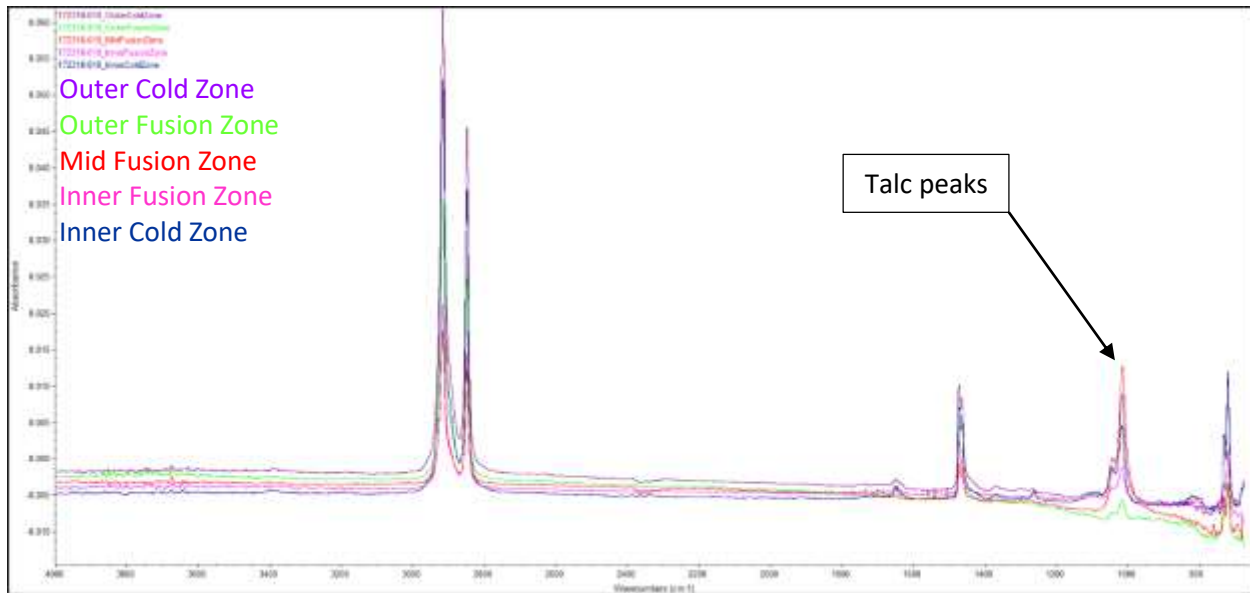
Figure 66. Sample 172318-018, FTIR spectra from decohesion test result

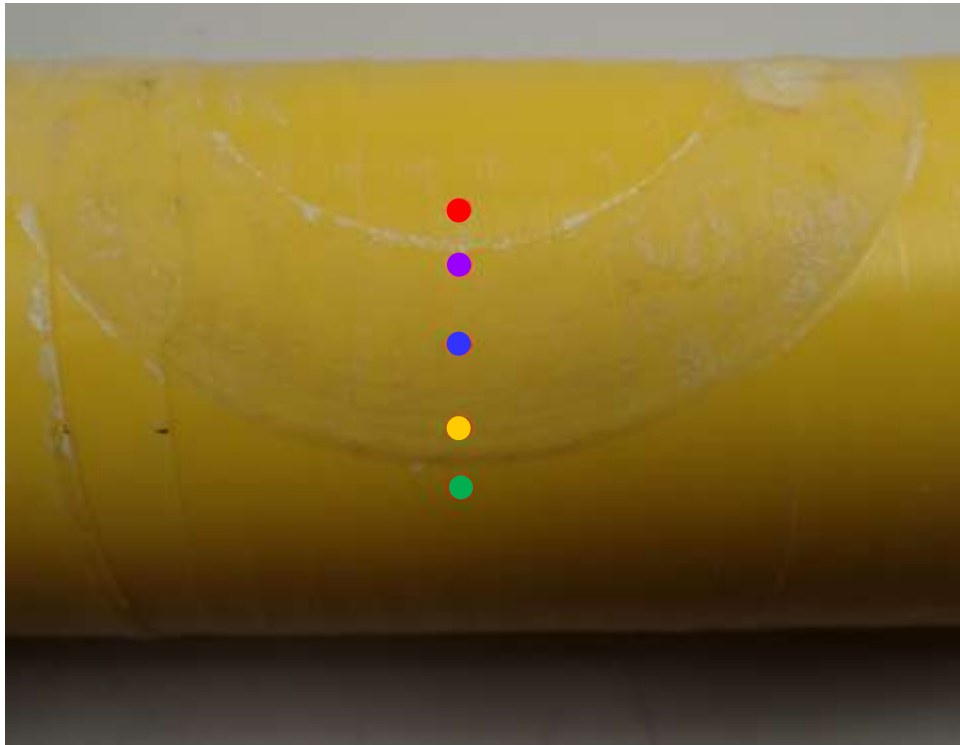
172318-019	172395-037	Talc	None	None
------------	------------	------	------	------

Figure 67. Sample 172318-019, decohesion test result
