▼
**Solvent Cleaning and PE
Joining Procedures**

Prepared by:
Gas Technology Institute
Des Plaines, Illinois

GTI-OTD FINAL REPORT

Solvent Cleaning and PE Joining Procedures

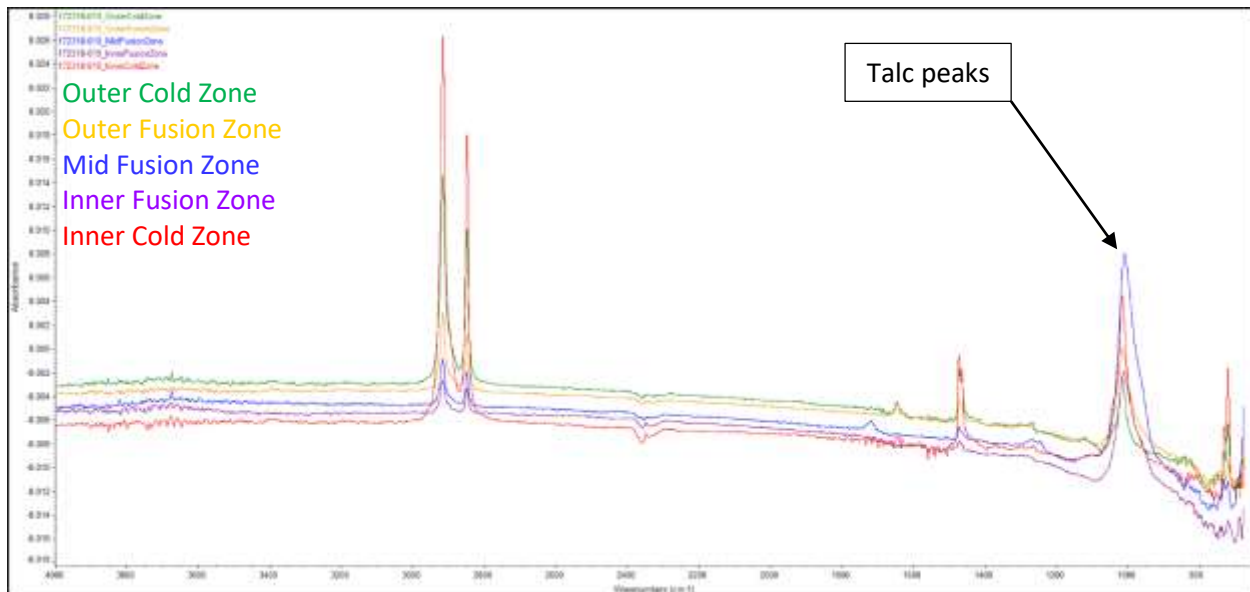
Figure 68. Sample 172318-019, FTIR spectra from decohesion test result

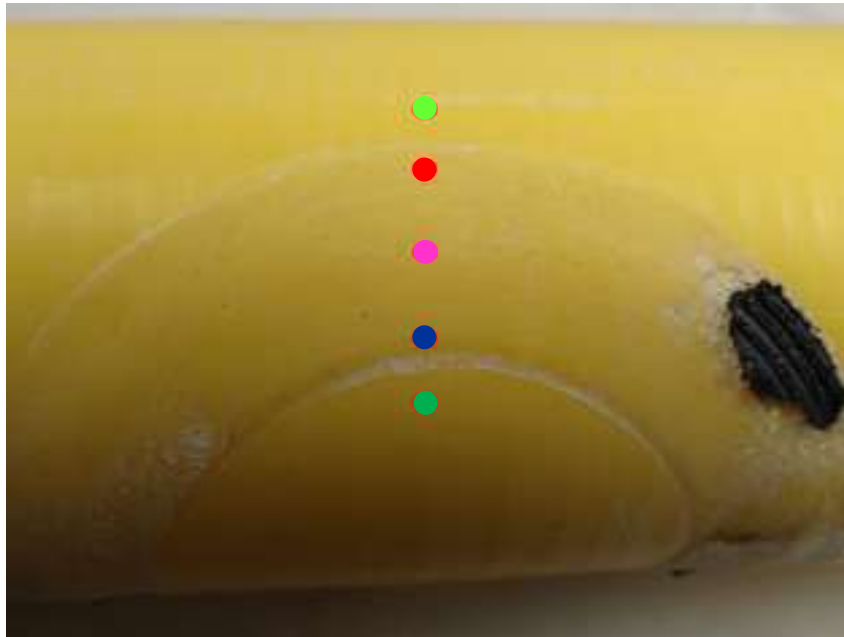
172318-020	172395-038	Talc	None	None
------------	------------	------	------	------

Figure 69. Sample 172318-020, decohesion test result

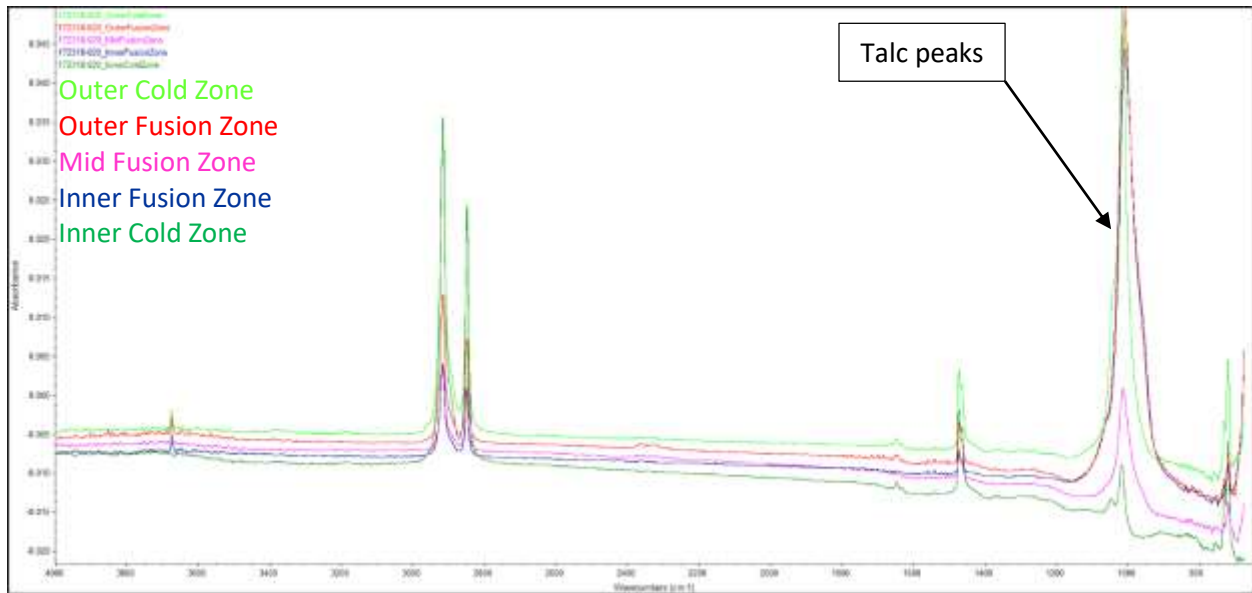
Figure 70. Sample 172318-020, FTIR spectra from decohesion test result

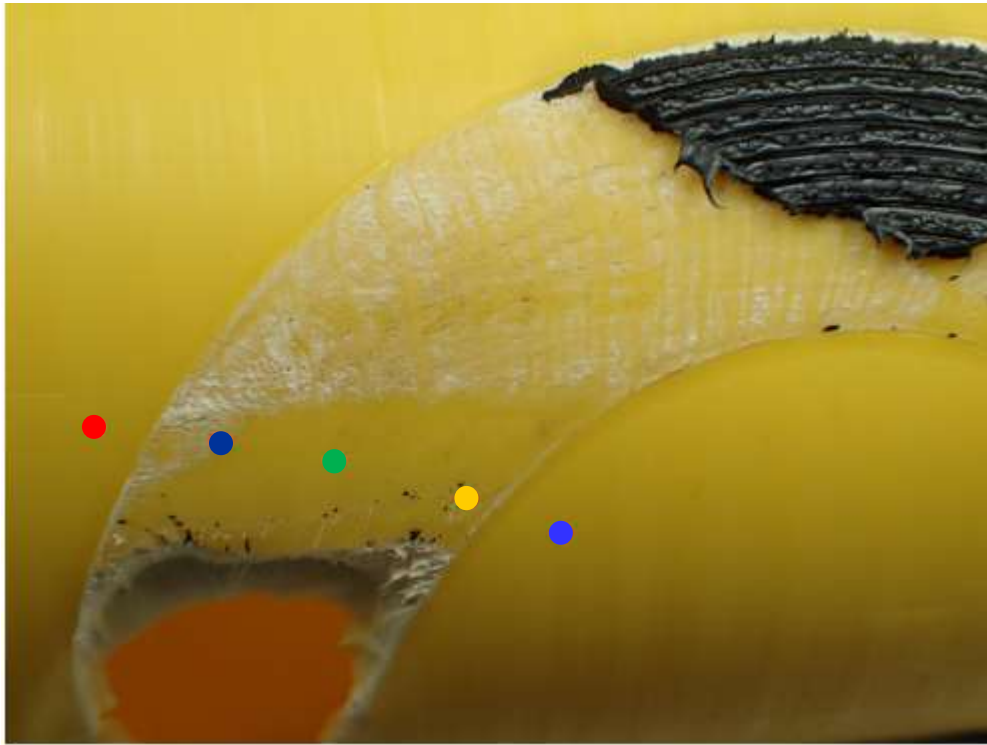
172318-021	172395-041	Bentonite	99% Isopropanol	Lint-Free Wipe
------------	------------	-----------	-----------------	----------------

Figure 71. Sample 172318-021, decohesion test result

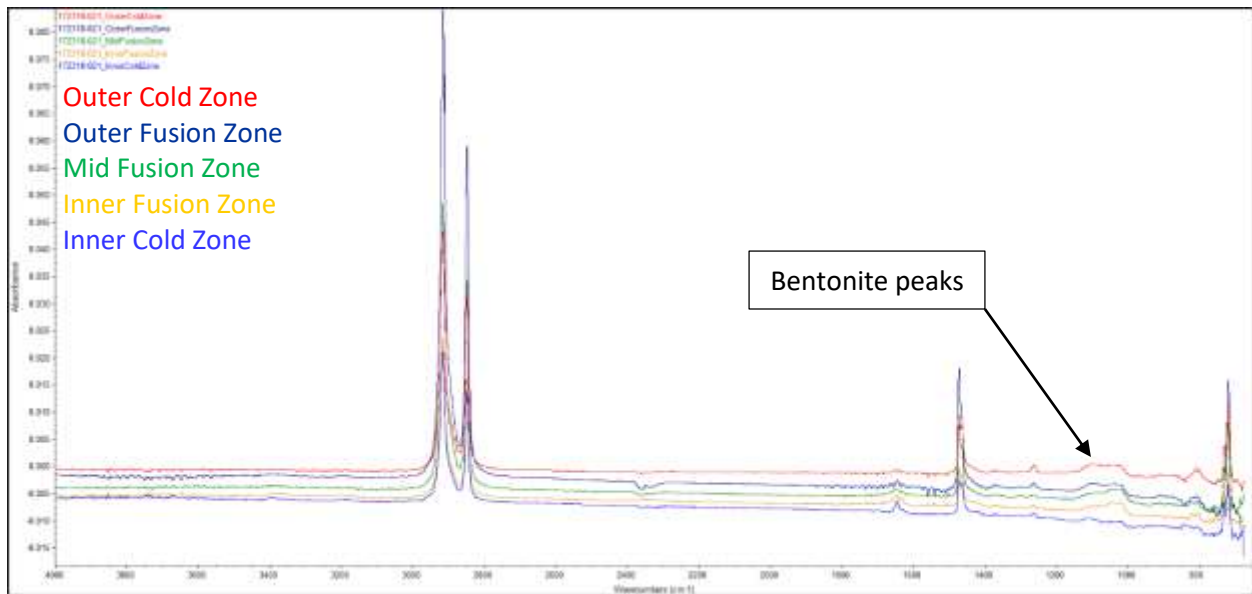
Figure 72. Sample 172318-021, FTIR spectra from decohesion test result

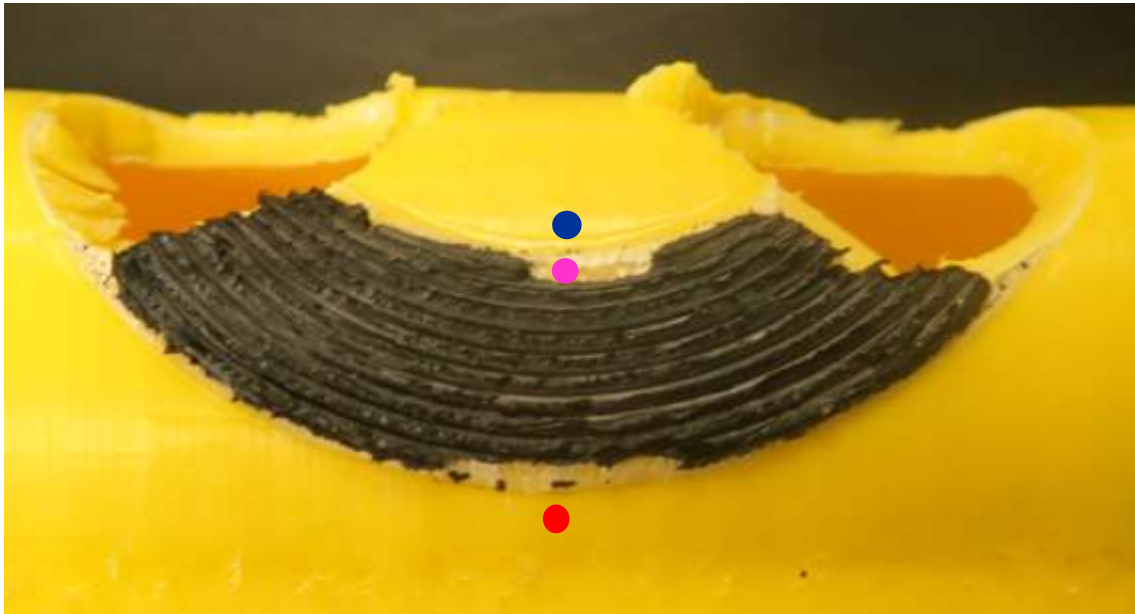
172318-022	172395-042	Bentonite	99% Isopropanol	Lint-Free Wipe
------------	------------	-----------	-----------------	----------------

Figure 73. Sample 172318-022, decohesion test result

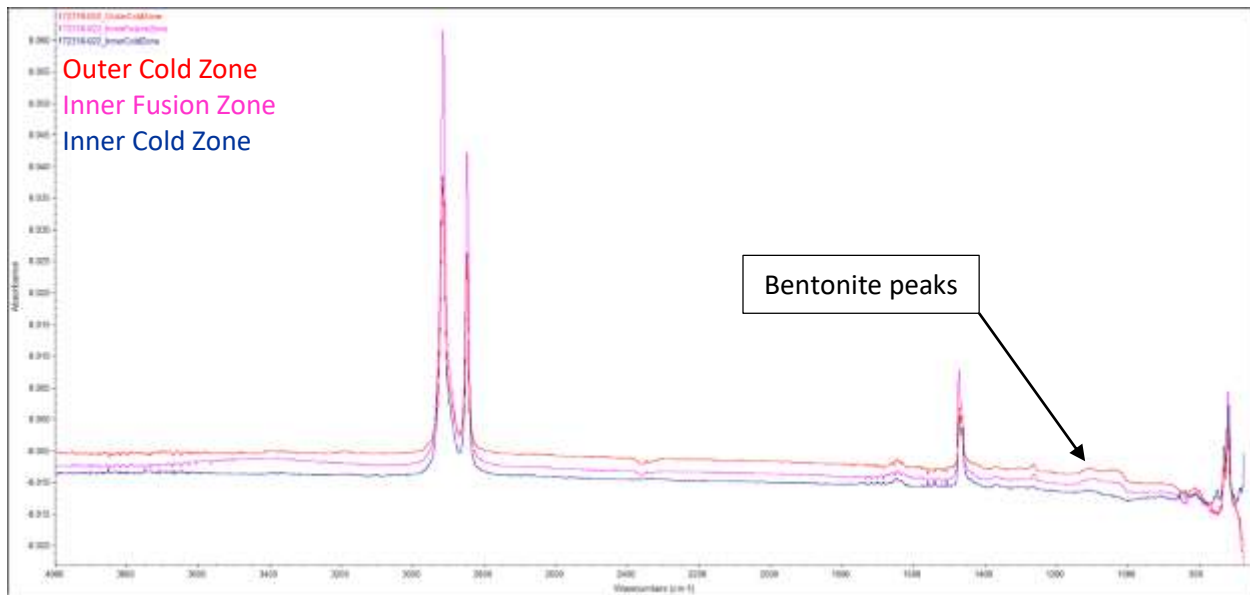
Figure 74. Sample 172318-022, FTIR spectra from decohesion test result

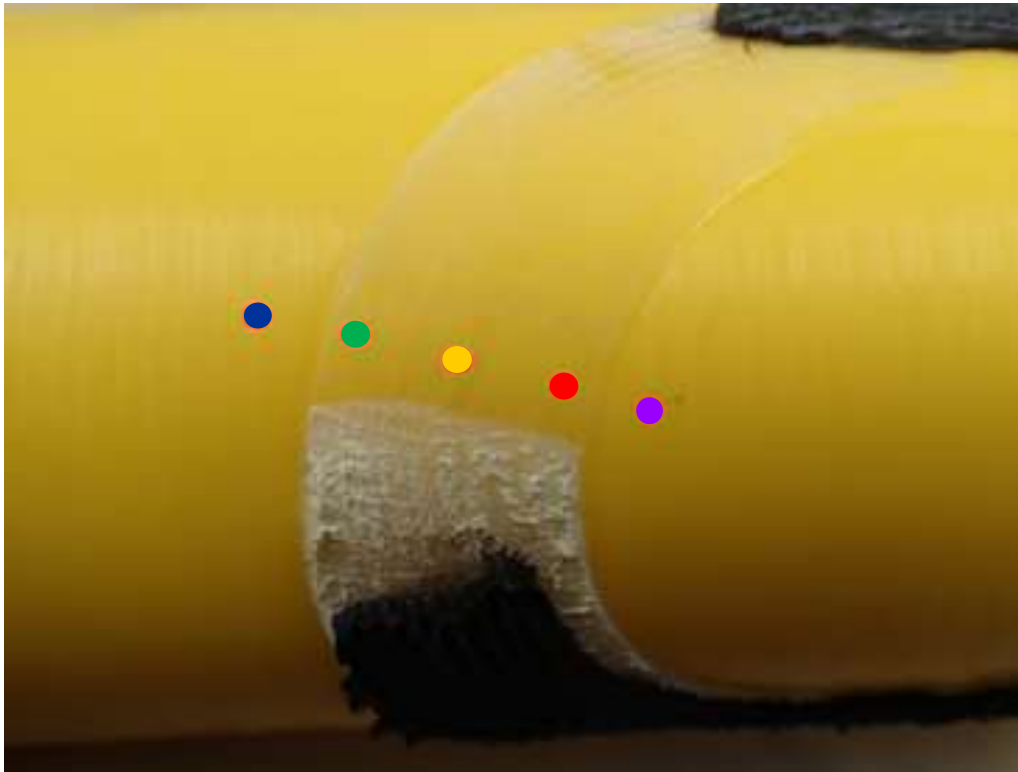
172318-023	172395-045	Bentonite	99% Isopropanol	Cotton Cloth Rag
------------	------------	-----------	-----------------	------------------

Figure 75. Sample 172318-023, decohesion test result

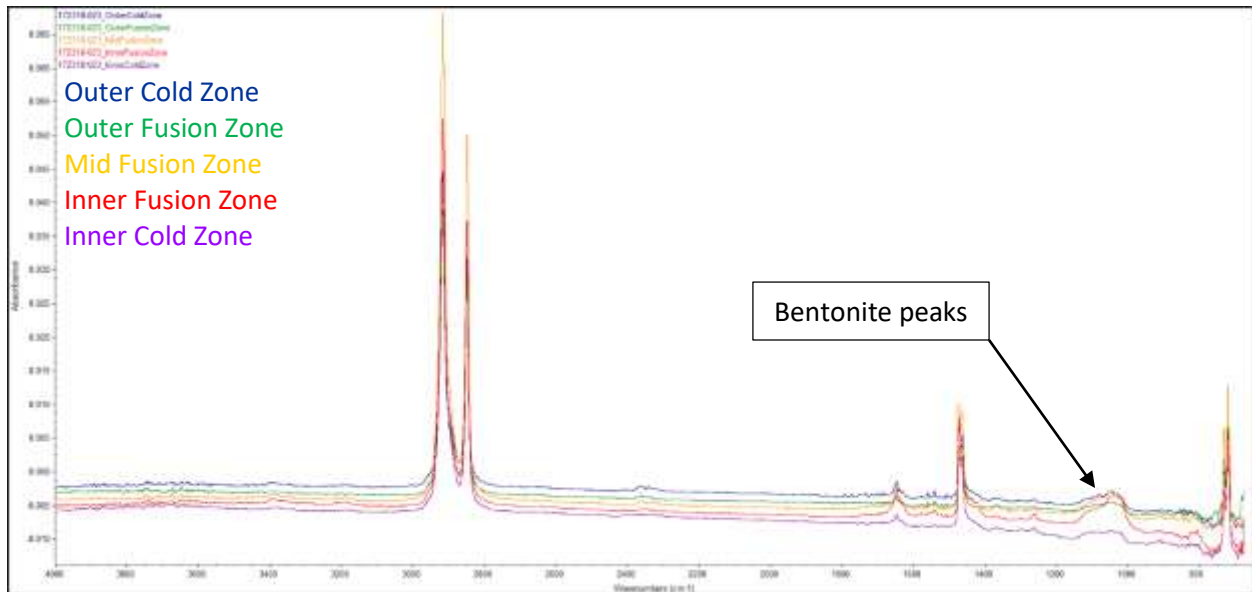
Figure 76. Sample 172318-023, FTIR spectra from decohesion test result

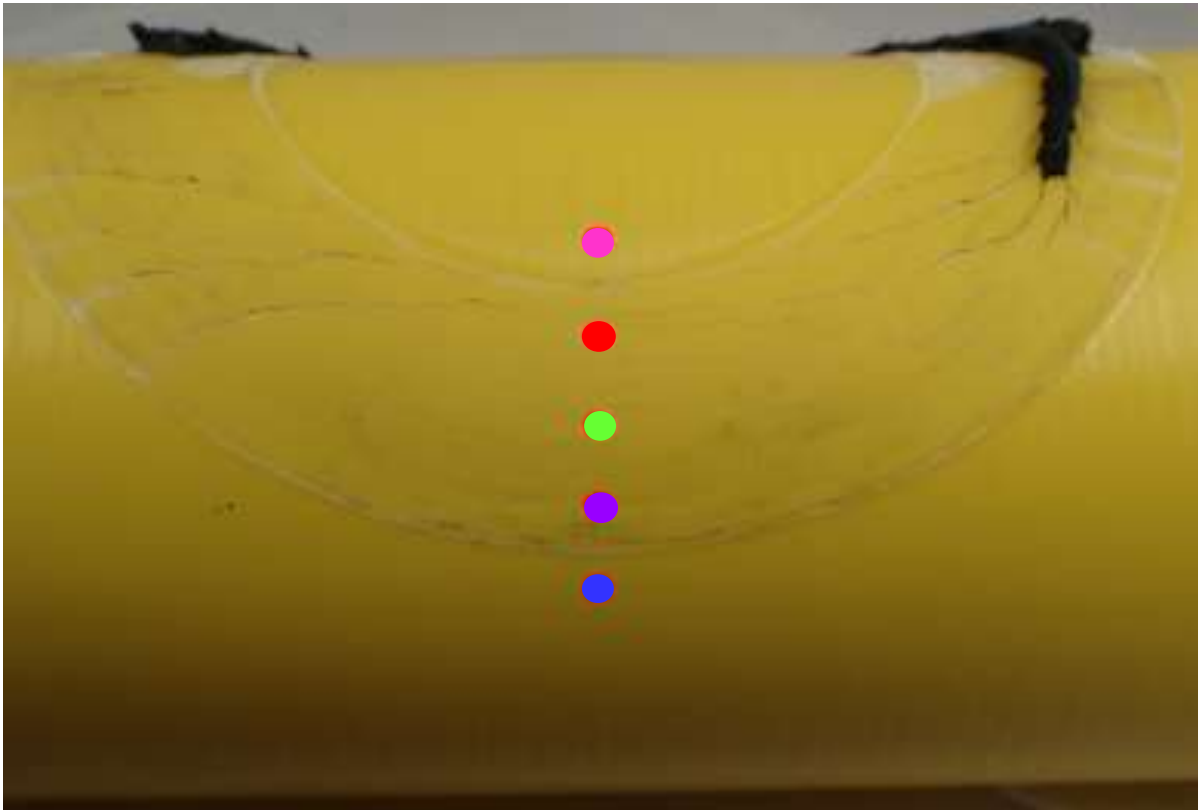
172318-024	172395-046	Bentonite	99% Isopropanol	Cotton Cloth Rag
------------	------------	-----------	-----------------	------------------

Figure 77. Sample 172318-024, decohesion test result

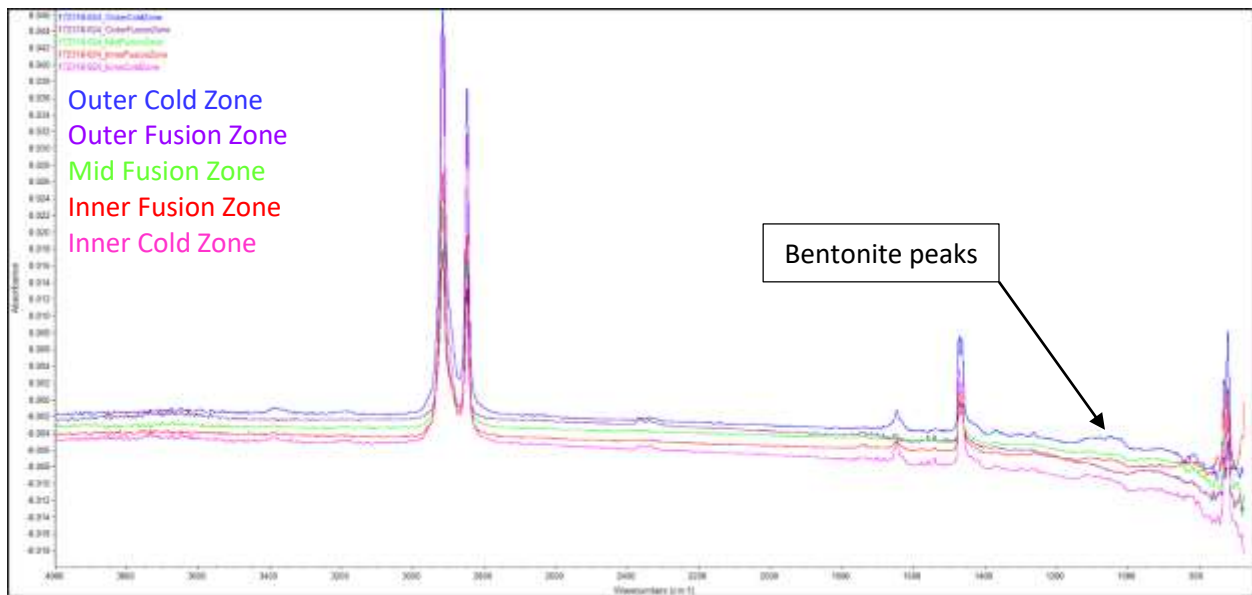
Figure 78. Sample 172318-024, FTIR spectra from decohesion test result

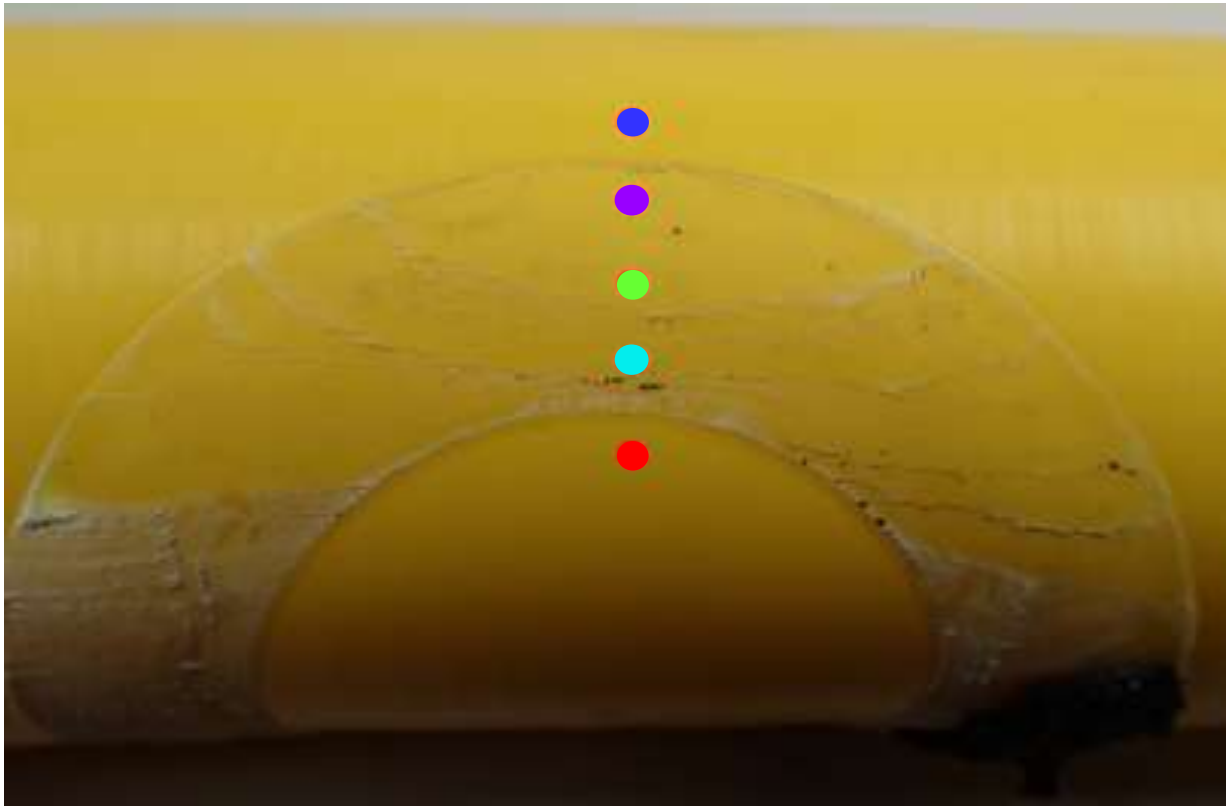
172318-025	172395-049	Bentonite	99% Isopropanol	Paper Towel
------------	------------	-----------	-----------------	-------------

Figure 79. Sample 172318-025, decohesion test result

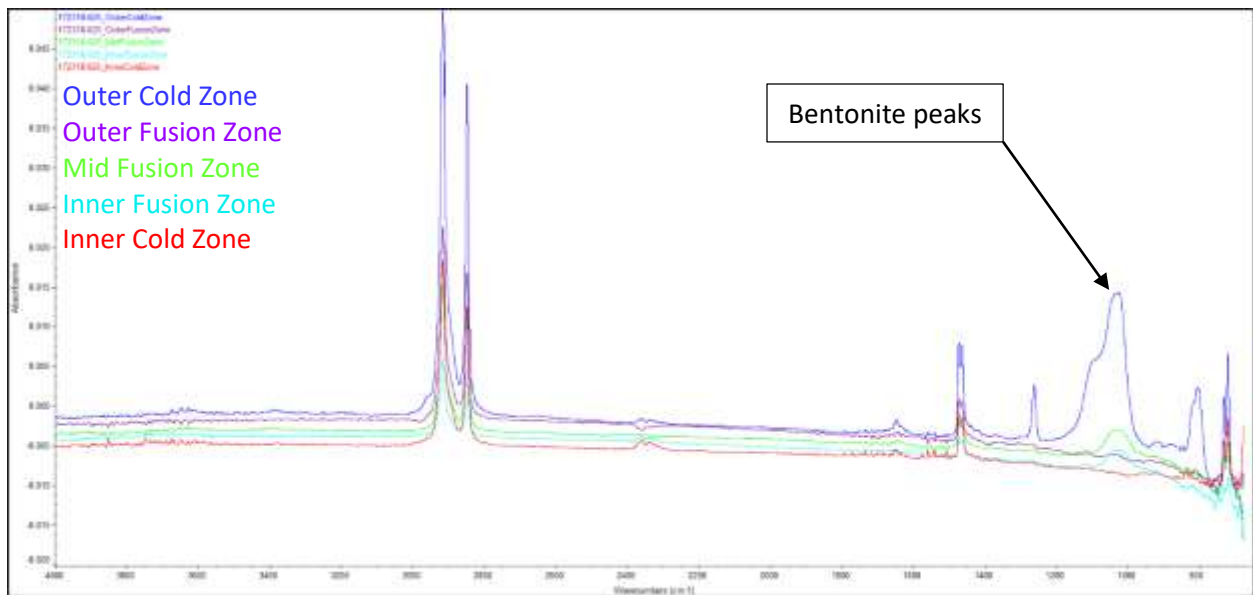
Figure 80. Sample 172318-025, FTIR spectra from decohesion test result

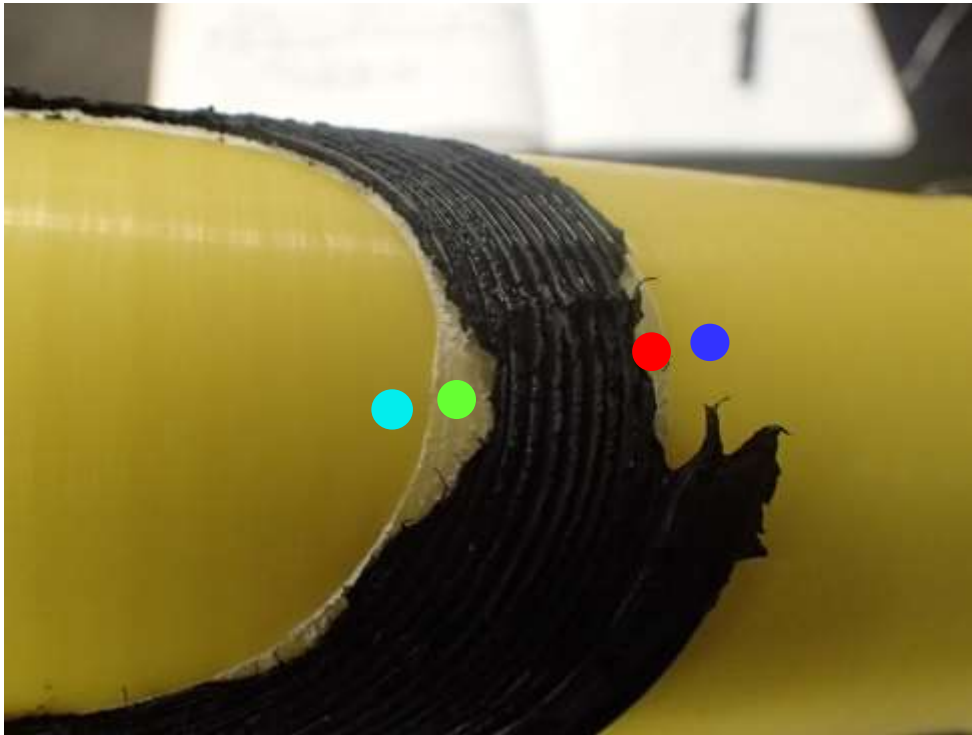
172318-026	172395-050	Bentonite	99% Isopropanol	Paper Towel
------------	------------	-----------	-----------------	-------------

Figure 81. Sample 172318-026, decohesion test result

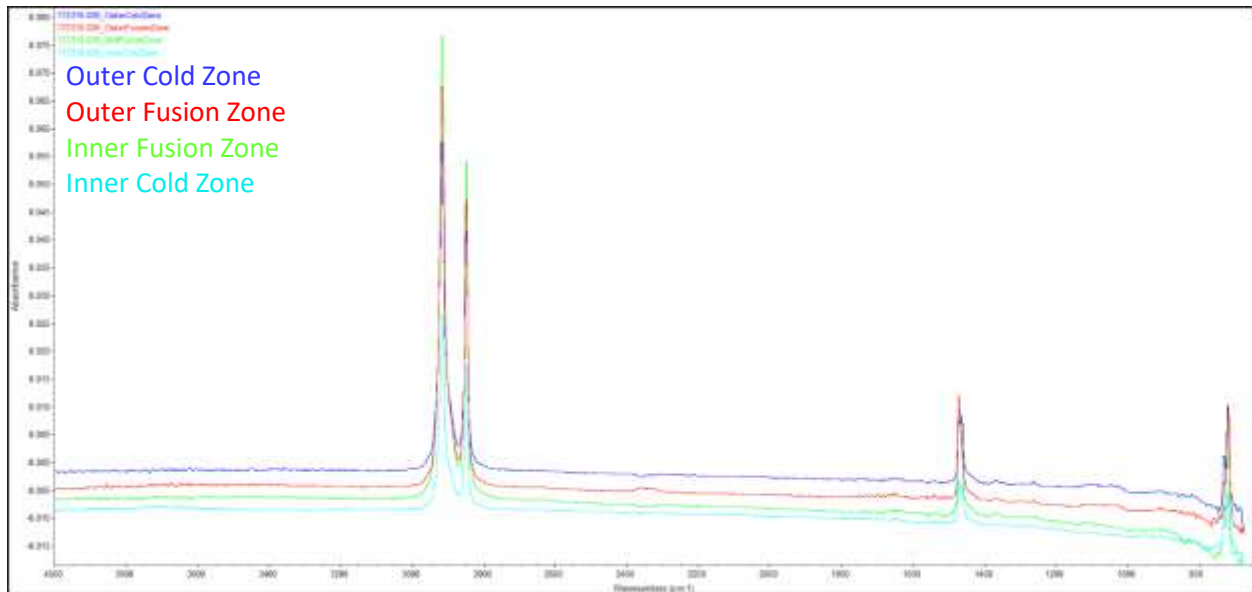
Figure 82. Sample 172318-026, FTIR spectra from decohesion test result

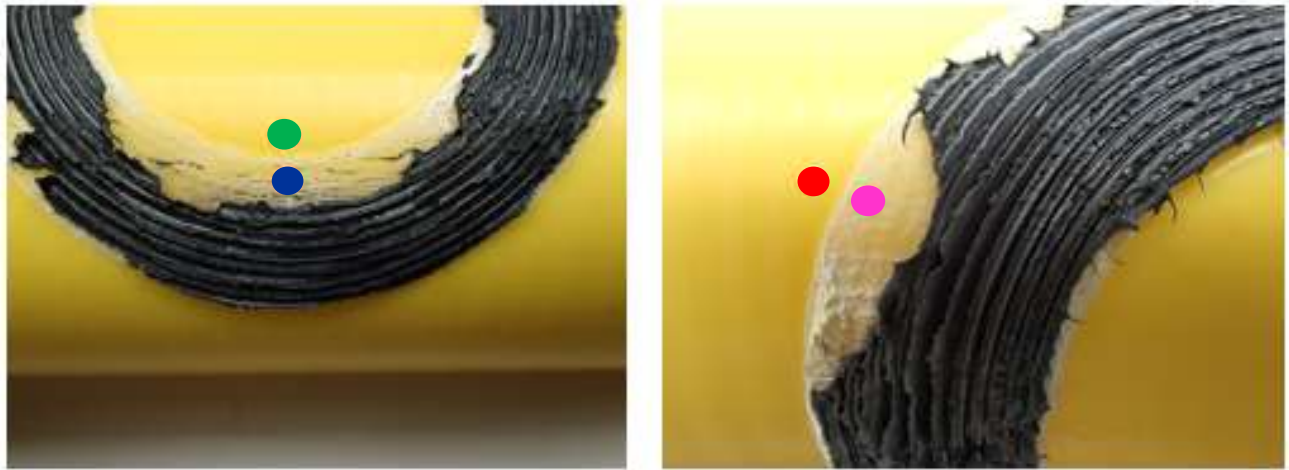
172318-027	172395-053	Bentonite	91% Isopropanol	Lint-Free Wipe
------------	------------	-----------	-----------------	----------------

Figure 83. Sample 172318-027, decohesion test result

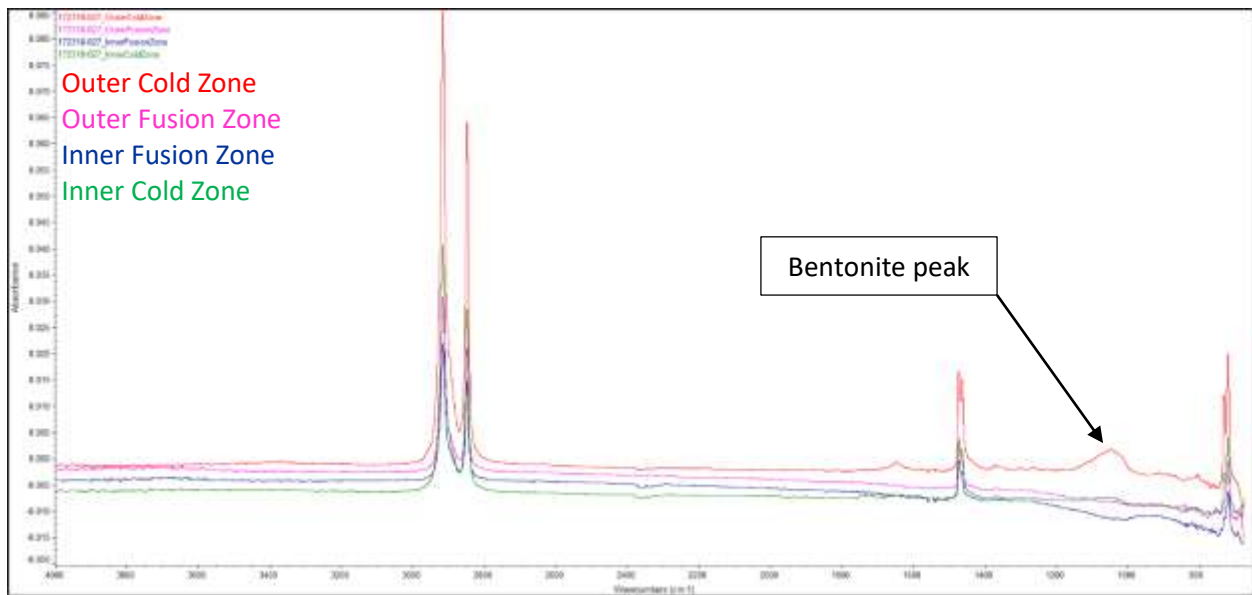
Figure 84. Sample 172318-027, FTIR spectra from decohesion test result

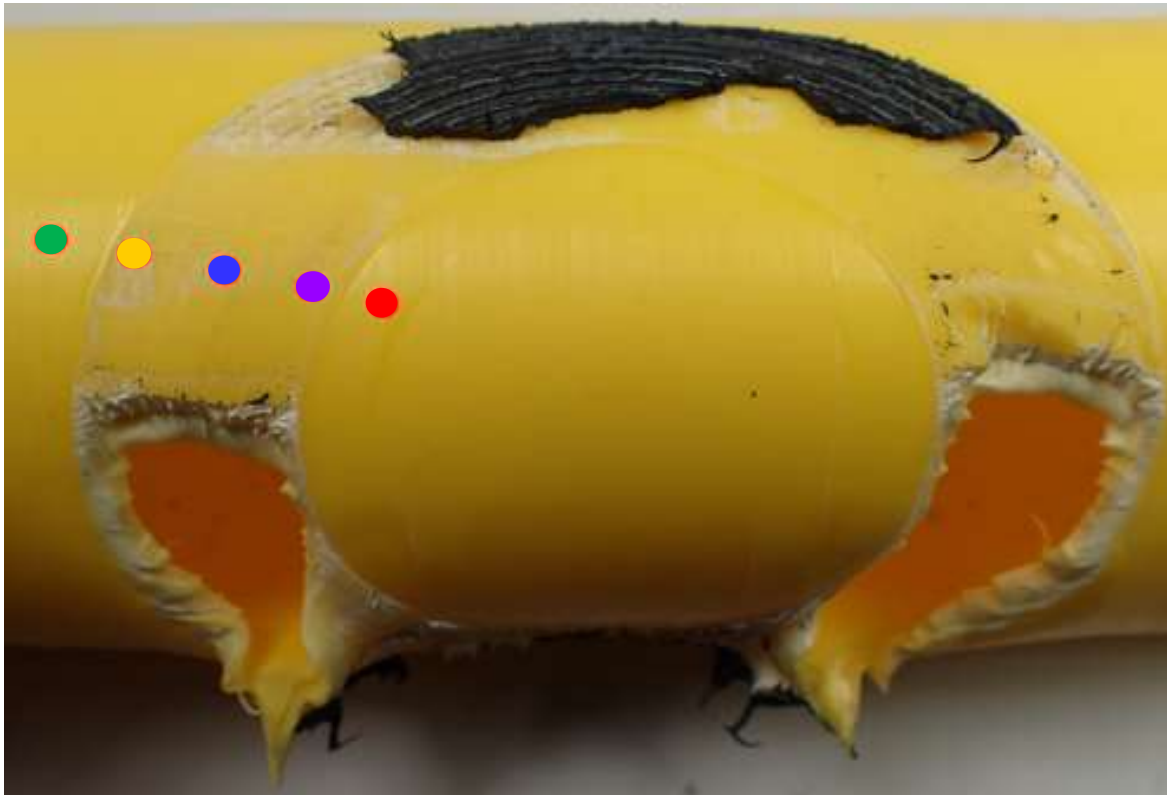
172318-028	172395-054	Bentonite	91% Isopropanol	Lint-Free Wipe
------------	------------	-----------	-----------------	----------------

Figure 85. Sample 172318-028, decohesion test result

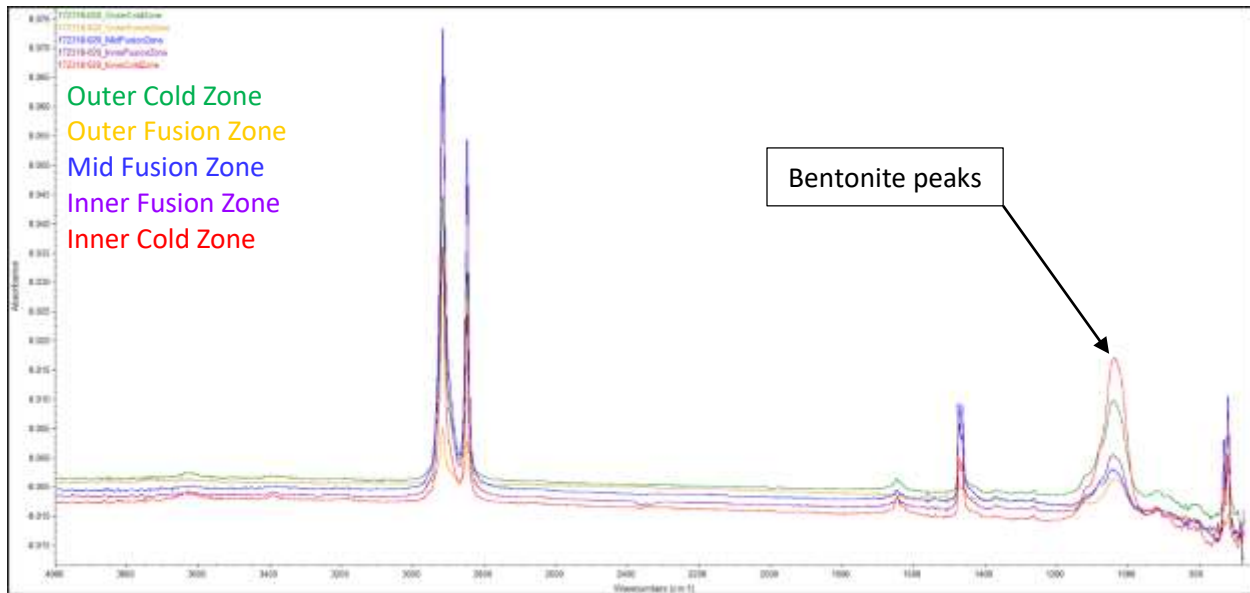
Figure 86. Sample 172318-028, FTIR spectra from decohesion test result

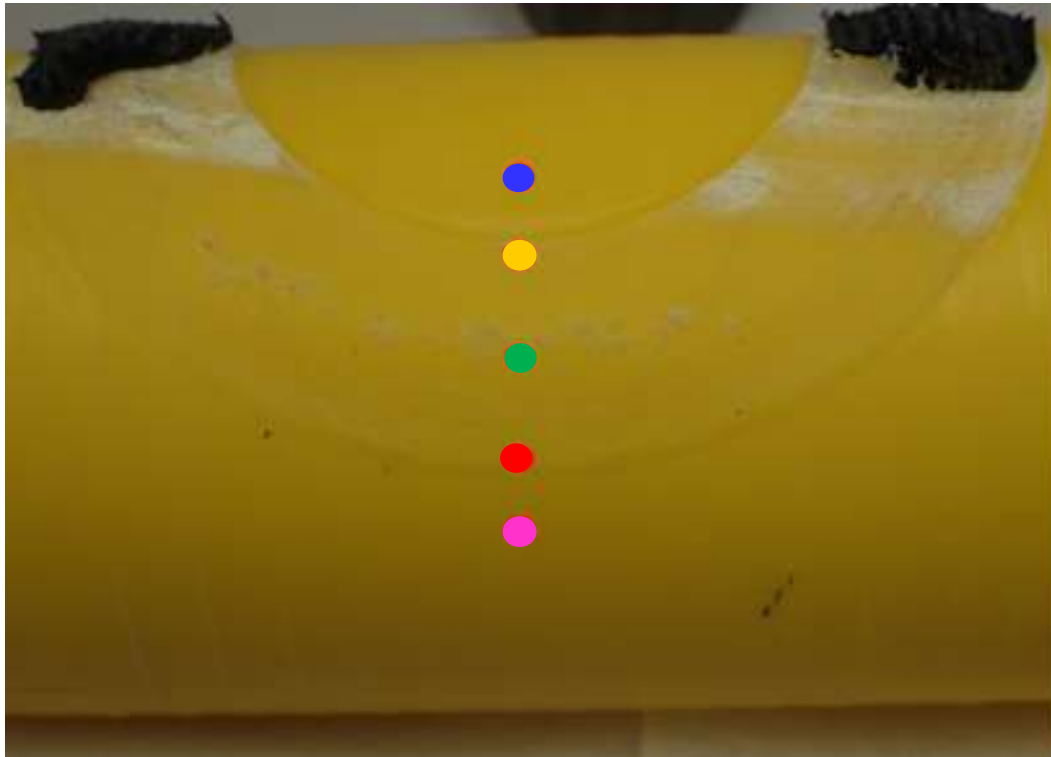
172318-029	172395-057	Bentonite	91% Isopropanol	Cotton Cloth Rag
------------	------------	-----------	-----------------	------------------

Figure 87. Sample 172318-029, decohesion test result

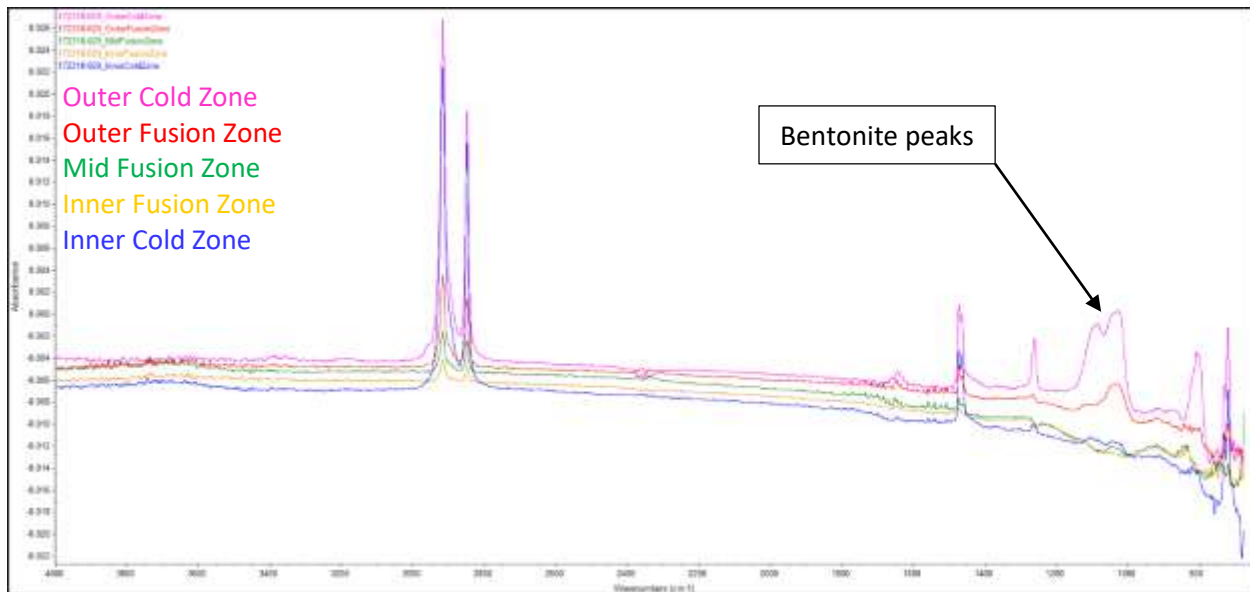
Figure 88. Sample 172318-029, FTIR spectra from decohesion test result

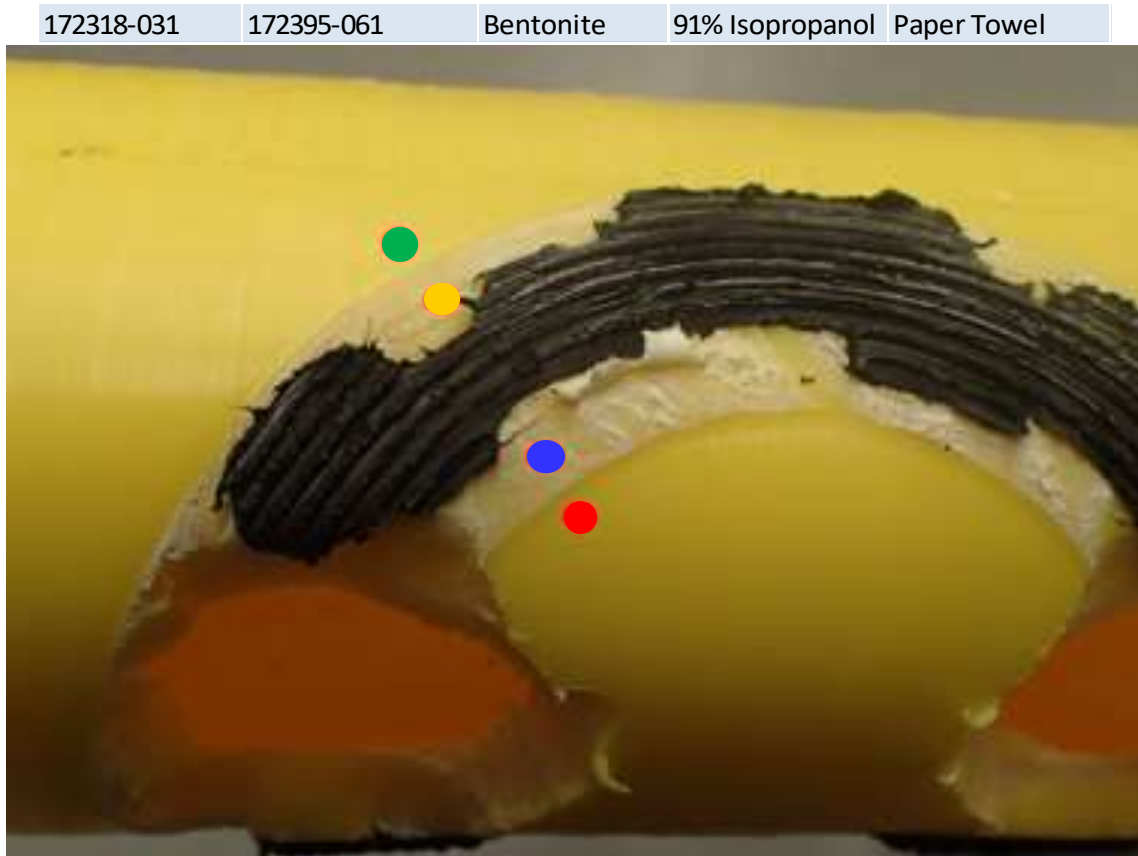
Figure 89. Sample 172318-031, decohesion test result

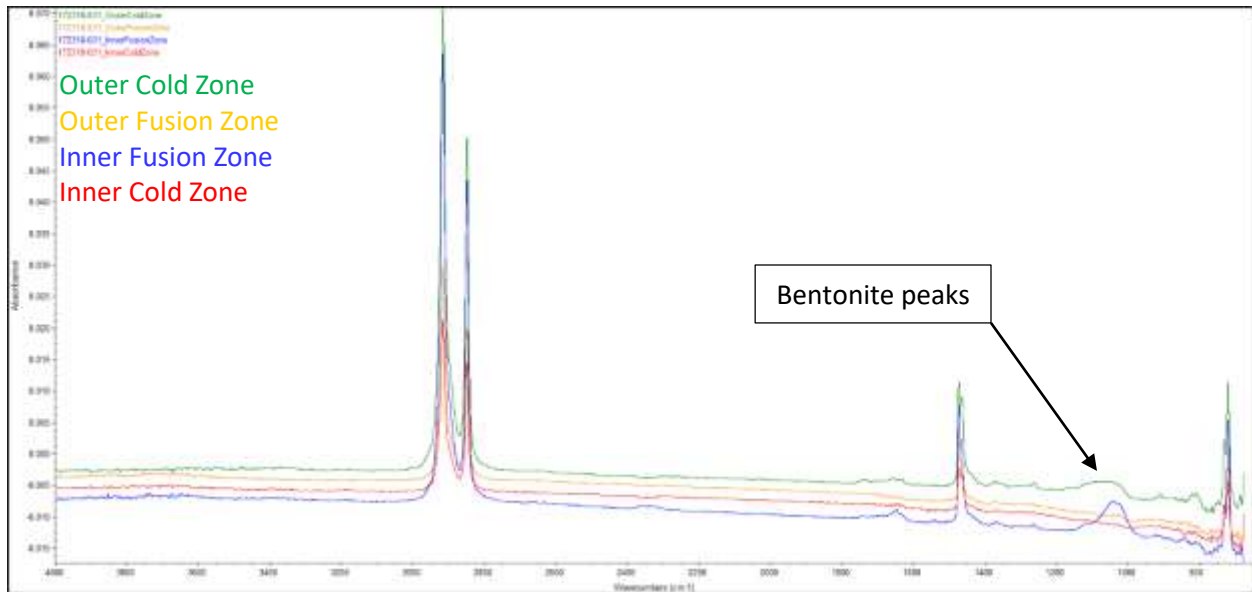
Figure 90. Sample 172318-031, FTIR spectra from decohesion test result

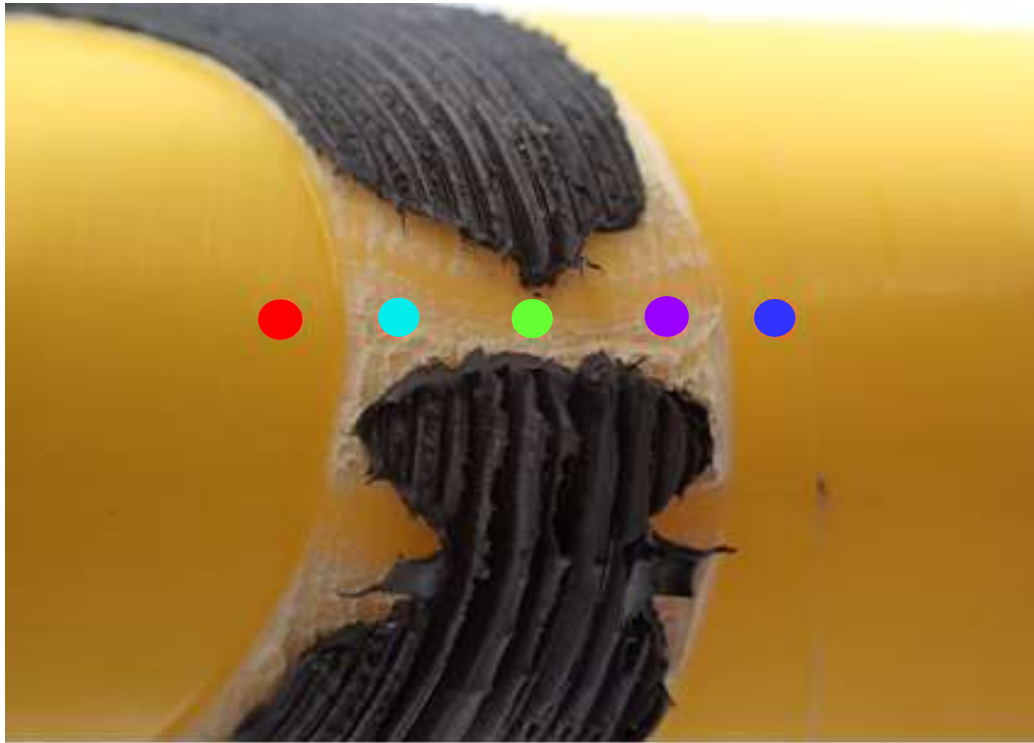
172318-033	172395-065	Bentonite	Acetone	Lint-Free Wipe
------------	------------	-----------	---------	----------------

Figure 91. Sample 172318-033, decohesion test result

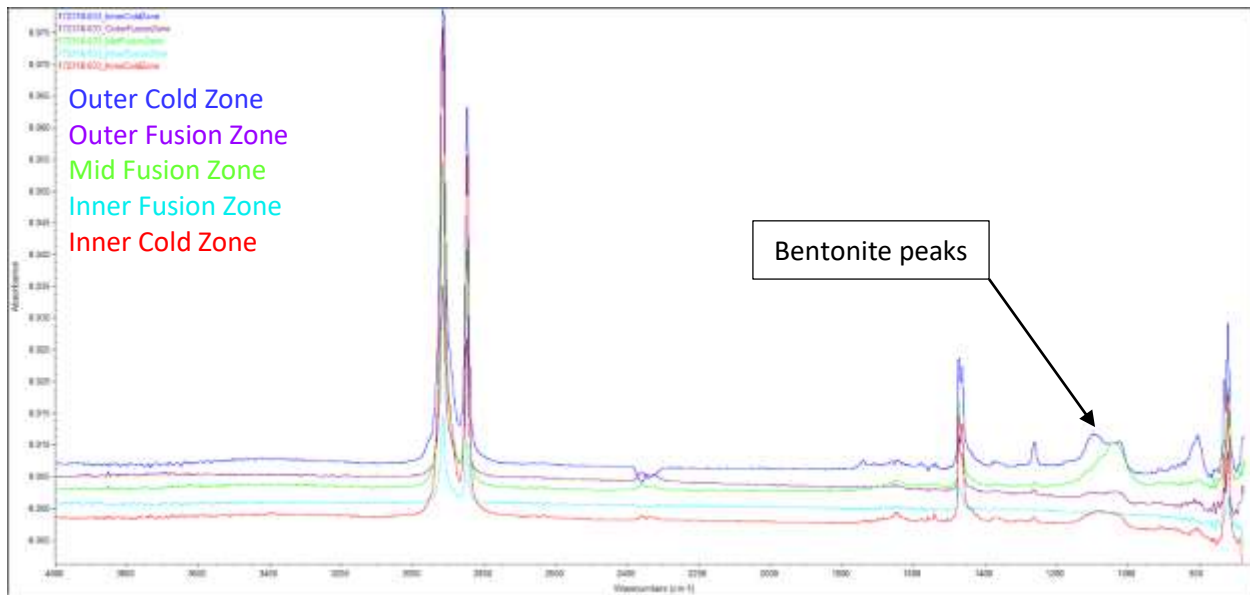
Figure 92: Sample 172318-033, FTIR spectra from decohesion test result

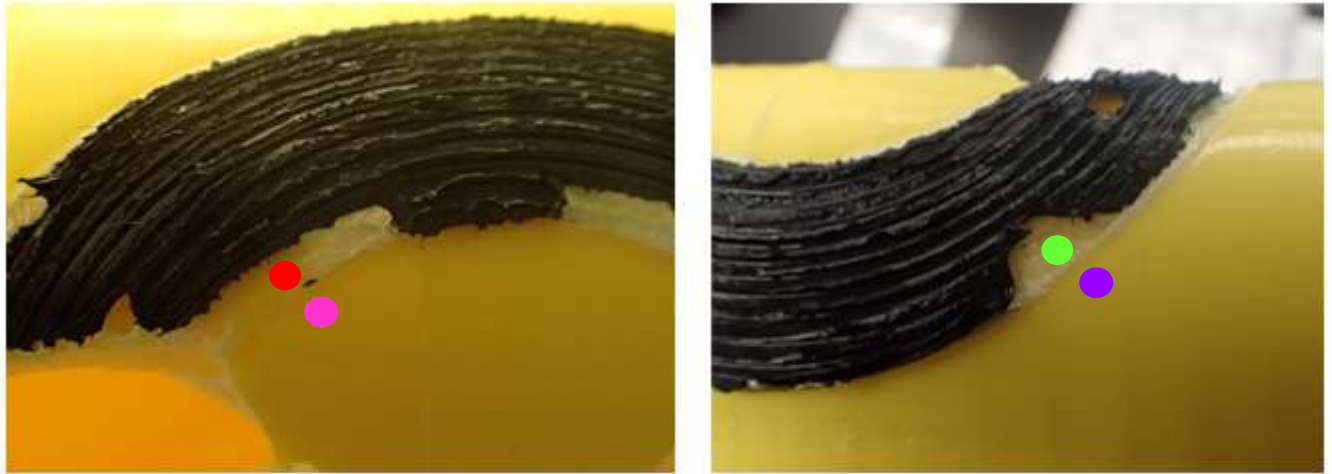
172318-034	172395-066	Bentonite	Acetone	Lint-Free Wipe
------------	------------	-----------	---------	----------------

Figure 93. Sample 172318-034, decohesion test result

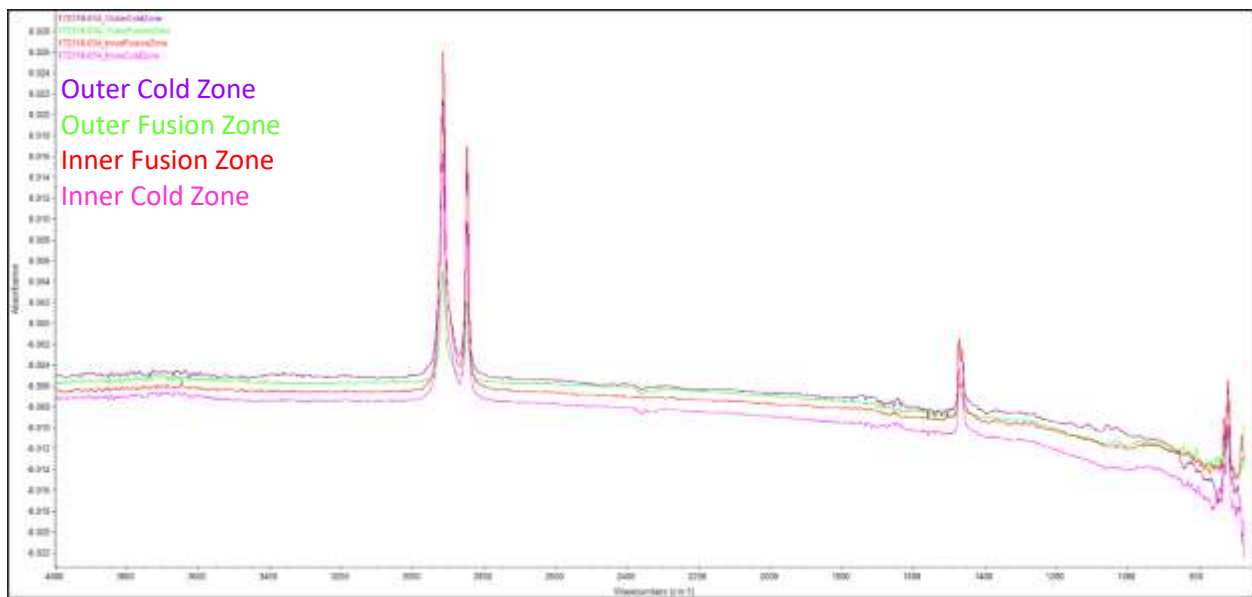
Figure 94. Sample 172318-034, FTIR spectra from decohesion test result

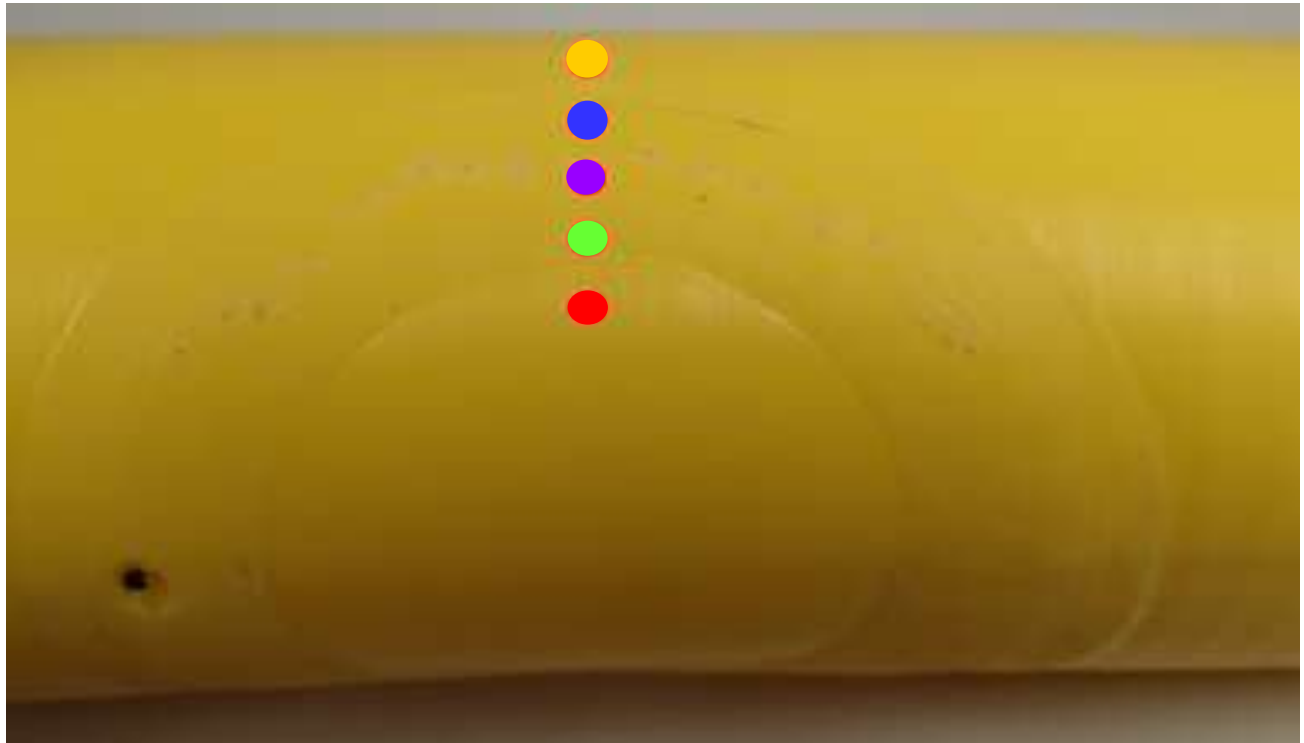
172318-035	172395-069	Bentonite	Acetone	Cotton Cloth Rag
------------	------------	-----------	---------	------------------

Figure 95. Sample 172318-035, decohesion test result

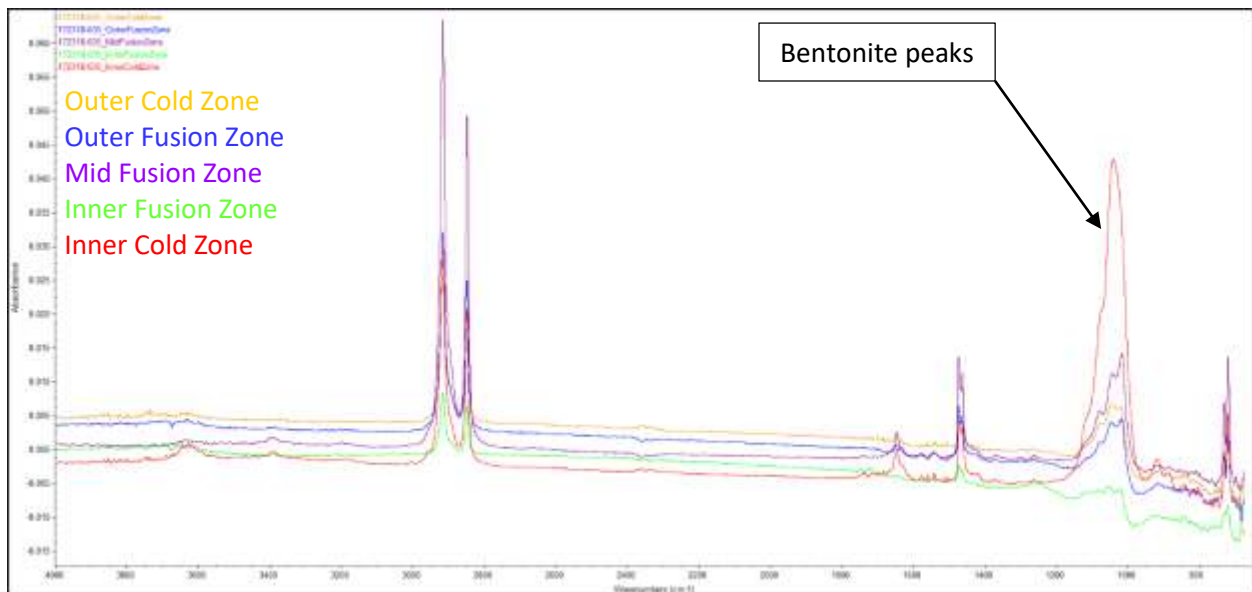
Figure 96. Sample 172318-035, FTIR spectra from decohesion test result
