▼
**Solvent Cleaning and PE
Joining Procedures**

Prepared by:
Gas Technology Institute
Des Plaines, Illinois

GTI-OTD FINAL REPORT

Solvent Cleaning and PE Joining Procedures

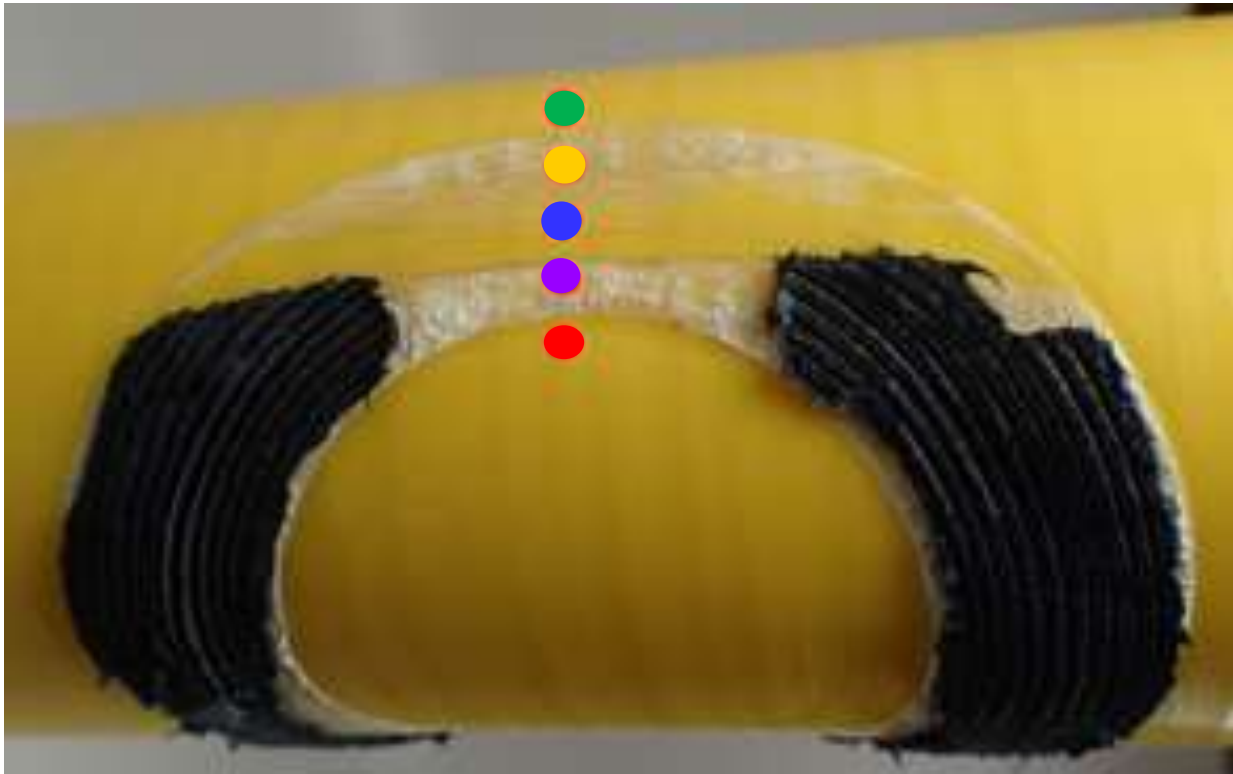
172318-036	172395-070	Bentonite	Acetone	Cotton Cloth Rag
------------	------------	-----------	---------	------------------

Figure 97. Sample 172318-036, decohesion test result

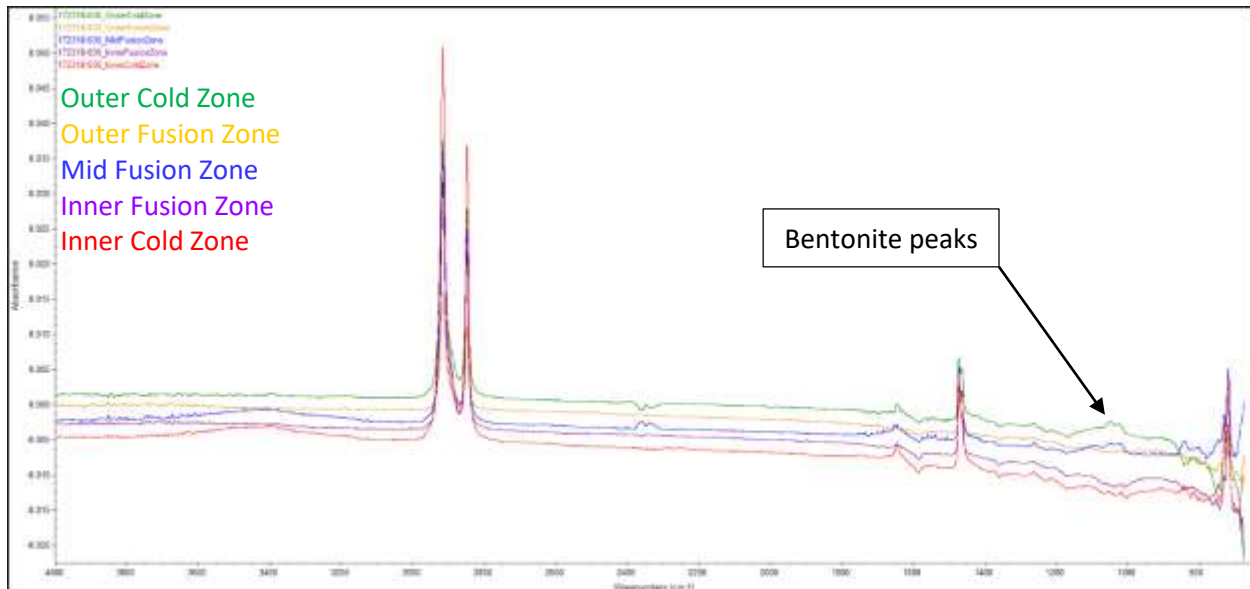
Figure 98. Sample 172318-036, FTIR spectra from decohesion test result

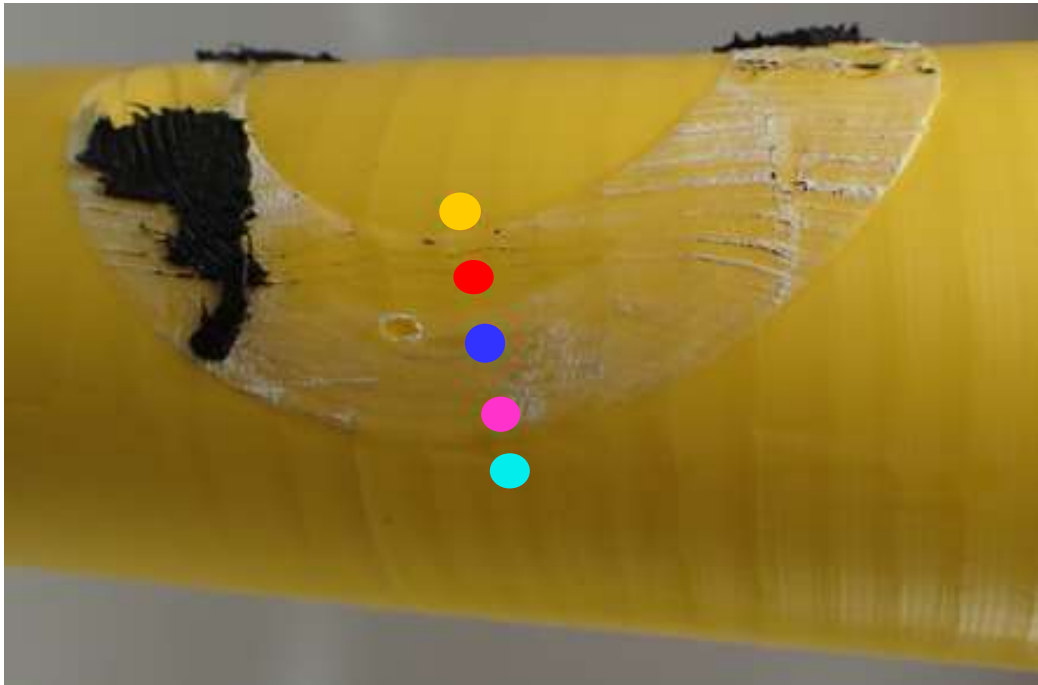
172318-037	172395-073	Bentonite	Acetone	Paper Towel
------------	------------	-----------	---------	-------------

Figure 99. Sample 172318-037, decohesion test result

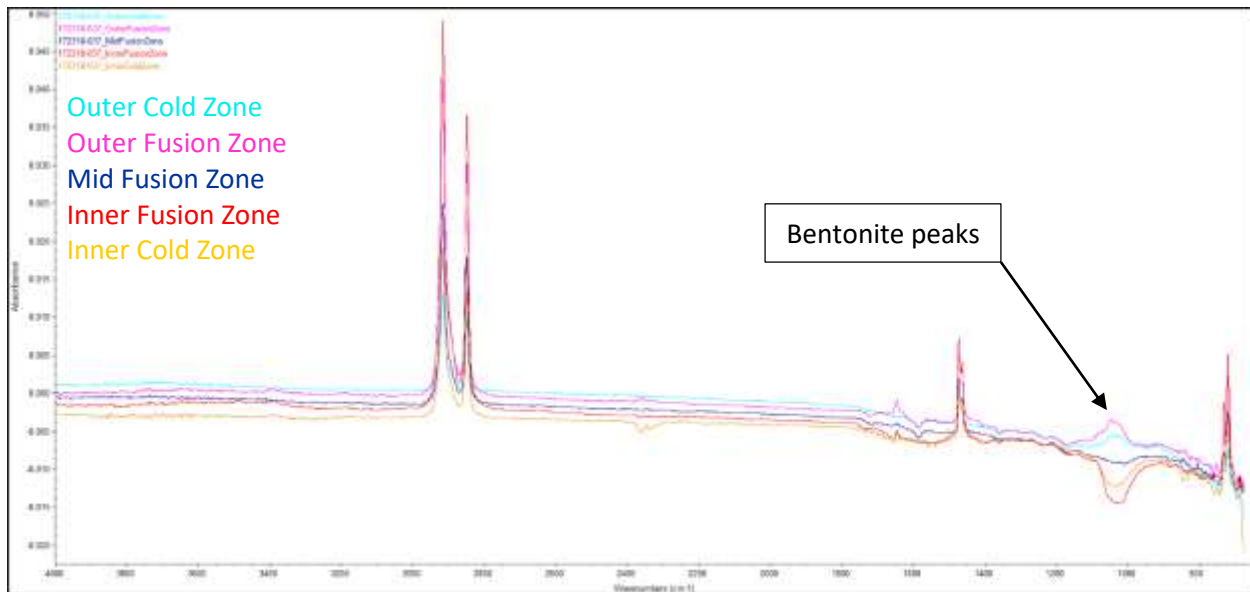
Figure 100. Sample 172318-037, FTIR spectra from decohesion test result

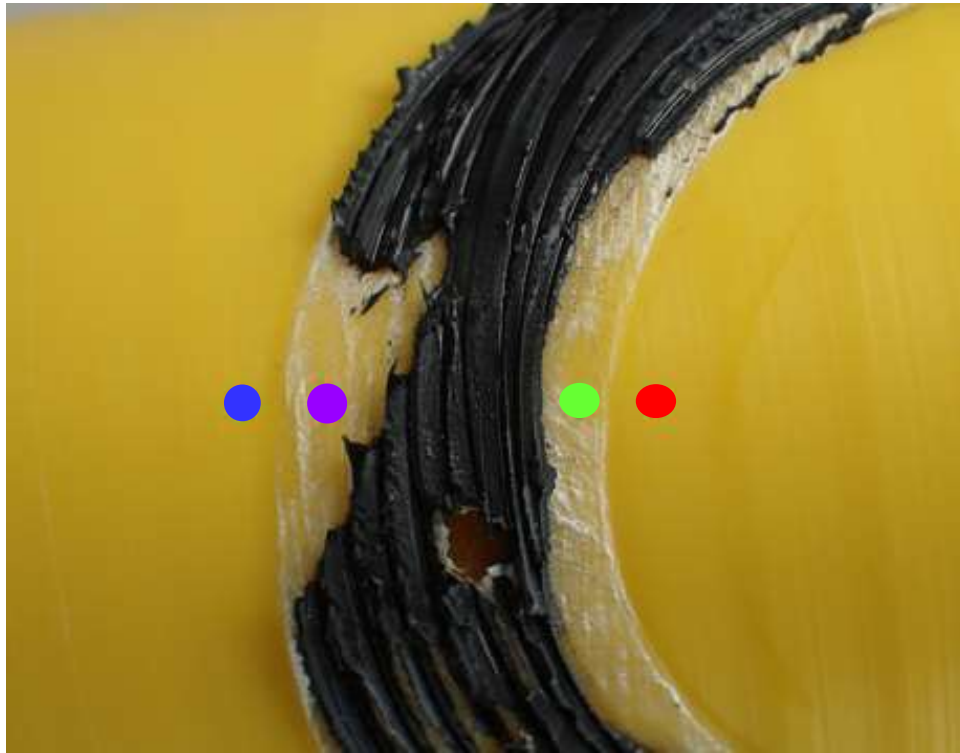
172318-038	172395-074	Bentonite	Acetone	Paper Towel
------------	------------	-----------	---------	-------------

Figure 101. Sample 172318-038, decohesion test result

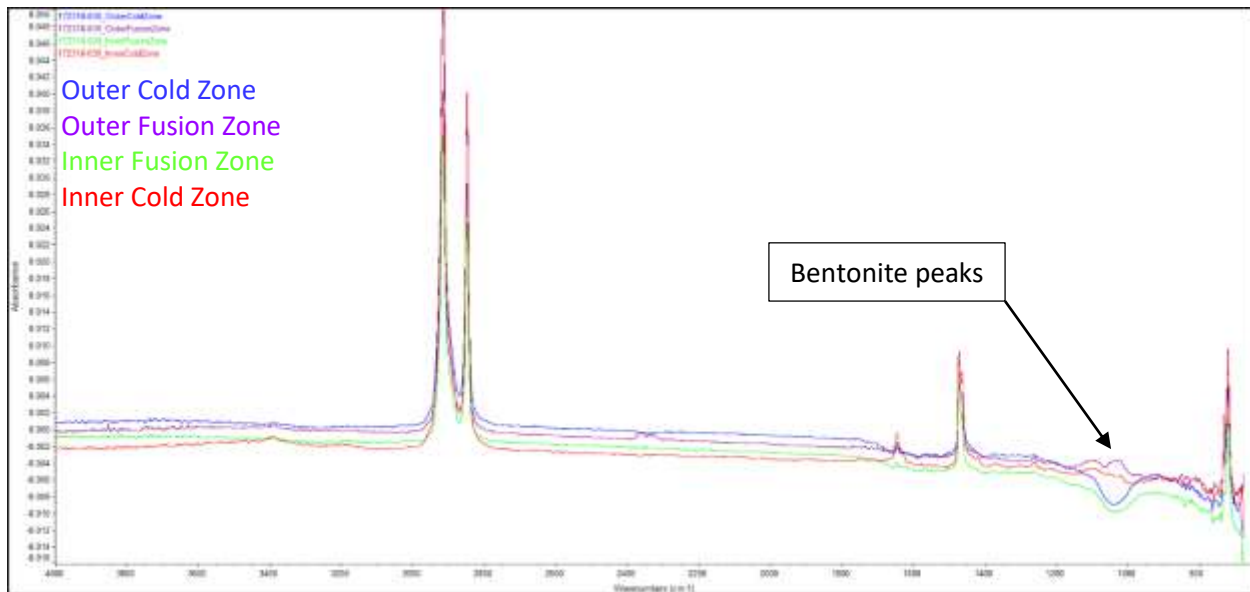
Figure 102. Sample 172318-038, FTIR spectra from decohesion test result

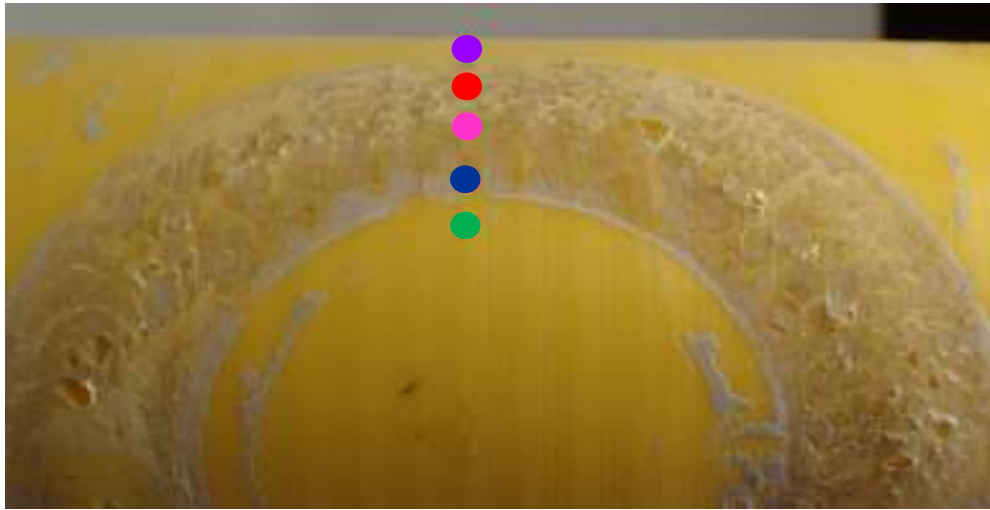
172318-039	172395-077	Bentonite	None	None
------------	------------	-----------	------	------

Figure 103. Sample 172318-039, decohesion test result

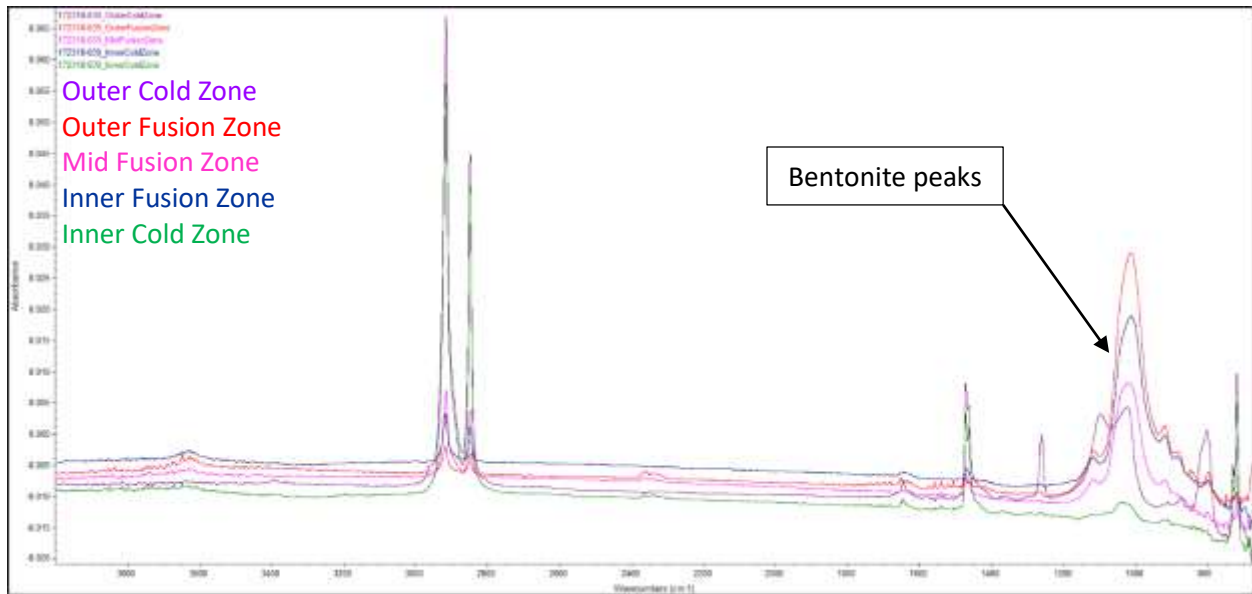
Figure 104. Sample 172318-039, FTIR spectra from decohesion test result

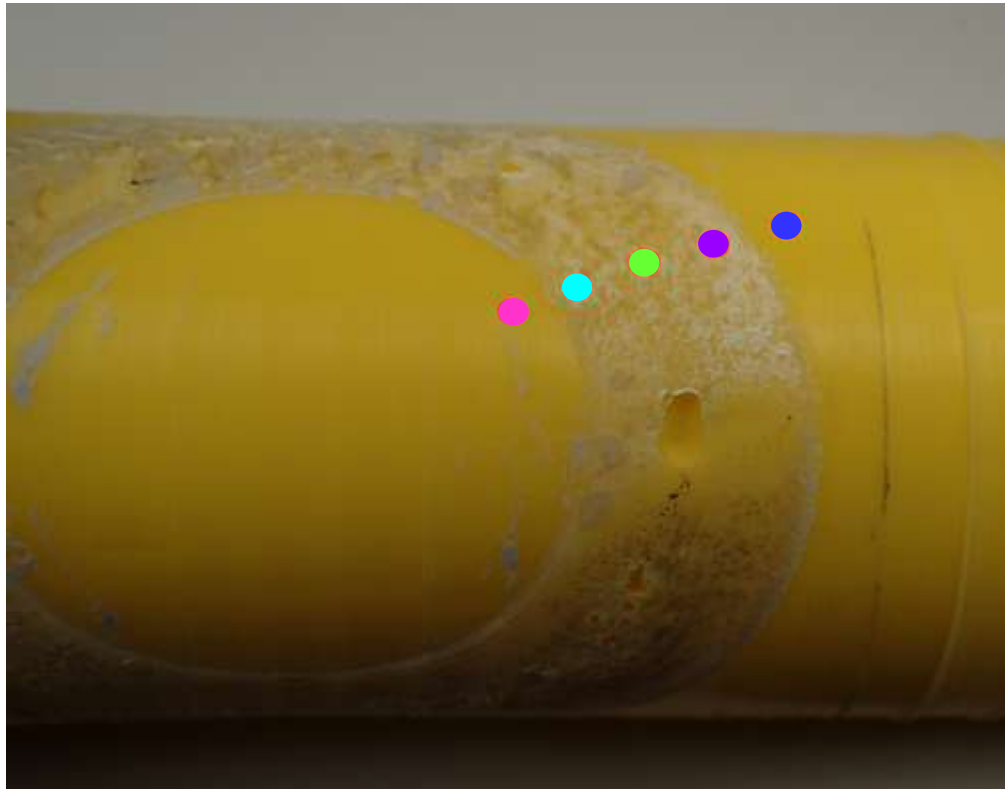
172318-040	172395-078	Bentonite	None	None
------------	------------	-----------	------	------

Figure 105. Sample 172318-040, decohesion test result

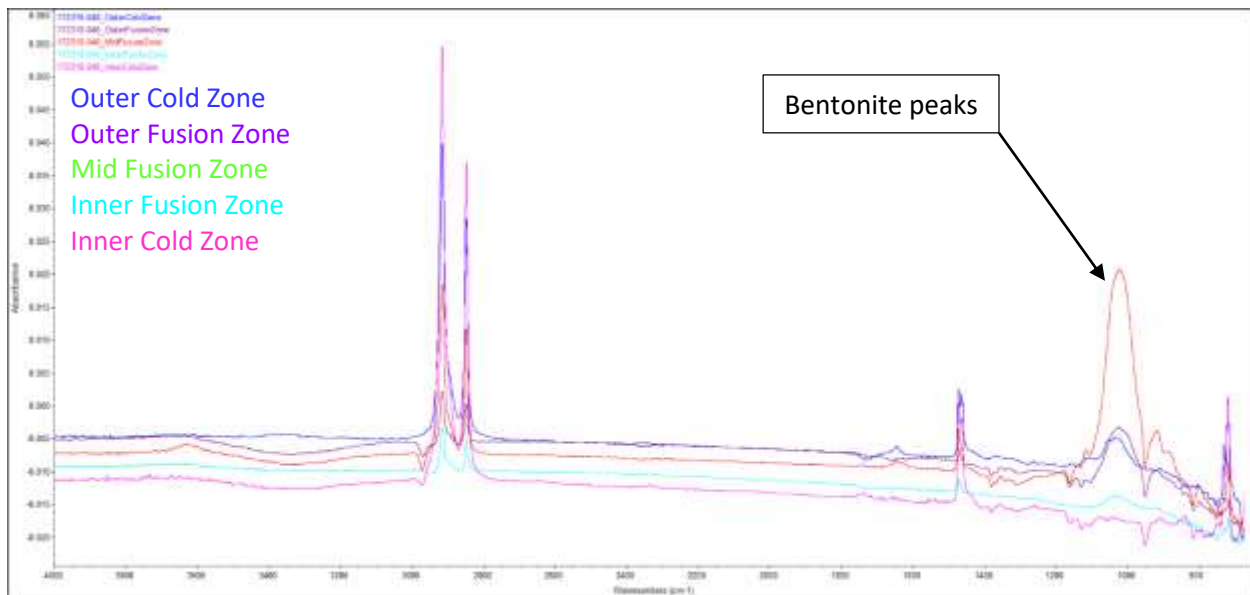
Figure 106. Sample 172318-040, FTIR spectra from decohesion test result

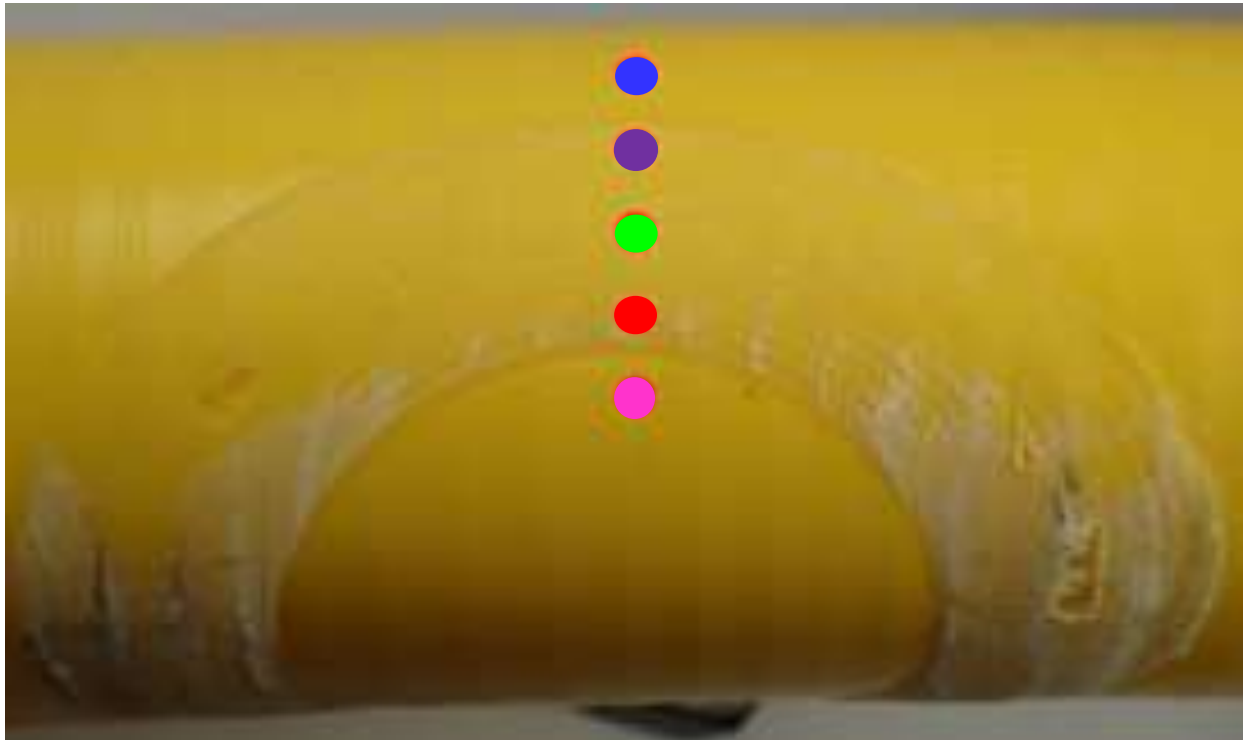
172318-041 172395-081 Silicon Grease 99% Isopropanol Lint-Free Wipe

Figure 107. Sample 172318-041, decohesion test result

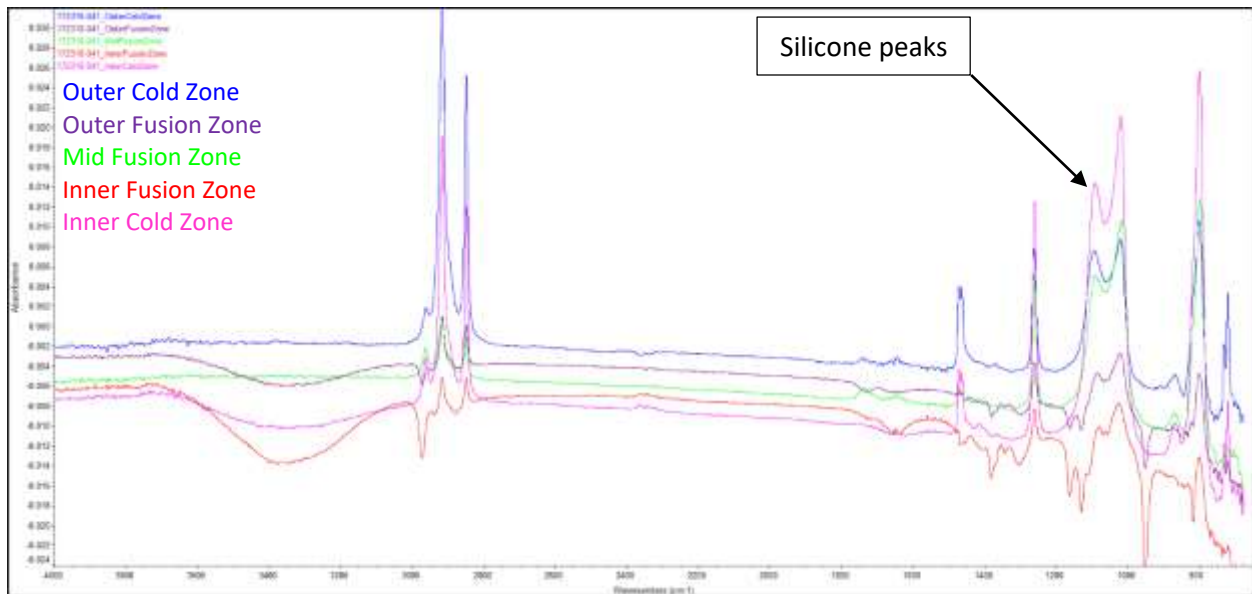
Figure 108. Sample 172318-041, FTIR spectra from decohesion test result

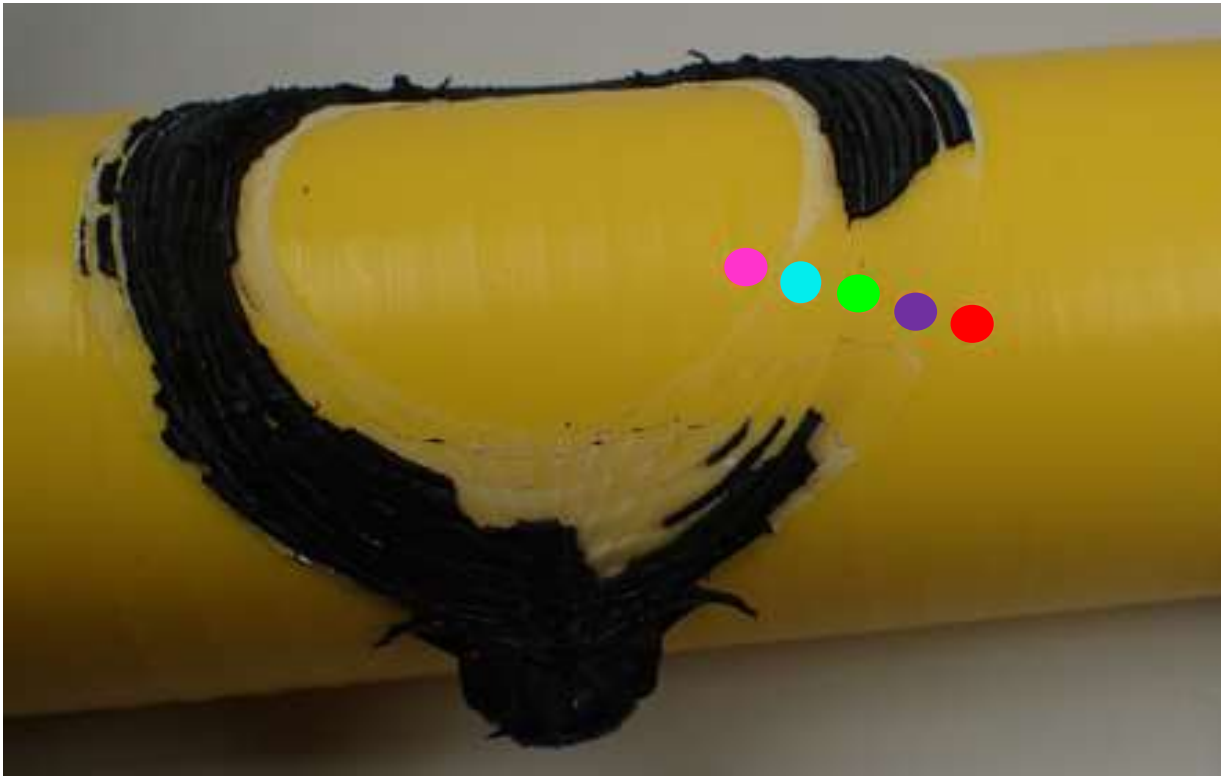
172318-042 172395-082 Silicon Grease 99% Isopropanol Lint-Free Wipe

Figure 109. Sample 172318-042, decohesion test result

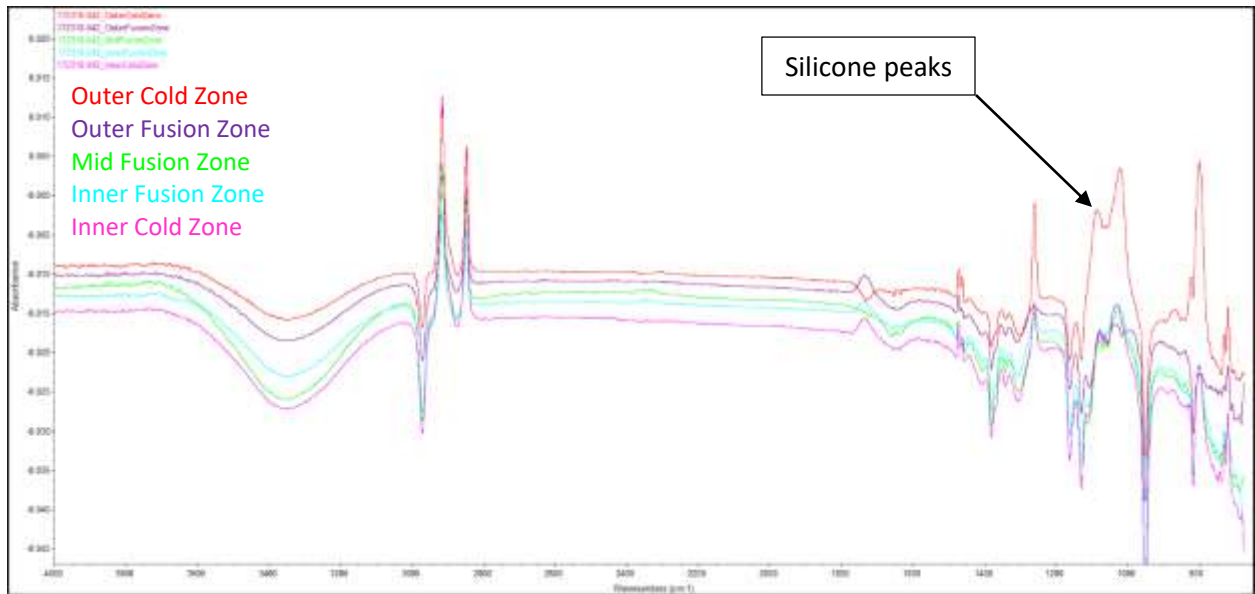
Figure 110. Sample 172318-042, FTIR spectra from decohesion test result

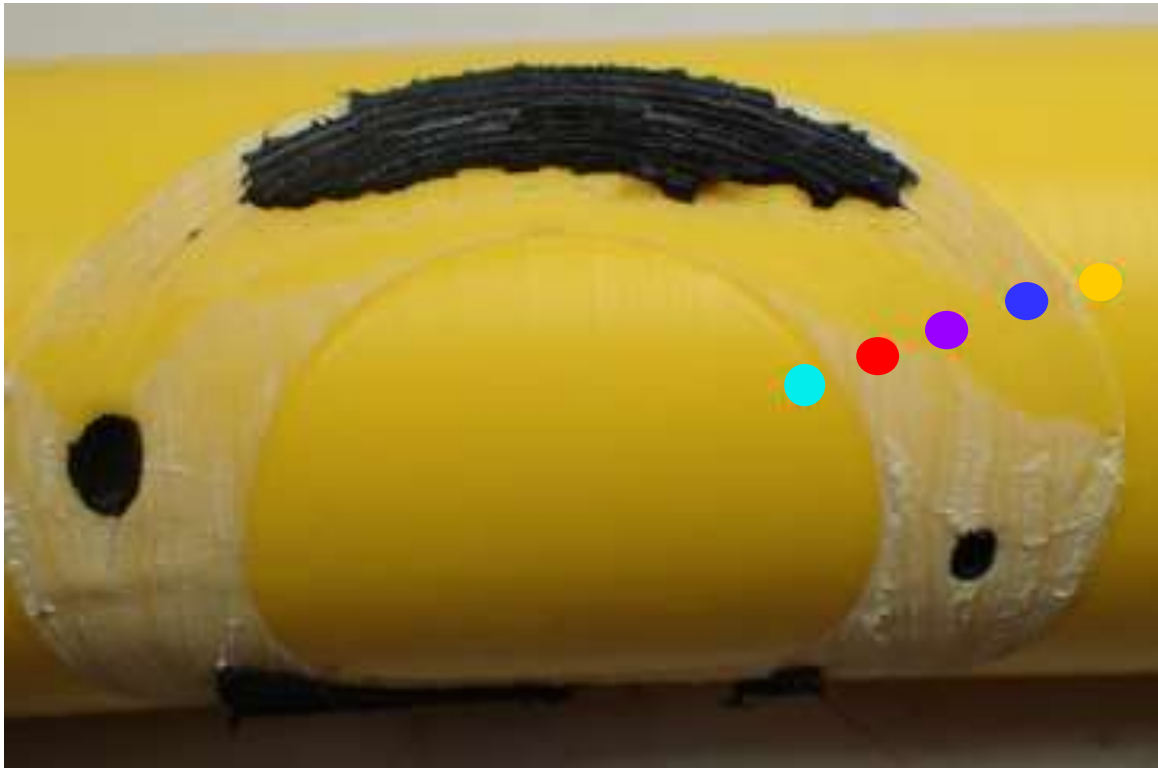
172318-042A 172395-082A Silicon Grease 99% Isopropanol Lint-Free Wipe

Figure 111. Sample 172318-042A, decohesion test result

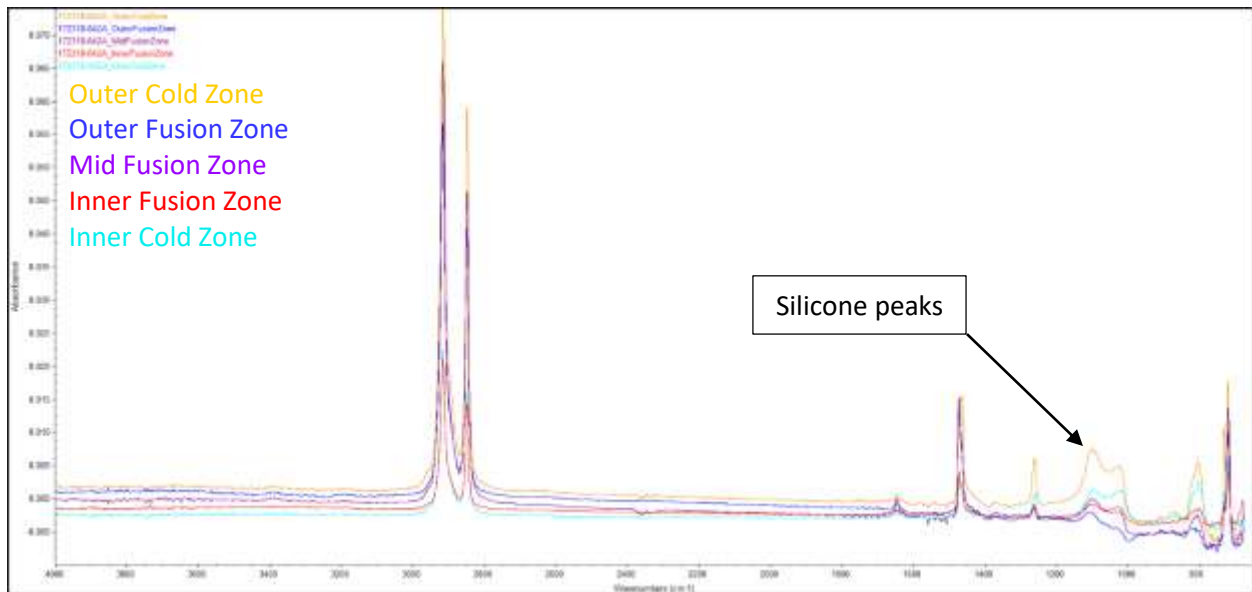
Figure 112. Sample 172318-042A, FTIR spectra from decohesion test result

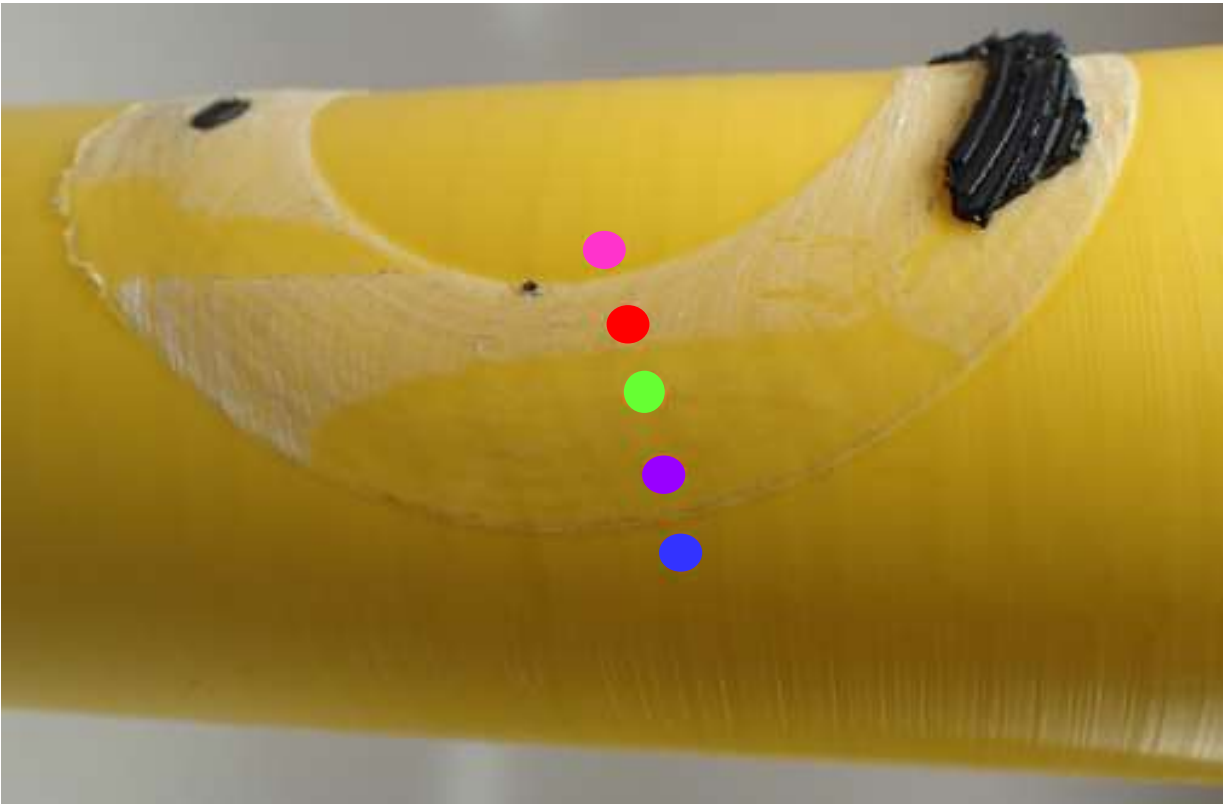
172318-043 172395-085 Silicon Grease 99% Isopropanol Cotton Cloth Rag

Figure 113. Sample 172318-043, decohesion test result

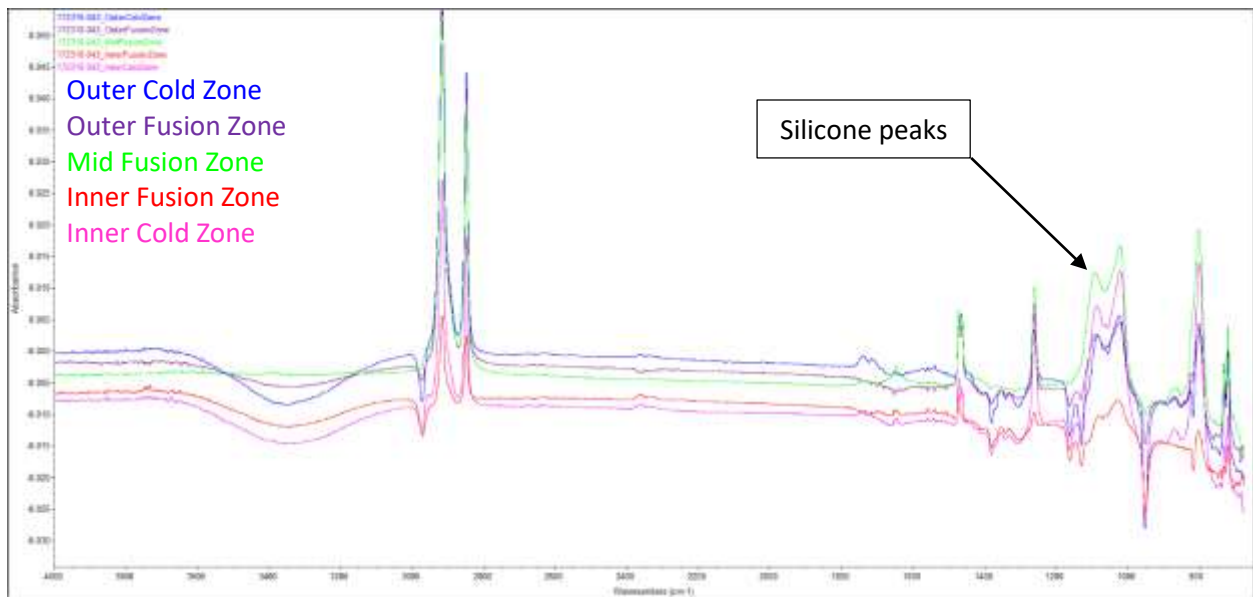
Figure 114. Sample 172318-043, FTIR spectra from decohesion test result

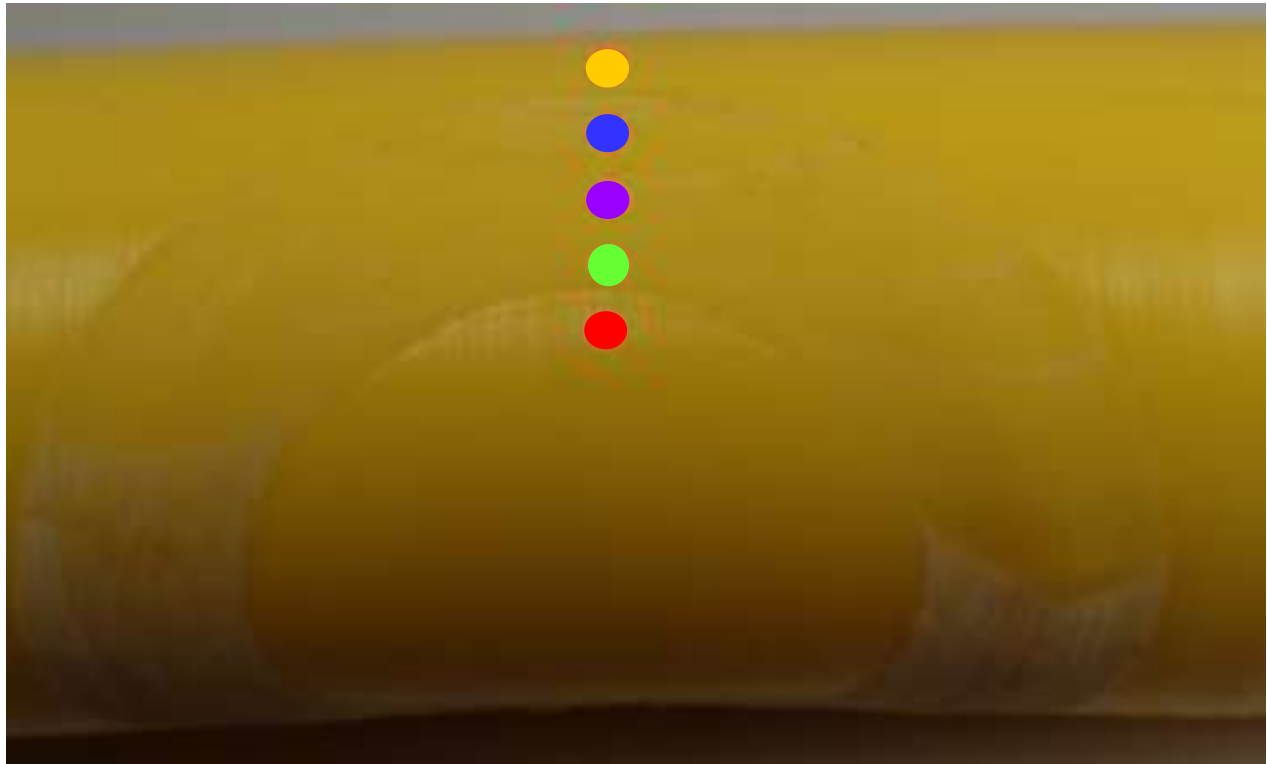
172318-044	172395-086	Silicon Grease	Acetone	Lint-Free Wipe
------------	------------	----------------	---------	----------------

Figure 115. Sample 172318-044, decohesion test result

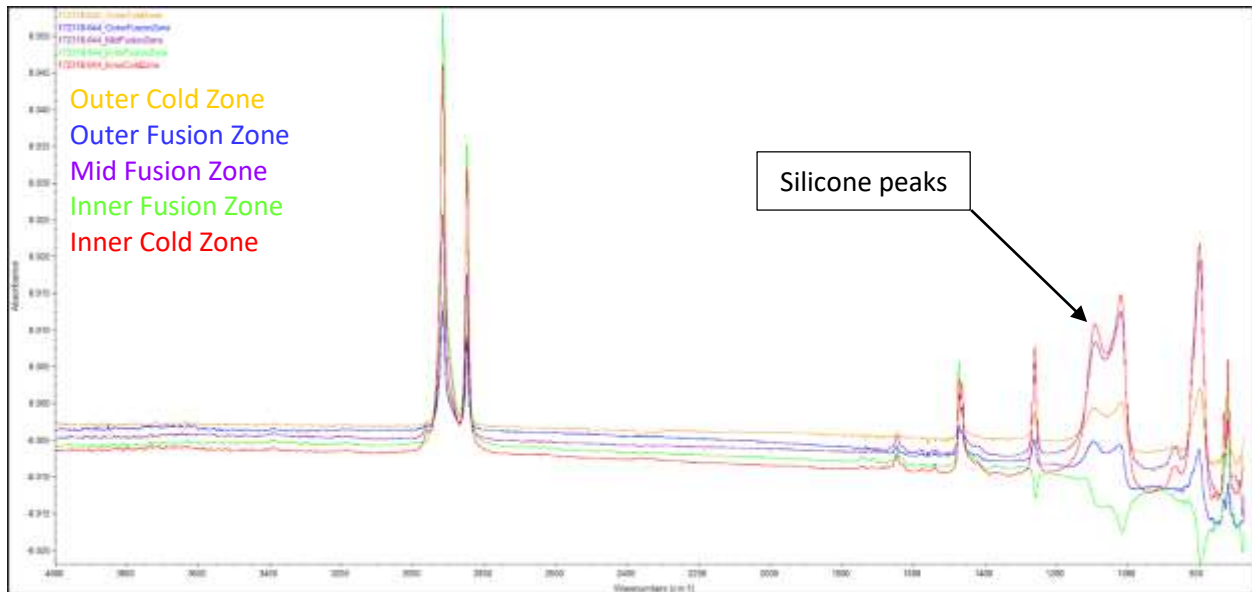
Figure 116. Sample 172318-044, FTIR spectra from decohesion test result

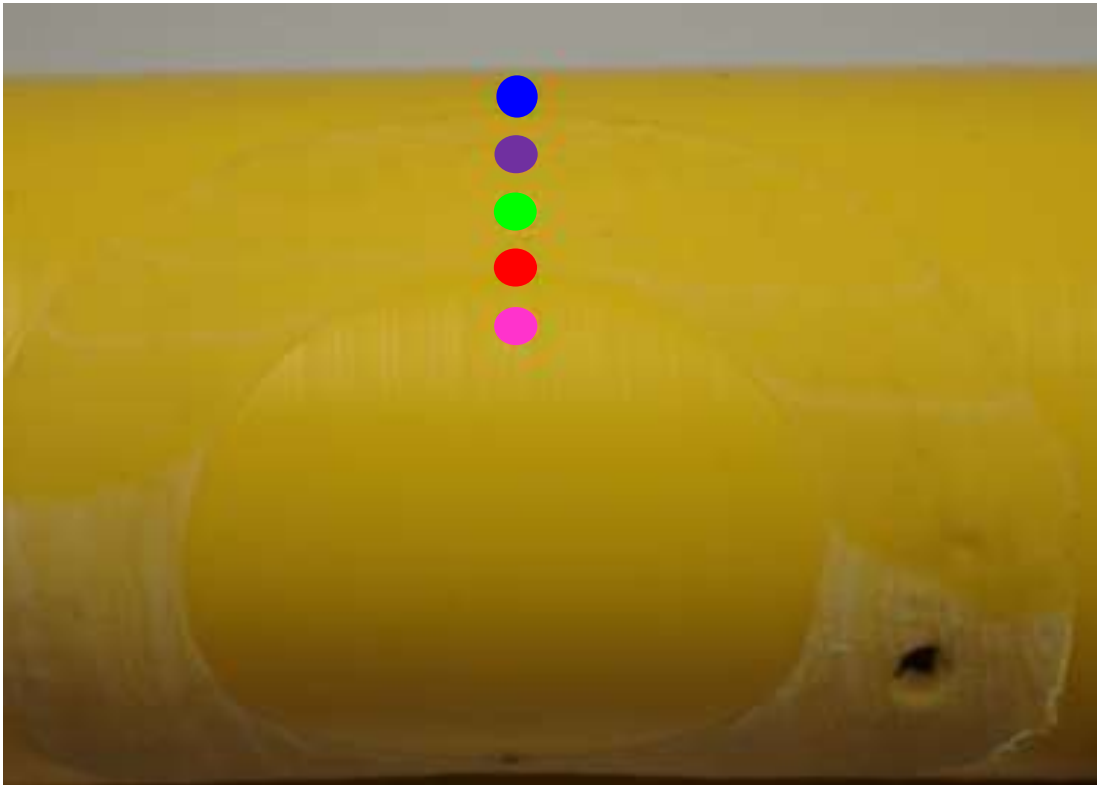
172318-045 172395-087 Silicon Grease Acetone Lint-Free Wipe

Figure 117. Sample 172318-045, decohesion test result

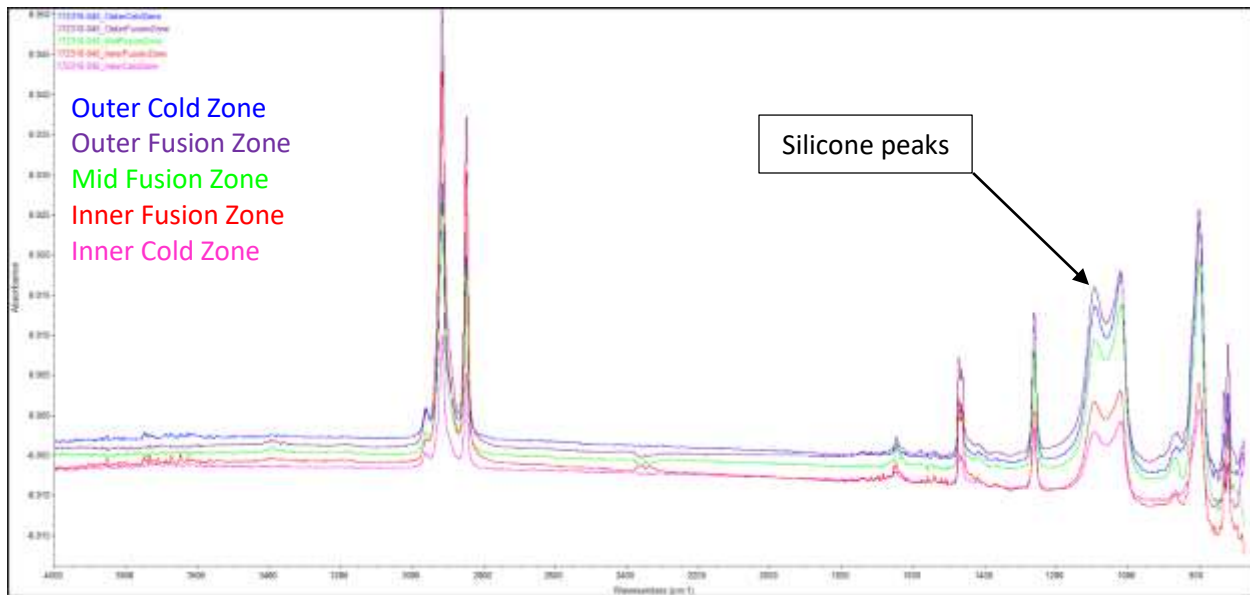
Figure 118. Sample 172318-045, FTIR spectra from decohesion test result

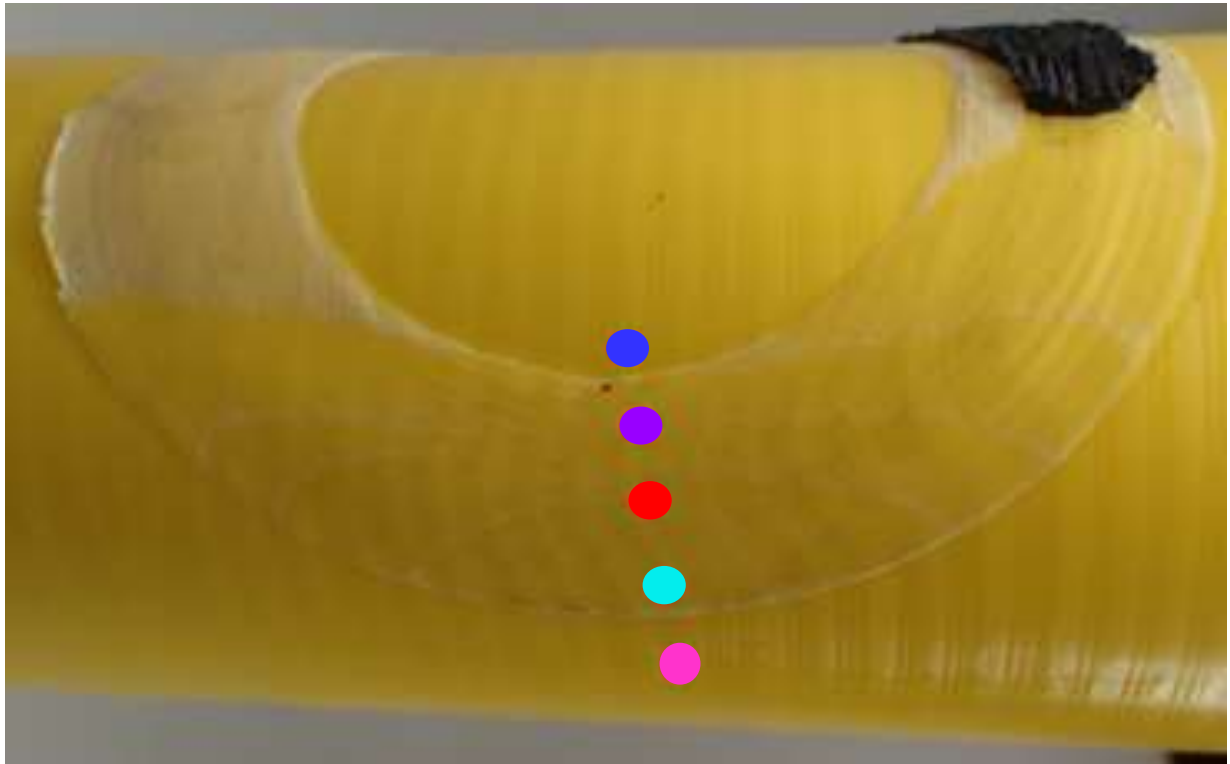
172318-046	172395-090	Silicon Grease	Acetone	Cotton Cloth Rag
------------	------------	----------------	---------	------------------

Figure 119. Sample 172318-046, decohesion test result

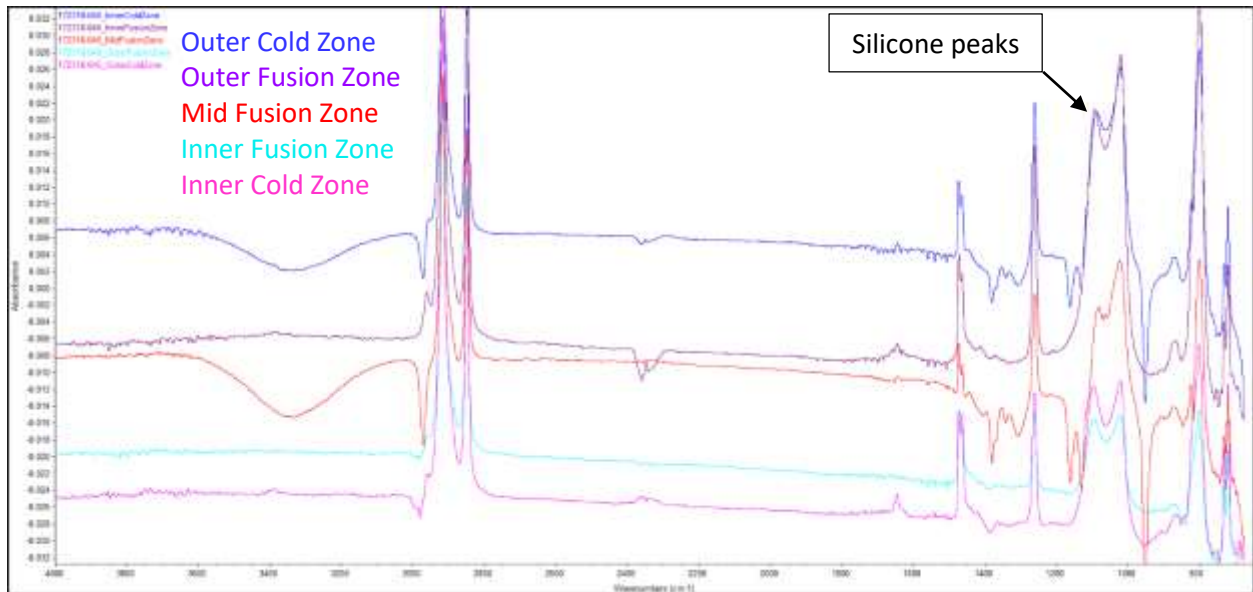
Figure 120. Sample 172318-046, FTIR spectra from decohesion test result

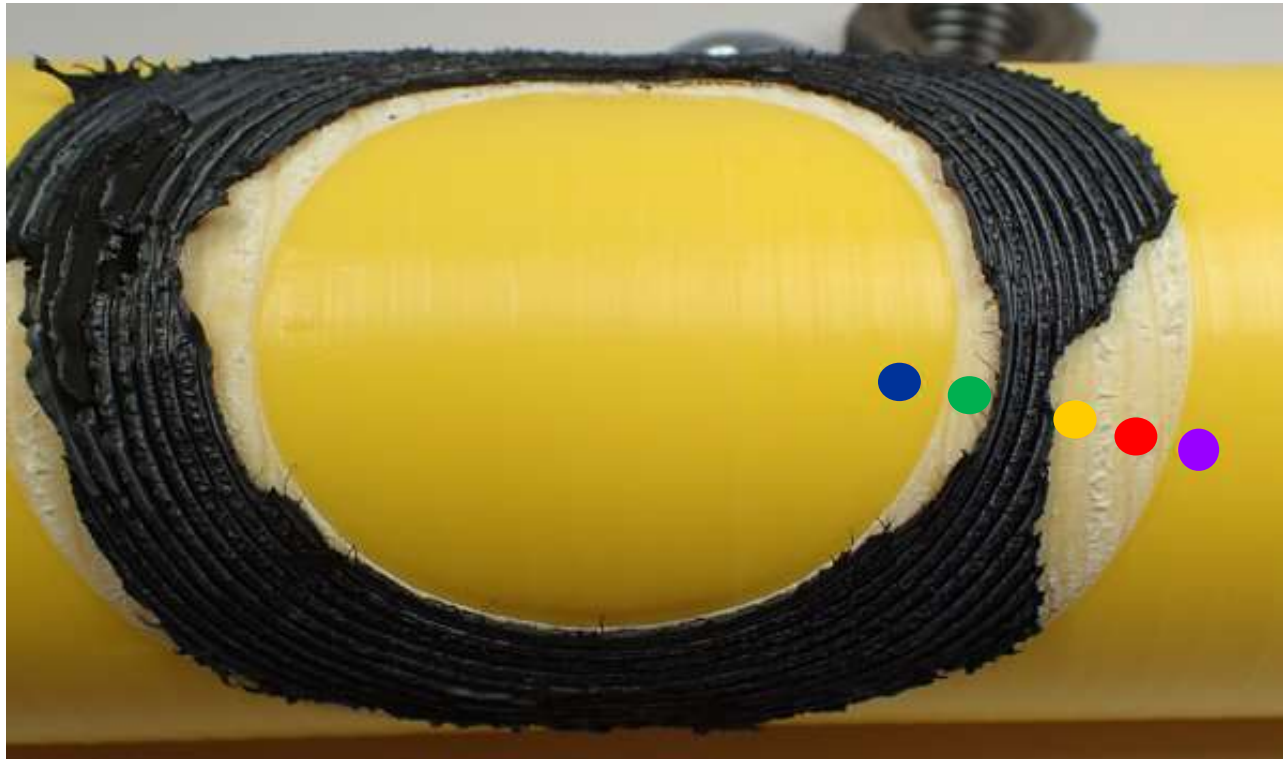
172318-047	172395-091	Silicon Grease	Acetone	Cotton Cloth Rag
------------	------------	----------------	---------	------------------

Figure 121. Sample 172318-047, decohesion test result

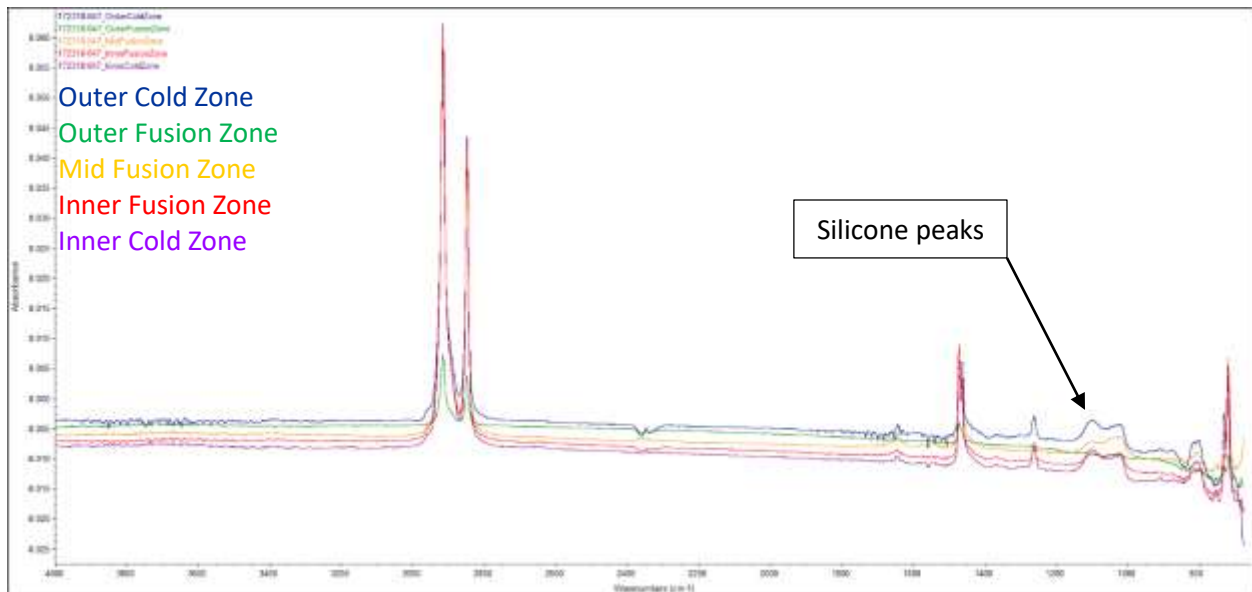
Figure 122. Sample 172318-047, FTIR spectra from decohesion test result

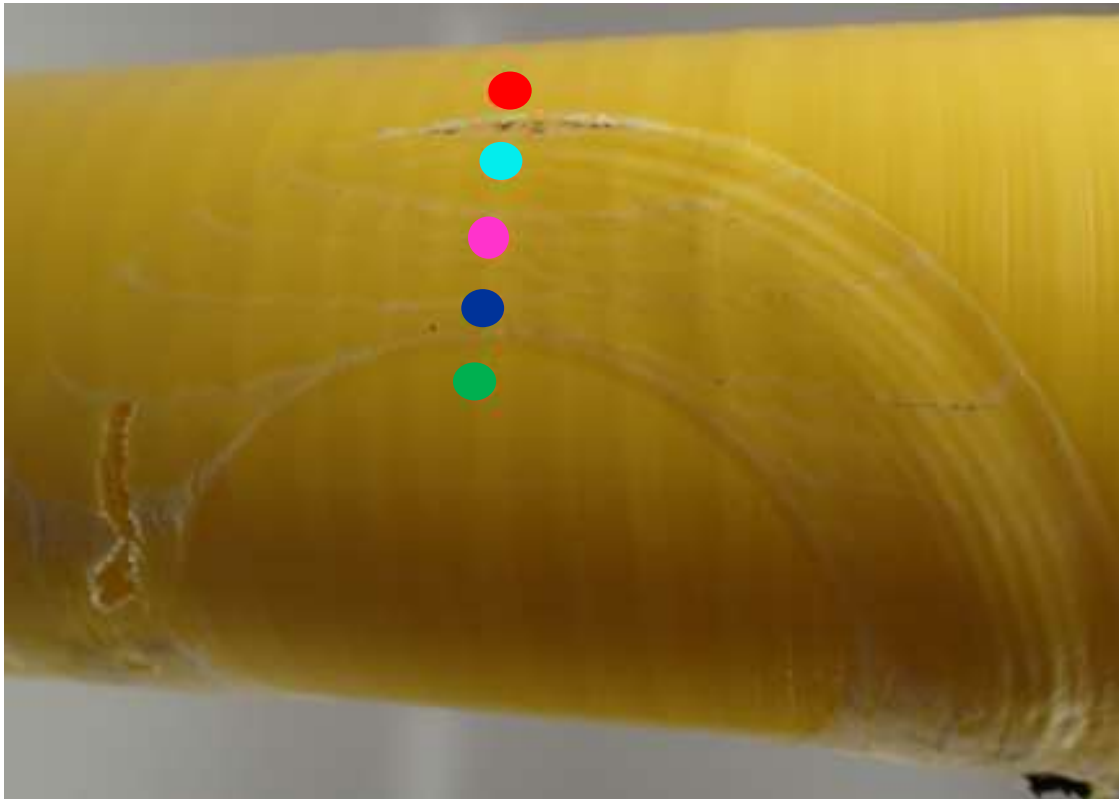
172318-048	172395-094	Silicon Grease	Acetone	Paper Towel
------------	------------	----------------	---------	-------------

Figure 123. Sample 172318-048, decohesion test result
