▼
**Solvent Cleaning and PE
Joining Procedures**

Prepared by:
Gas Technology Institute
Des Plaines, Illinois

GTI-OTD FINAL REPORT

Solvent Cleaning and PE Joining Procedures

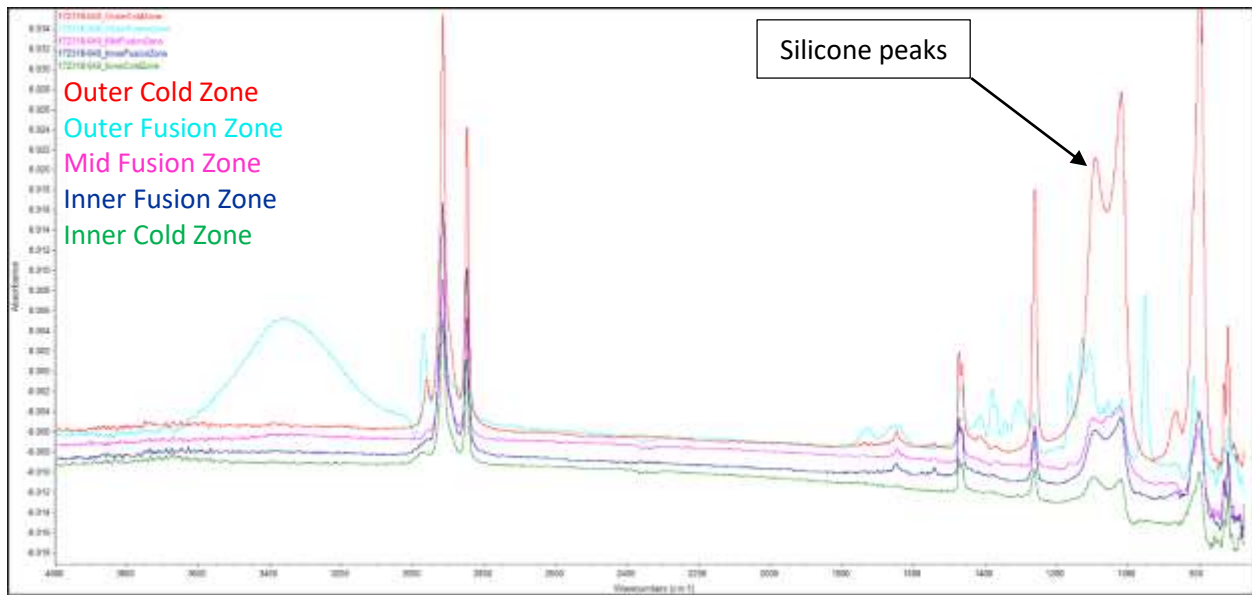
Figure 124. Sample 172318-048, FTIR spectra from decohesion test result

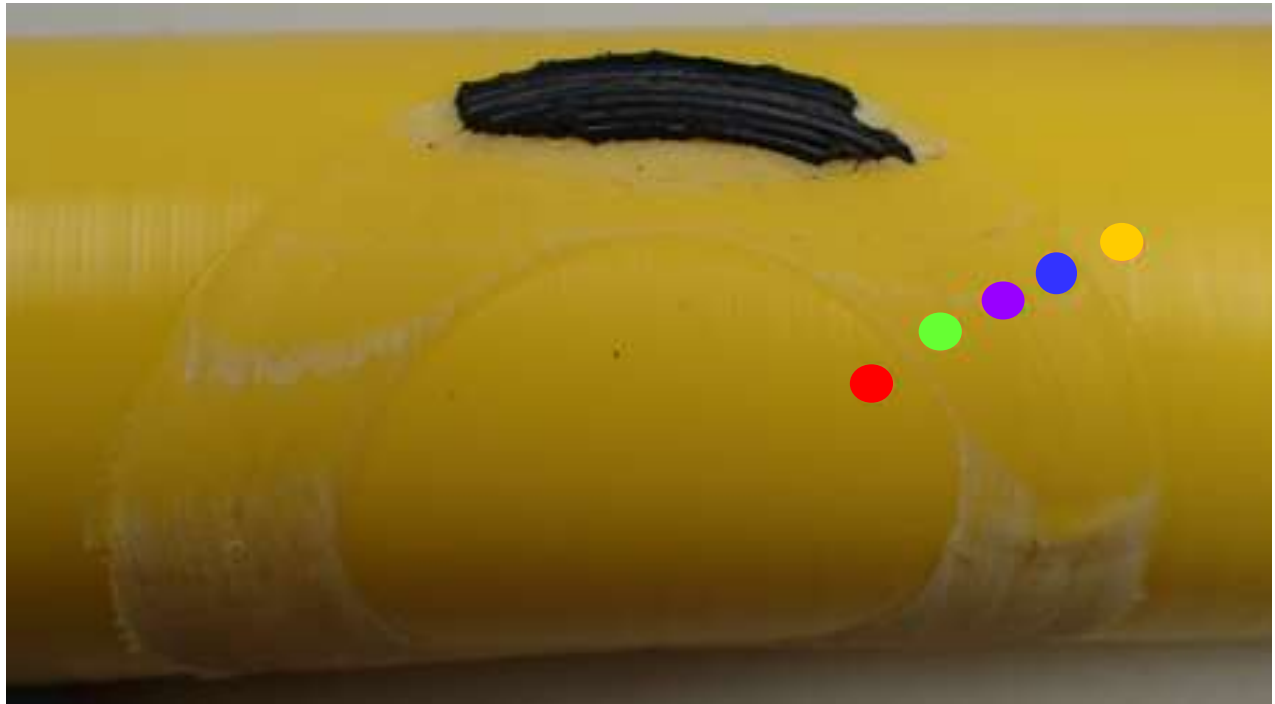
172318-049	172395-095	Silicon Grease	Acetone	Paper Towel
------------	------------	----------------	---------	-------------

Figure 125. Sample 172318-049, decohesion test result

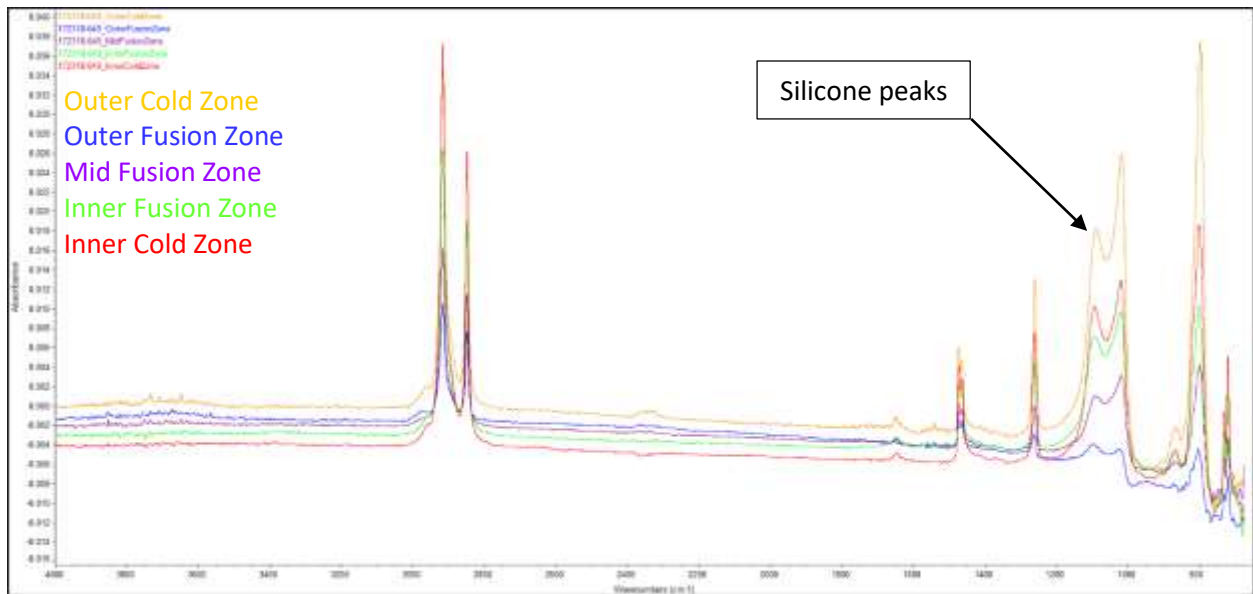
Figure 126. Sample 172318-049, FTIR spectra from decohesion test result

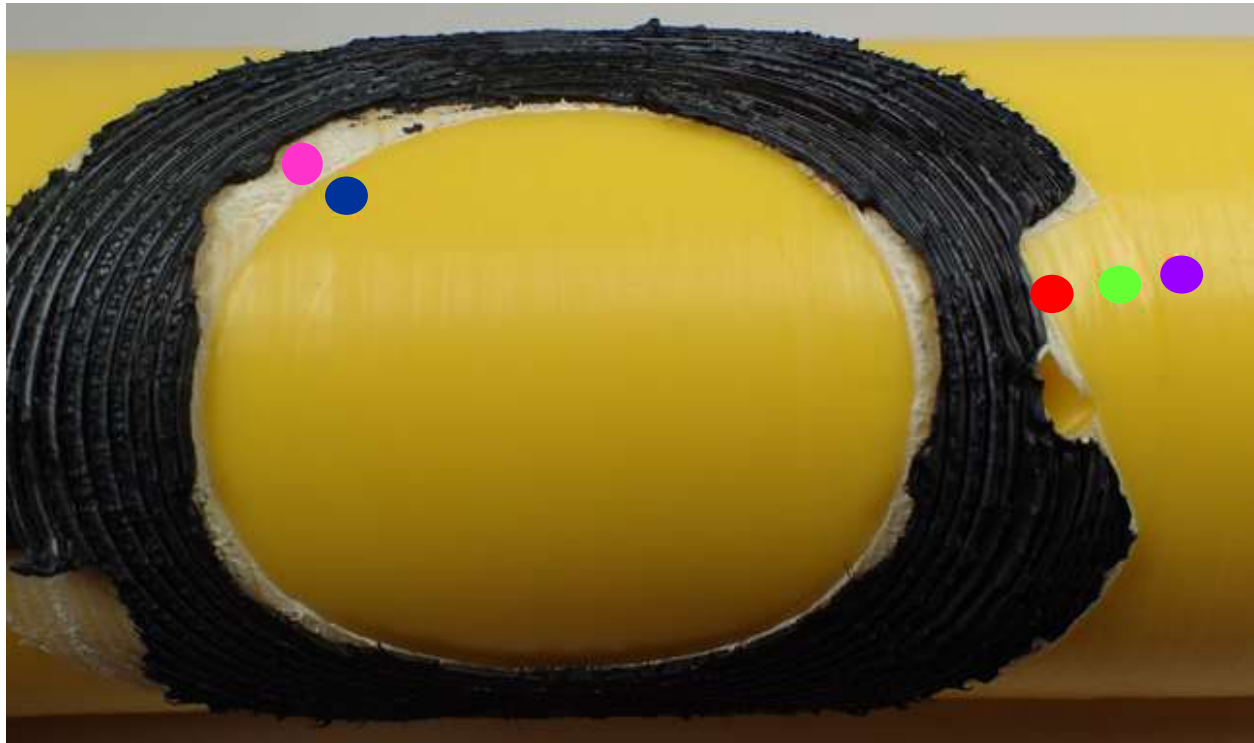
172318-050 172395-098 Silicon Grease 99% Isopropanol Cotton Cloth Rag

Figure 127. Sample 172318-050, decohesion test result

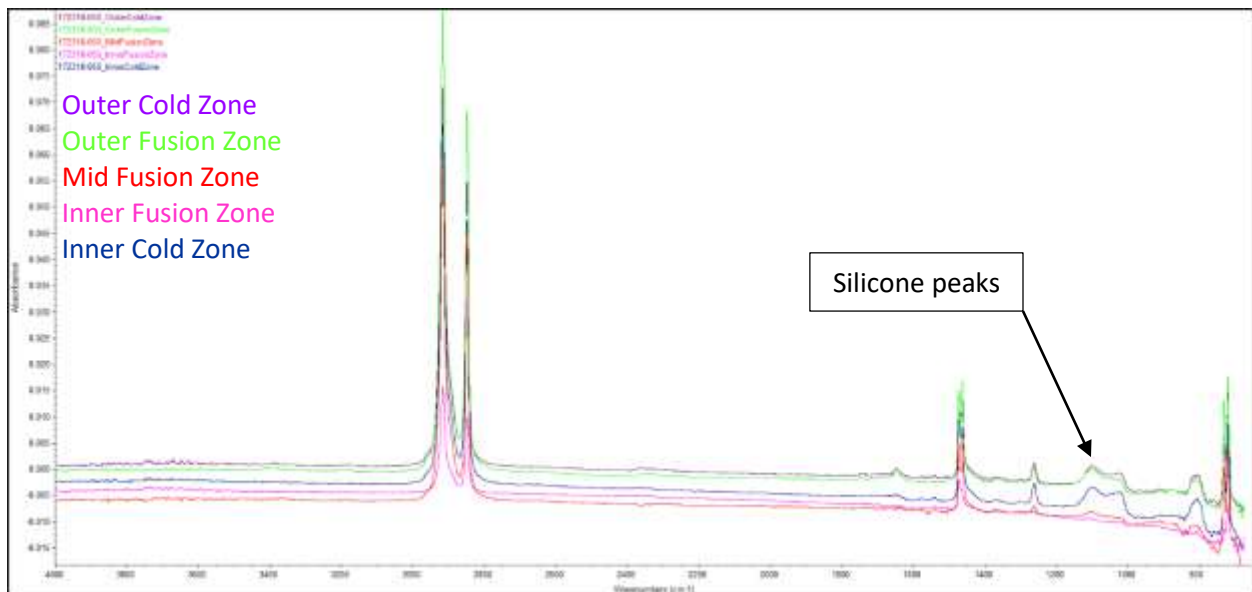
Figure 128. Sample 172318-050, FTIR spectra from decohesion test result

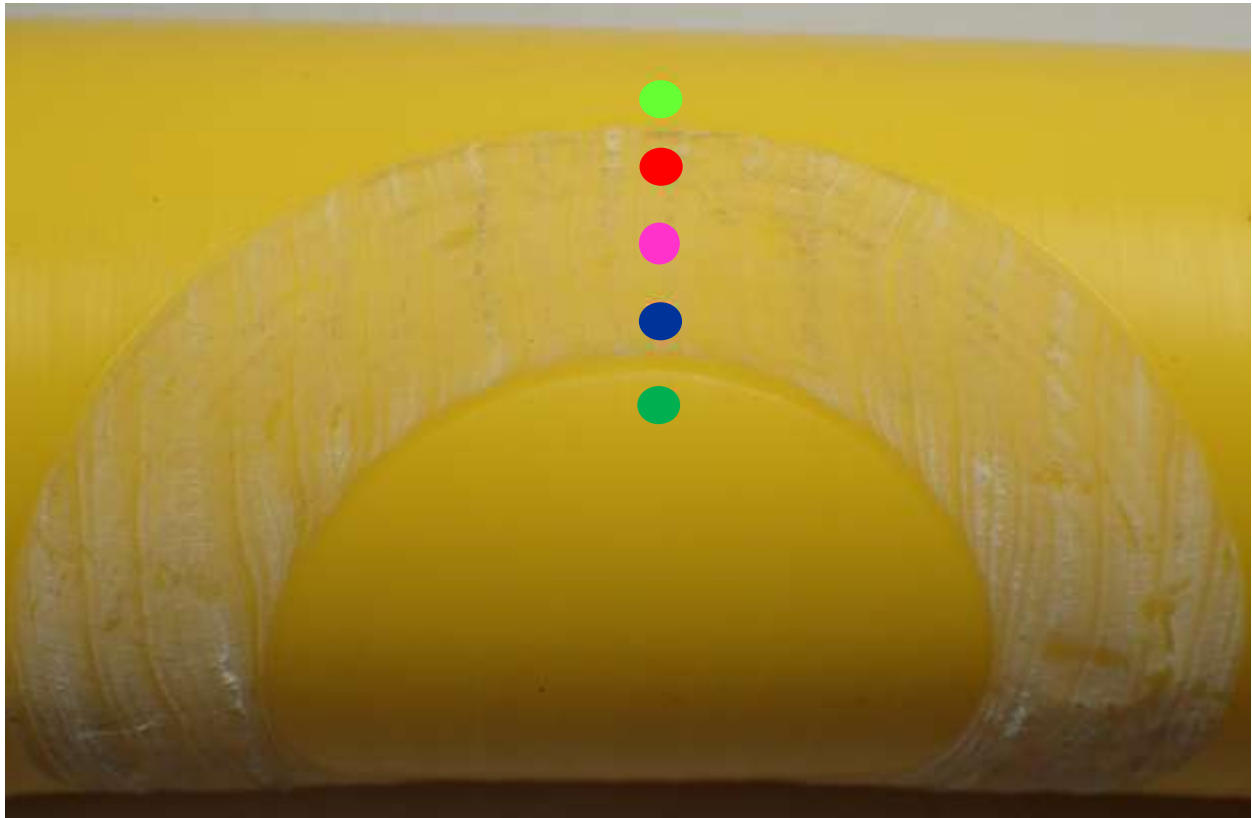
172318-051 172395-101 Silicon Grease 99% Isopropanol Paper Towel

Figure 129. Sample 172318-051, decohesion test result

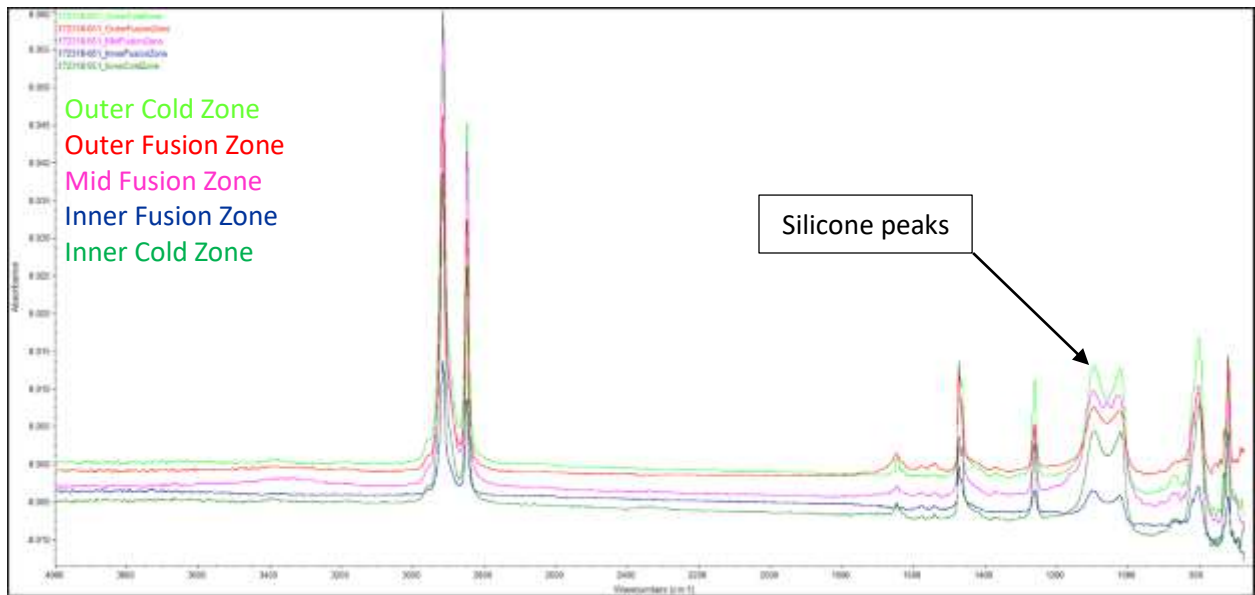
Figure 130. Sample 172318-051, FTIR spectra from decohesion test result

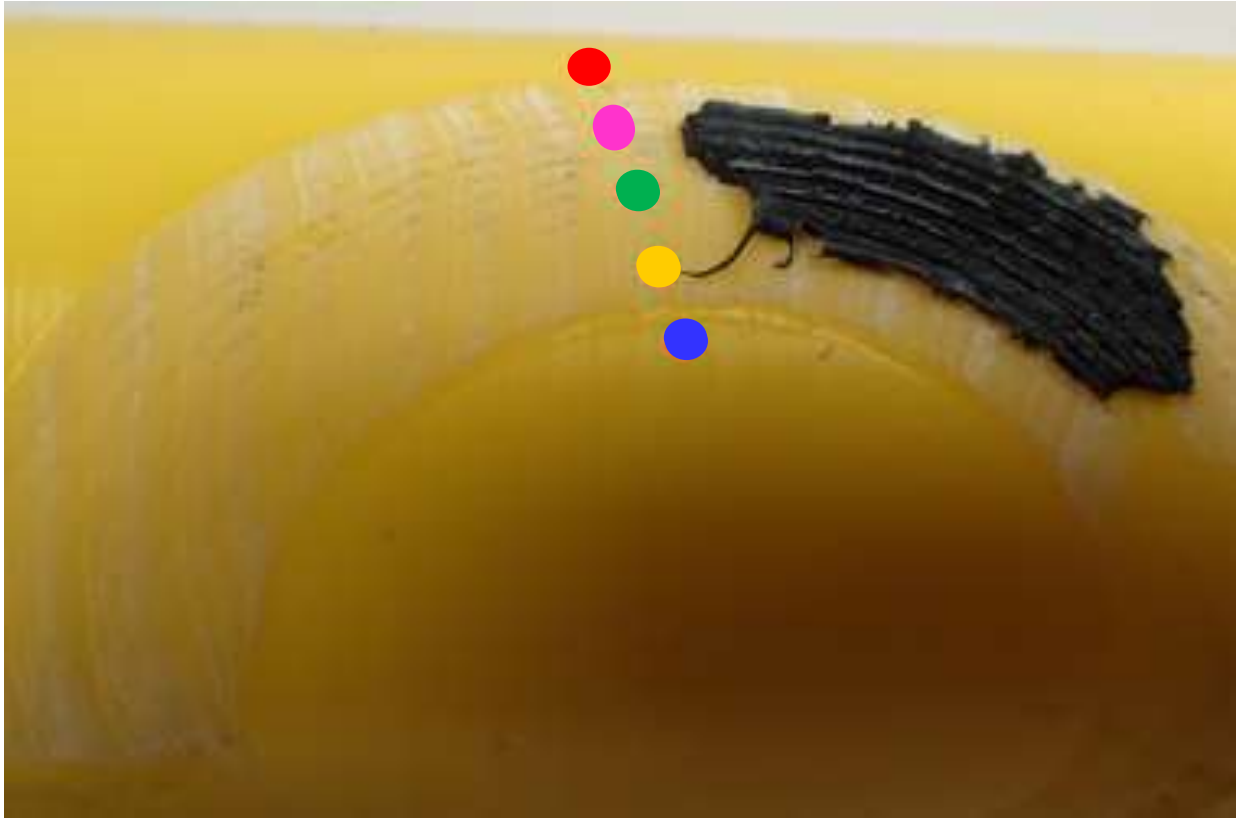
172318-052 172395-102 Silicon Grease 99% Isopropanol Paper Towel

Figure 131. Sample 172318-052, decohesion test result

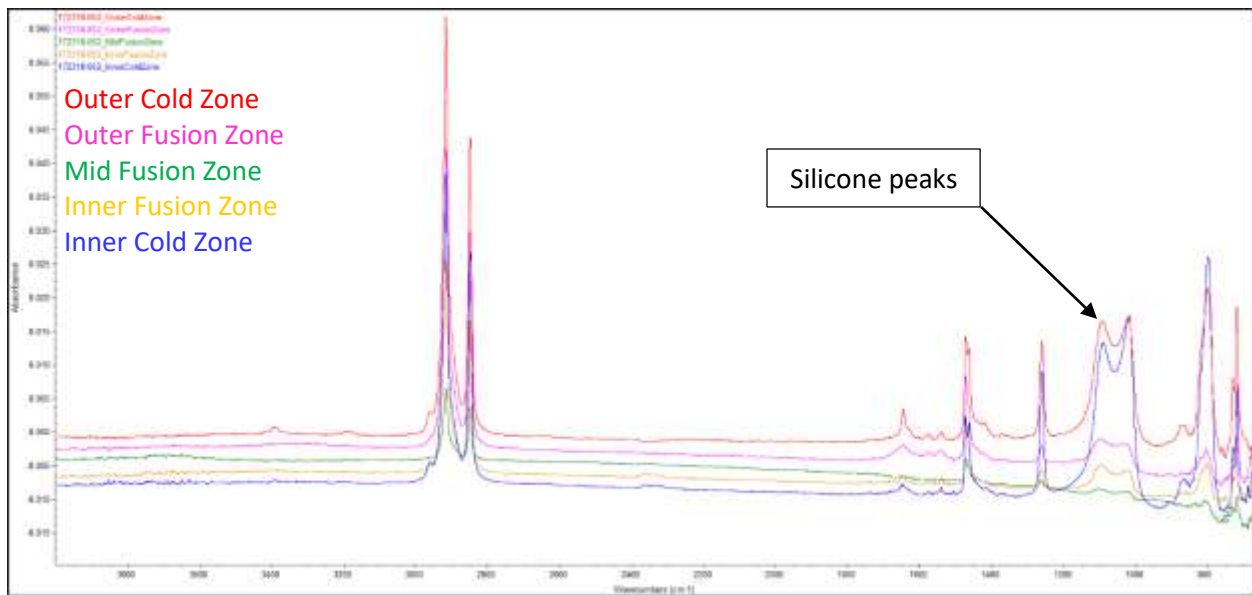
Figure 132. Sample 172318-052, FTIR spectra from decohesion test result

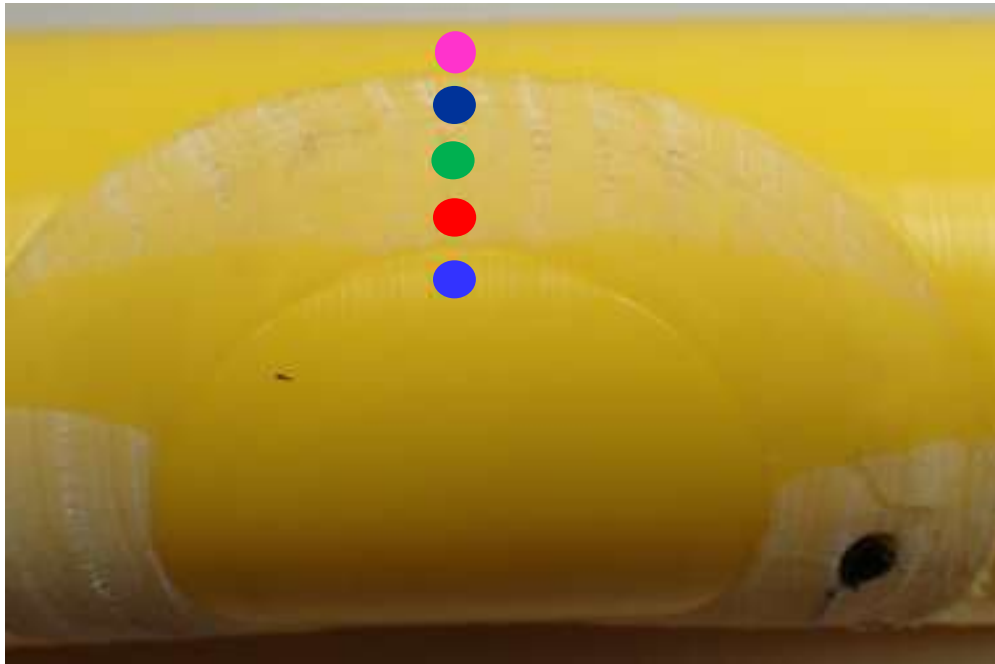
172318-053	172395-105	Silicon Grease	91% Isopropanol	Lint-Free Wipe
------------	------------	----------------	-----------------	----------------

Figure 133. Sample 172318-053, decohesion test result

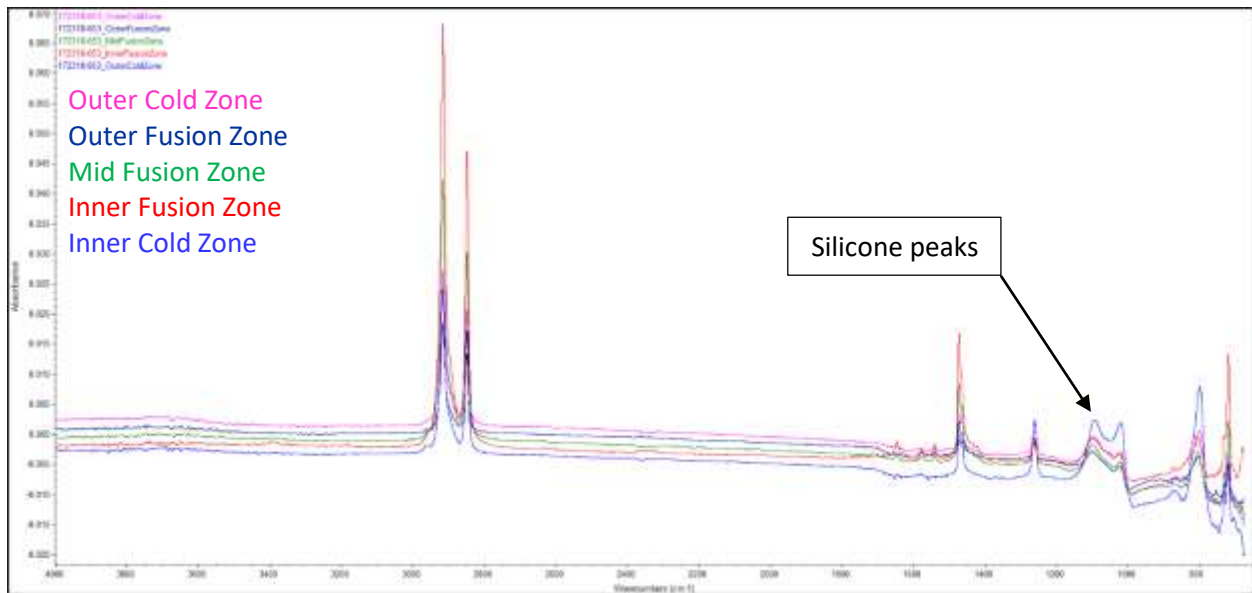
Figure 134. Sample 172318-053, FTIR spectra from decohesion test result

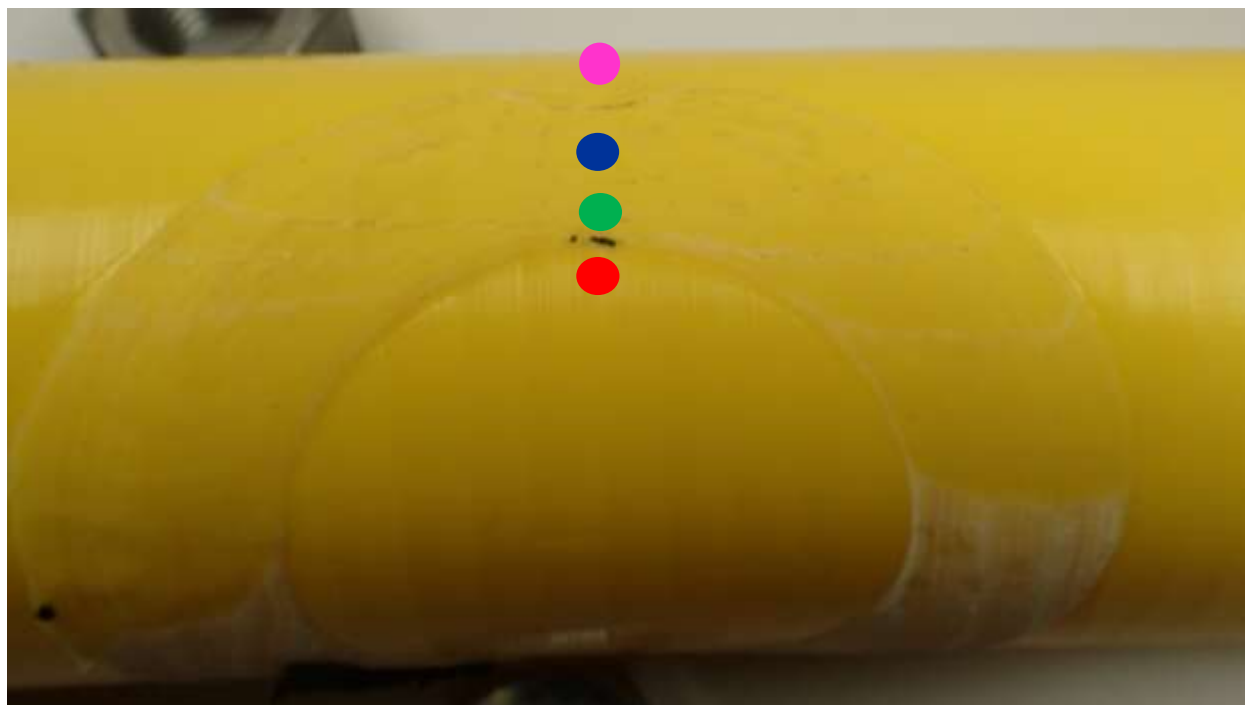
172318-054 172395-106 Silicon Grease 91% Isopropanol Lint-Free Wipe

Figure 135. Sample 172318-054, decohesion test result

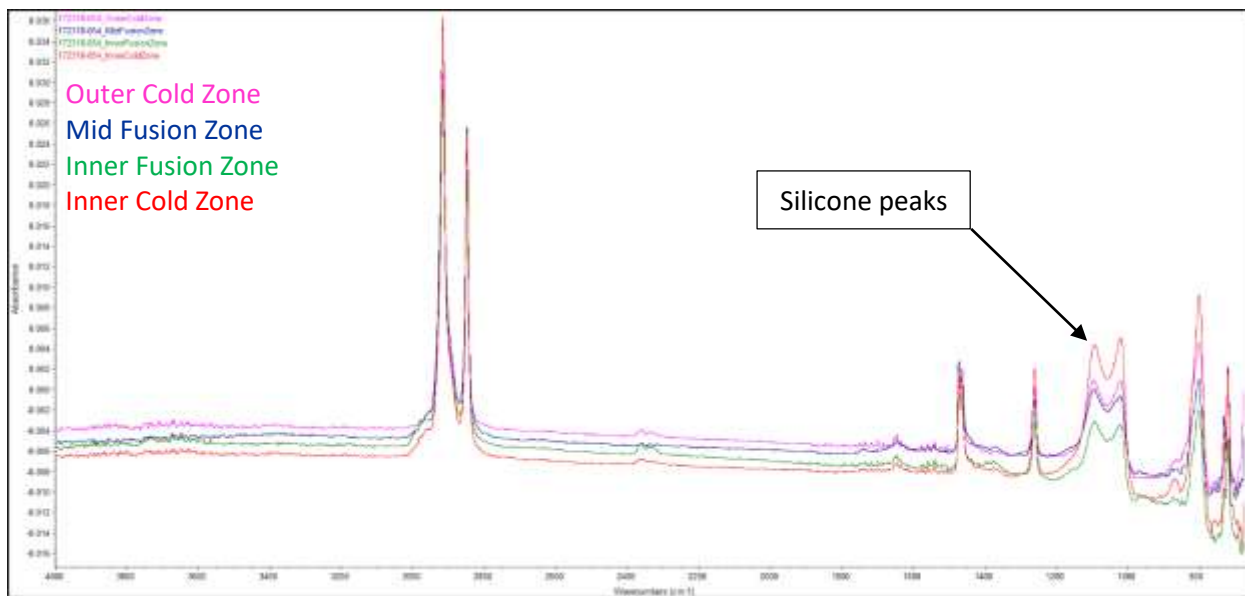
Figure 136. Sample 172318-054, FTIR spectra from decohesion test result

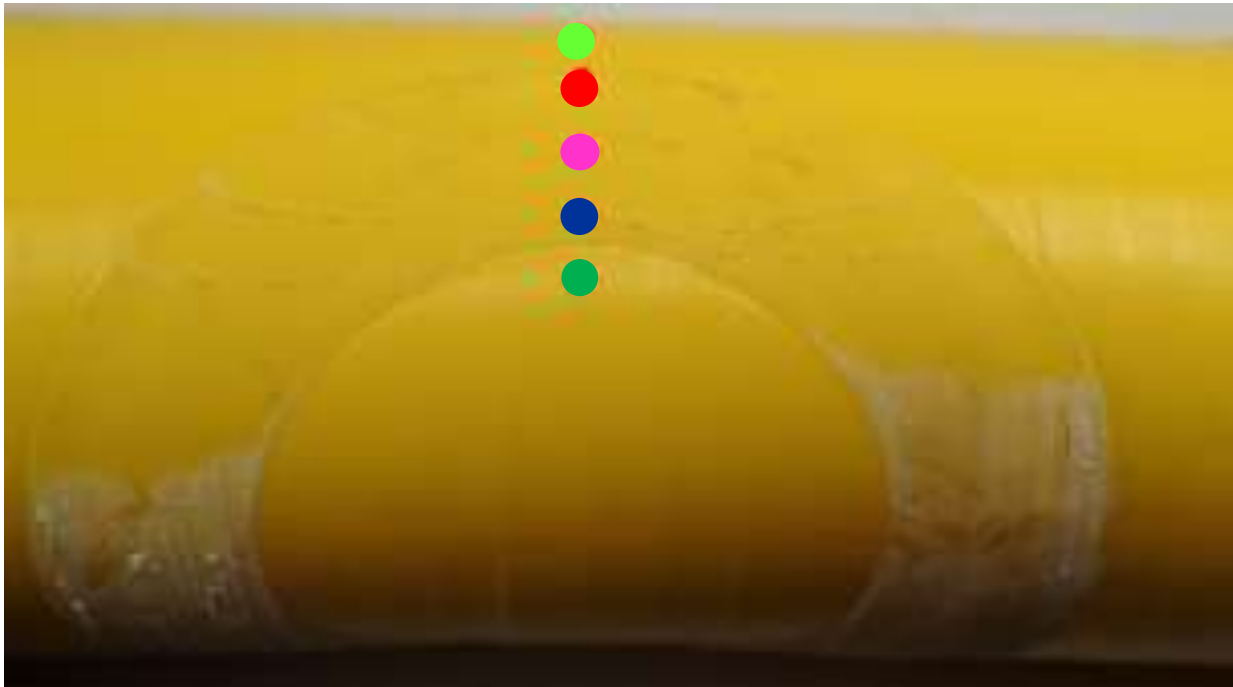
172318-055 172395-109 Silicon Grease 91% Isopropanol Cotton Cloth Rag

Figure 137. Sample 172318-055, decohesion test result

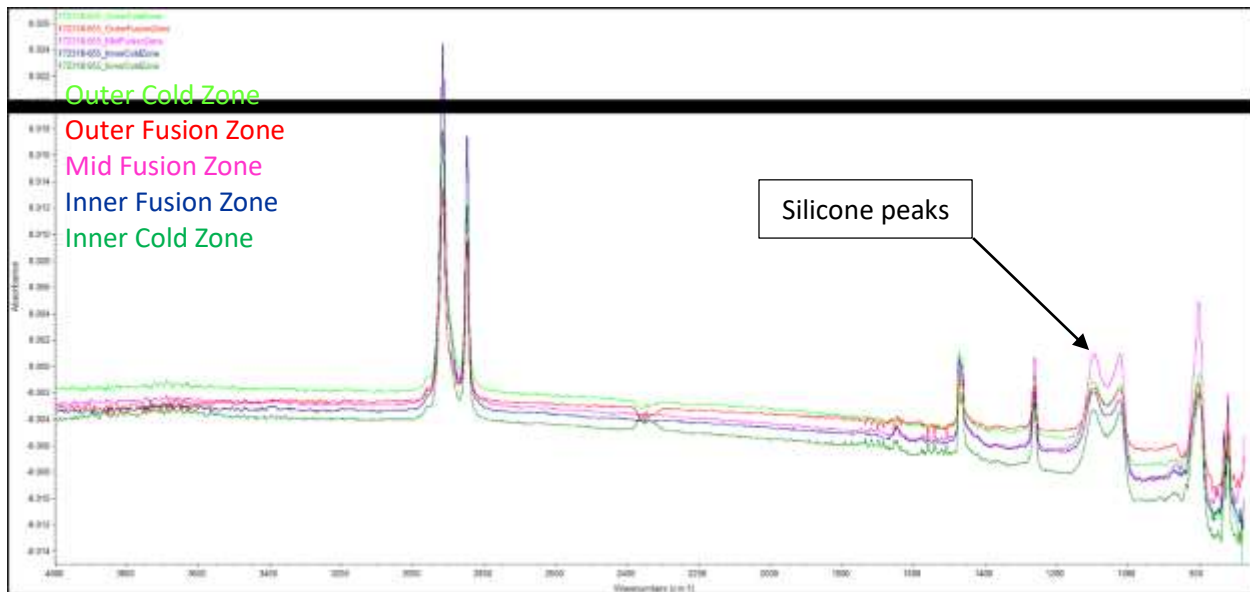
Figure 138. Sample 172318-055, FTIR spectra from decohesion test result

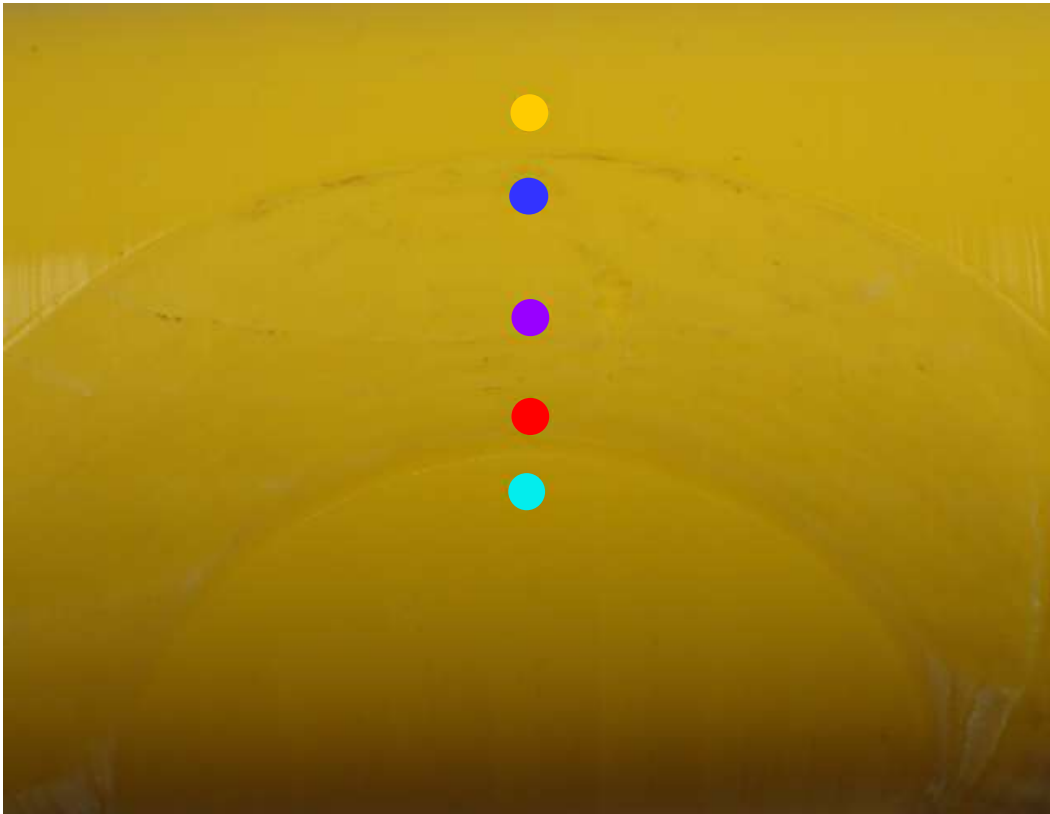
172318-057 172395-113 Silicon Grease 91% Isopropanol Paper Towel

Figure 139. Sample 172318-057, decohesion test result

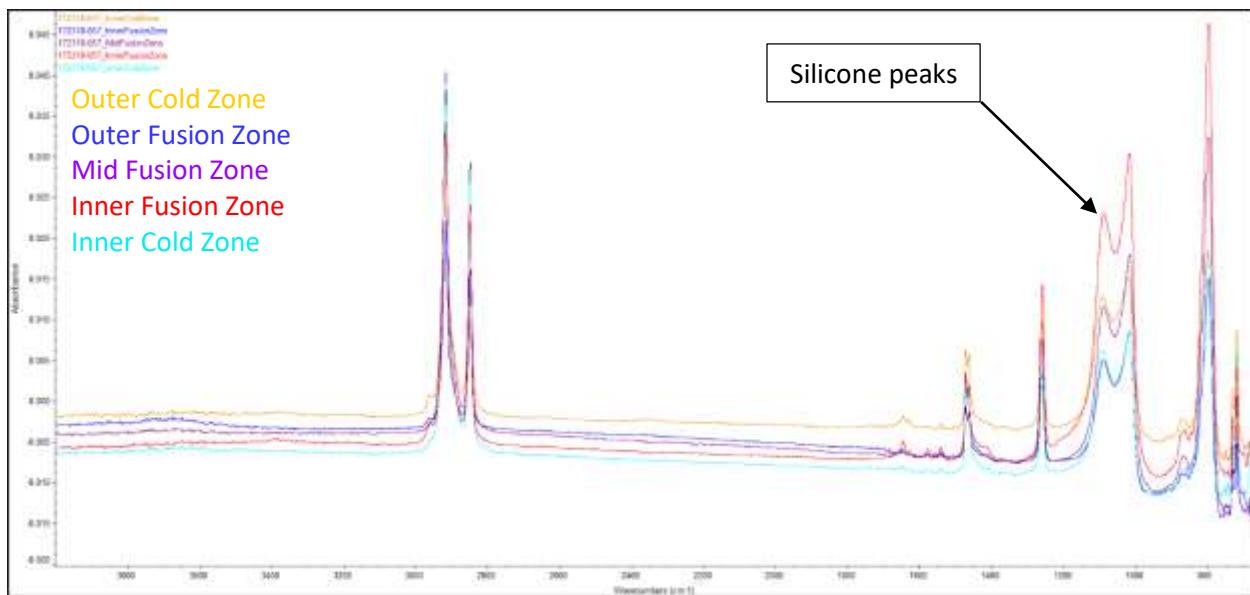
Figure 140. Sample 172318-057, FTIR spectra from decohesion test result

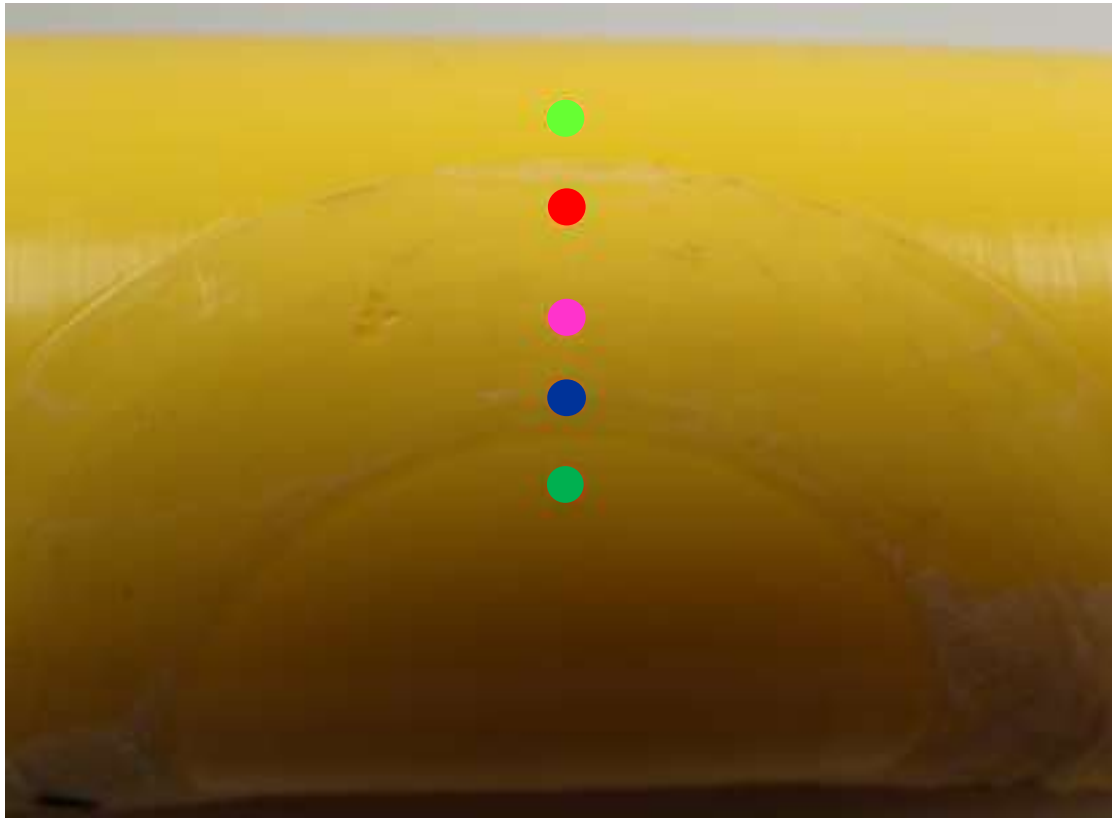
172318-058	172395-114	Silicon Grease	91% Isopropanol	Paper Towel
------------	------------	----------------	-----------------	-------------

Figure 141. Sample 172318-058, decohesion test result

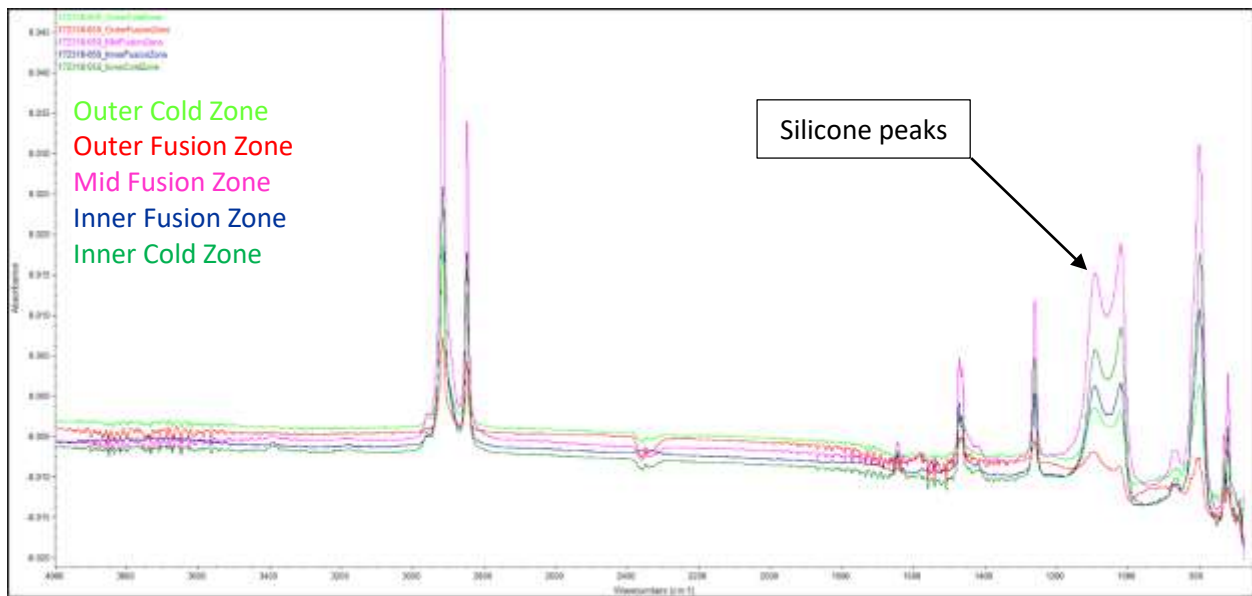
Figure 142. Sample 172318-058, FTIR spectra from decohesion test result

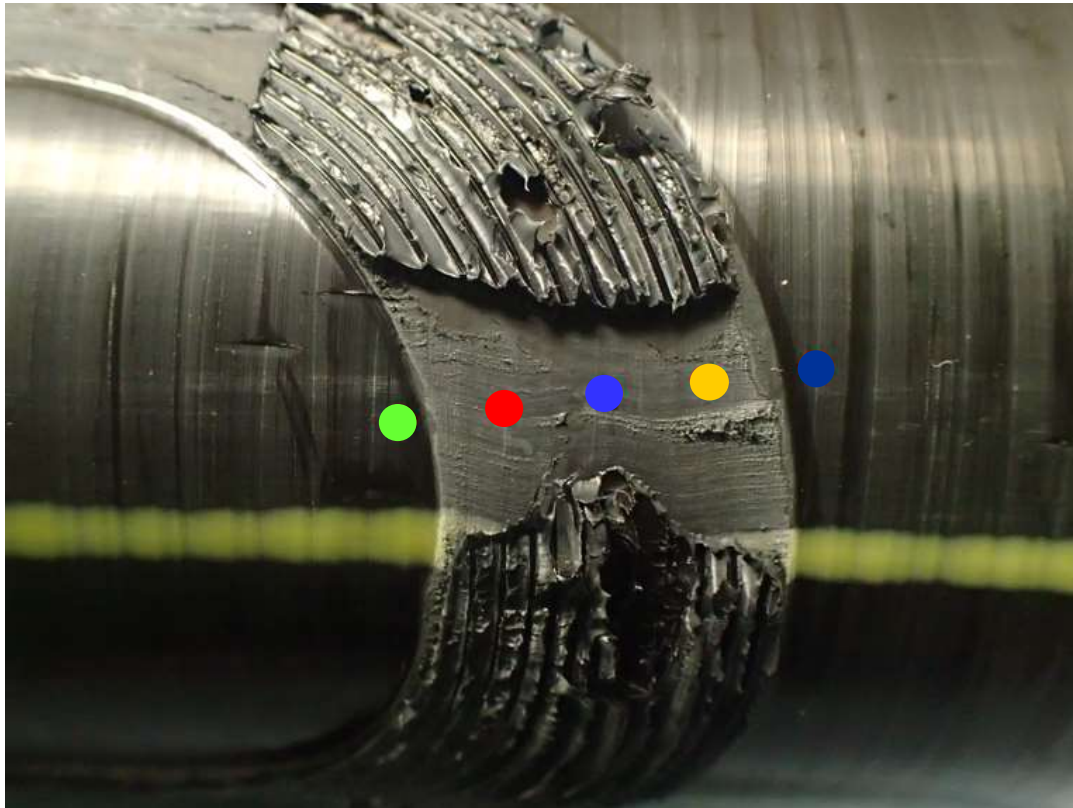
172316-032	172395-011	Talc	99% Isopropanol	Lint-Free Wipe
------------	------------	------	-----------------	----------------

Figure 143. Sample 172316-032, decohesion test result

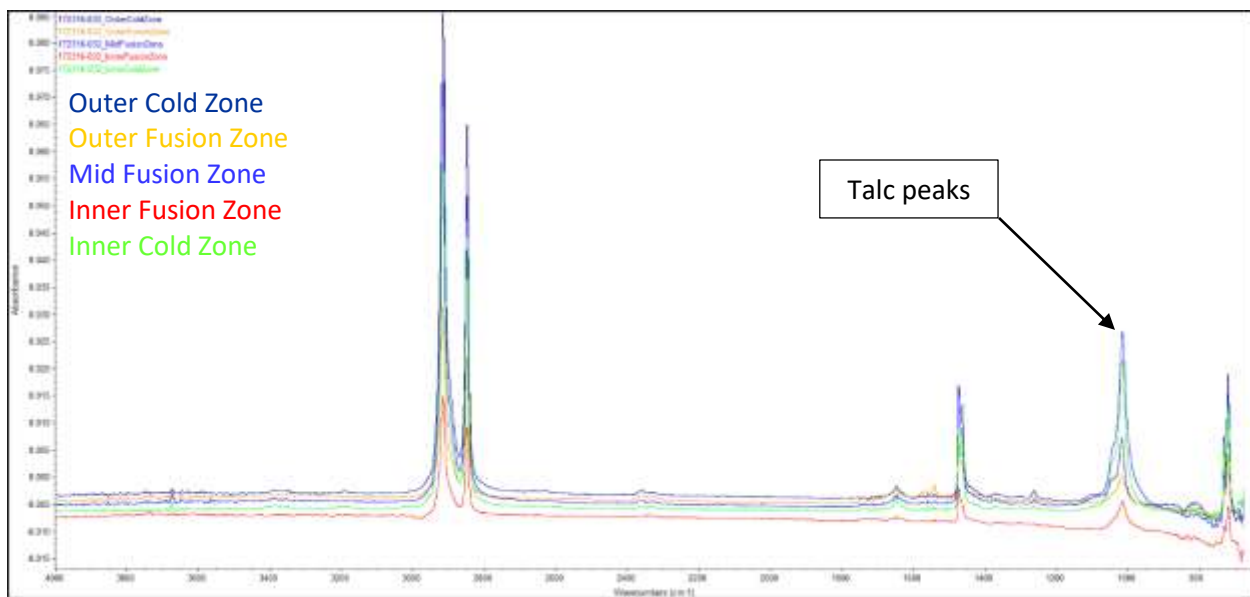
Figure 144. Sample 172316-032, FTIR spectra from decohesion test result

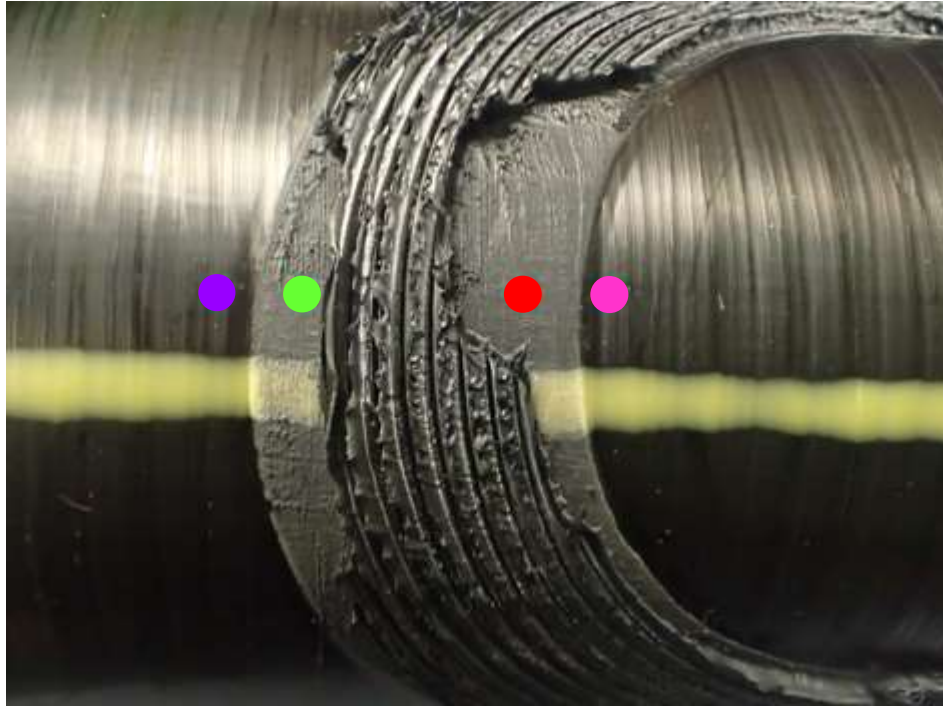
172316-033	172395-012	Talc	99% Isopropanol	Paper Towel
------------	------------	------	-----------------	-------------

Figure 145. Sample 172316-033, decohesion test result

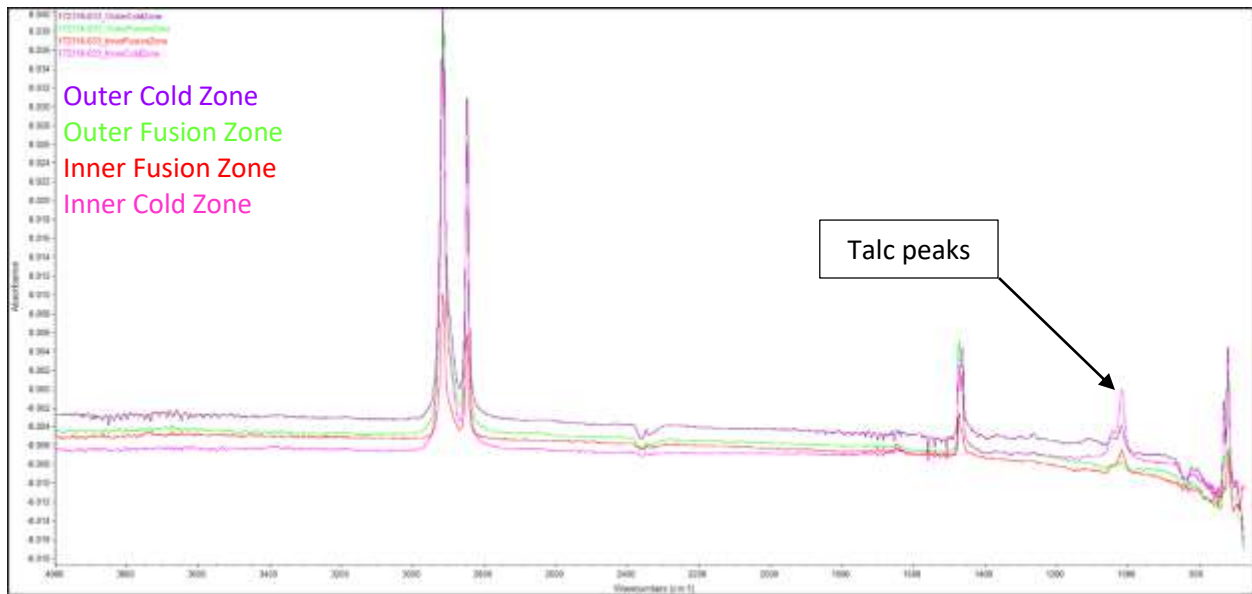
Figure 146. Sample 172316-033, FTIR spectra from decohesion test result

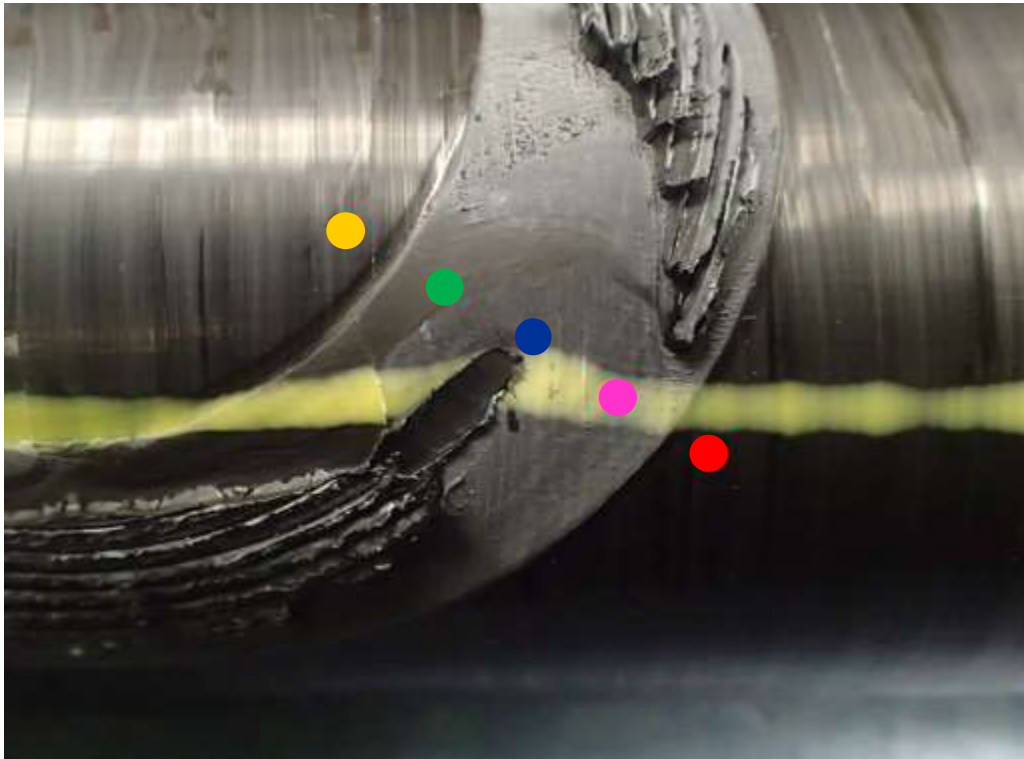
172316-035	172395-015	Talc	99% Isopropanol	Cotton Cloth Rag
------------	------------	------	-----------------	------------------

Figure 147. Sample 172316-035, decohesion test result

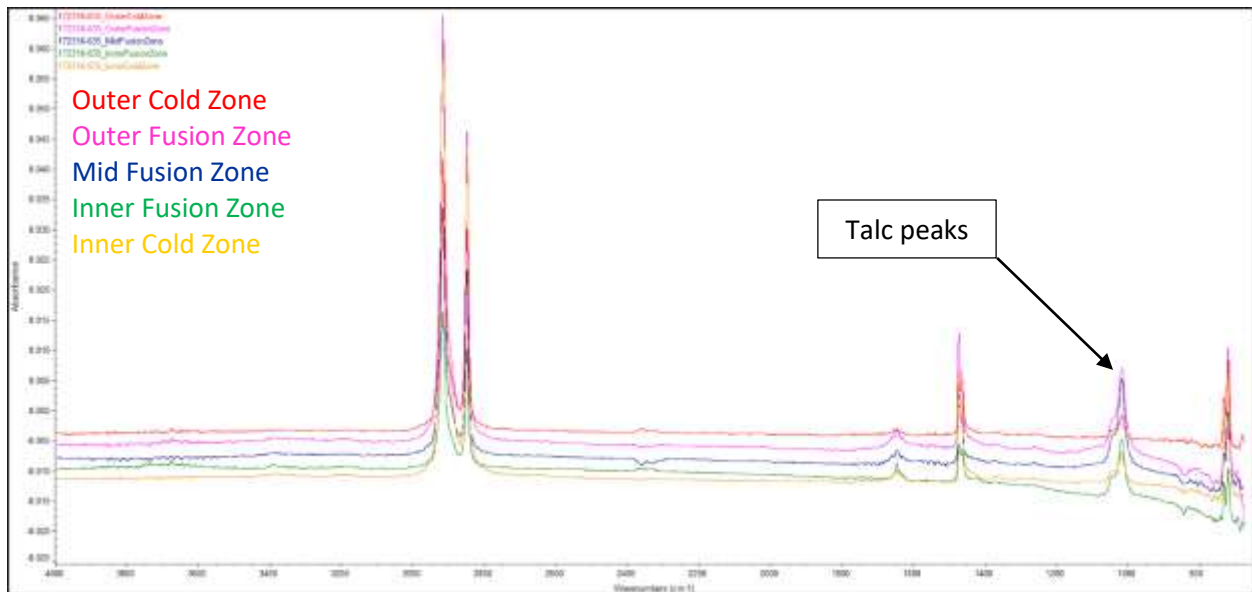
Figure 148. Sample 172316-035, FTIR spectra from decohesion test result

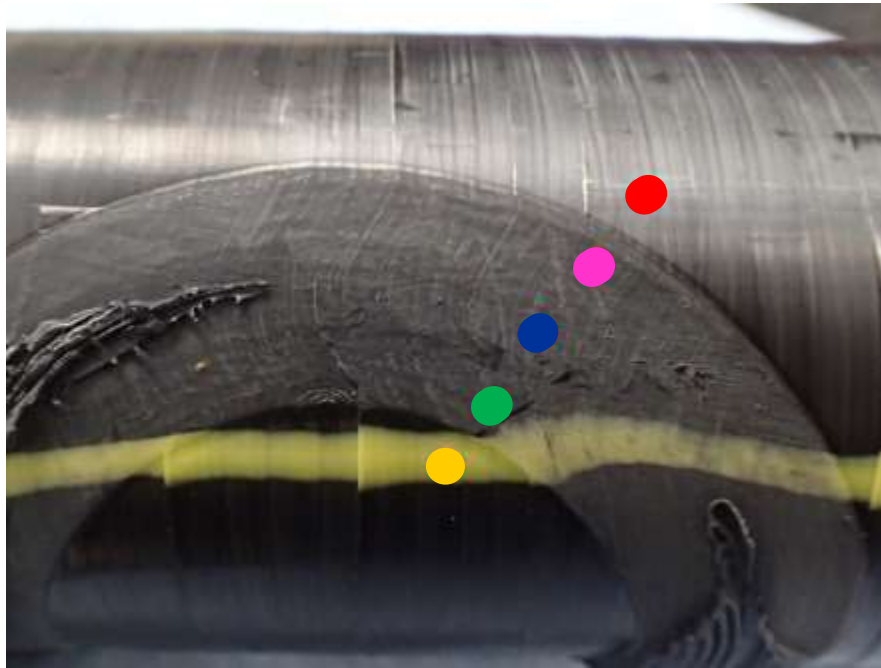
172316-036	172395-016	Talc	99% Isopropanol	Cotton Cloth Rag
------------	------------	------	-----------------	------------------

Figure 149. Sample 172316-036, decohesion test result

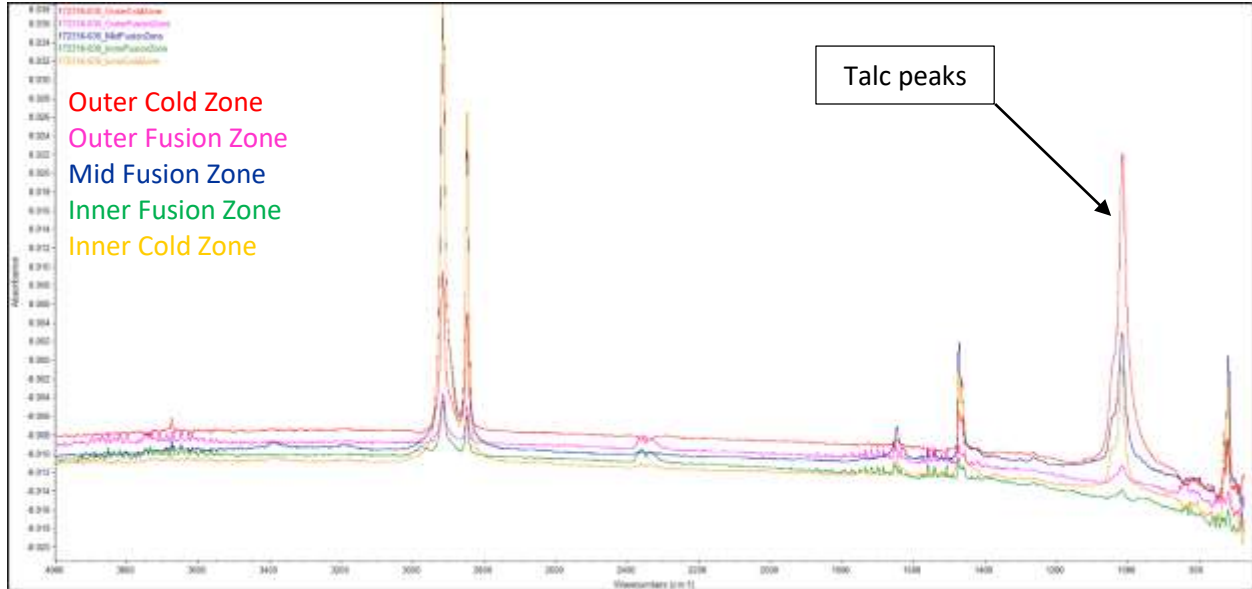
Figure 150. Sample 172316-036, FTIR spectra from decohesion test result

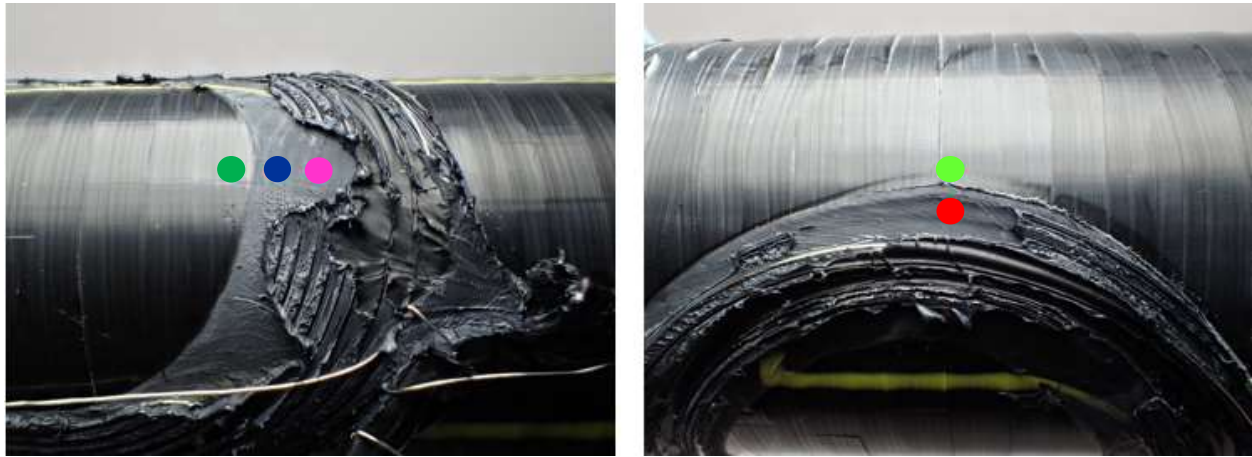
172316-037	172395-017	Talc	91% Isopropanol	Cotton Cloth Rag
------------	------------	------	-----------------	------------------

Figure 151. Sample 172316-037, decohesion test result
