▼
**Solvent Cleaning and PE
Joining Procedures**

Prepared by:
Gas Technology Institute
Des Plaines, Illinois

GTI-OTD FINAL REPORT

Solvent Cleaning and PE Joining Procedures

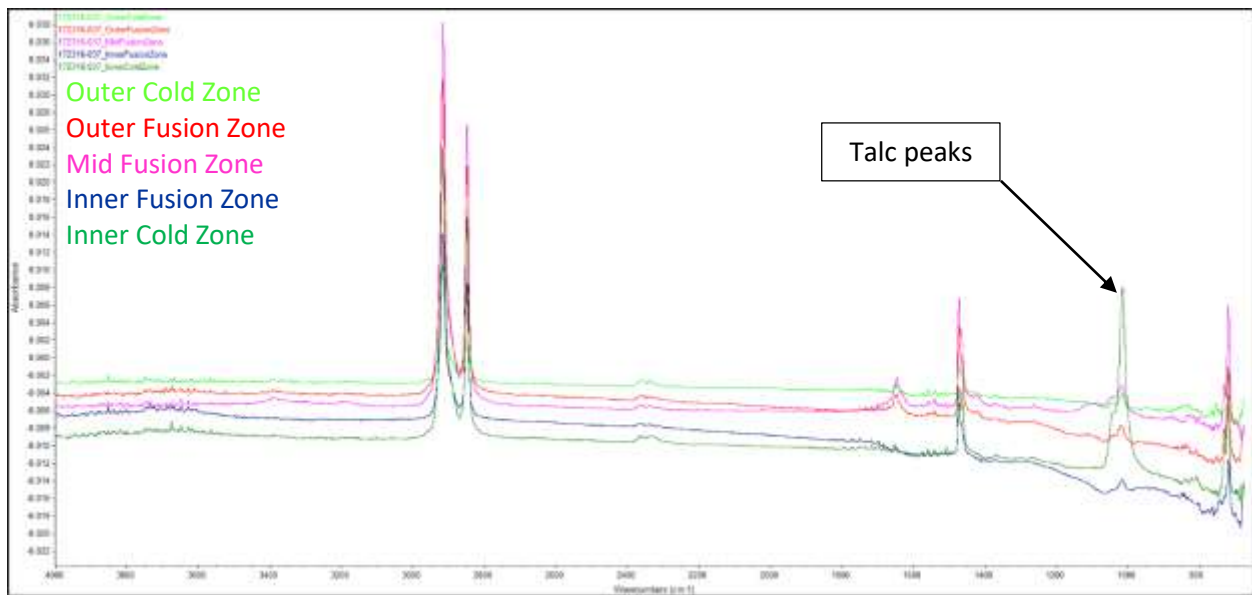
Figure 152. Sample 172316-037, FTIR spectra from decohesion test result

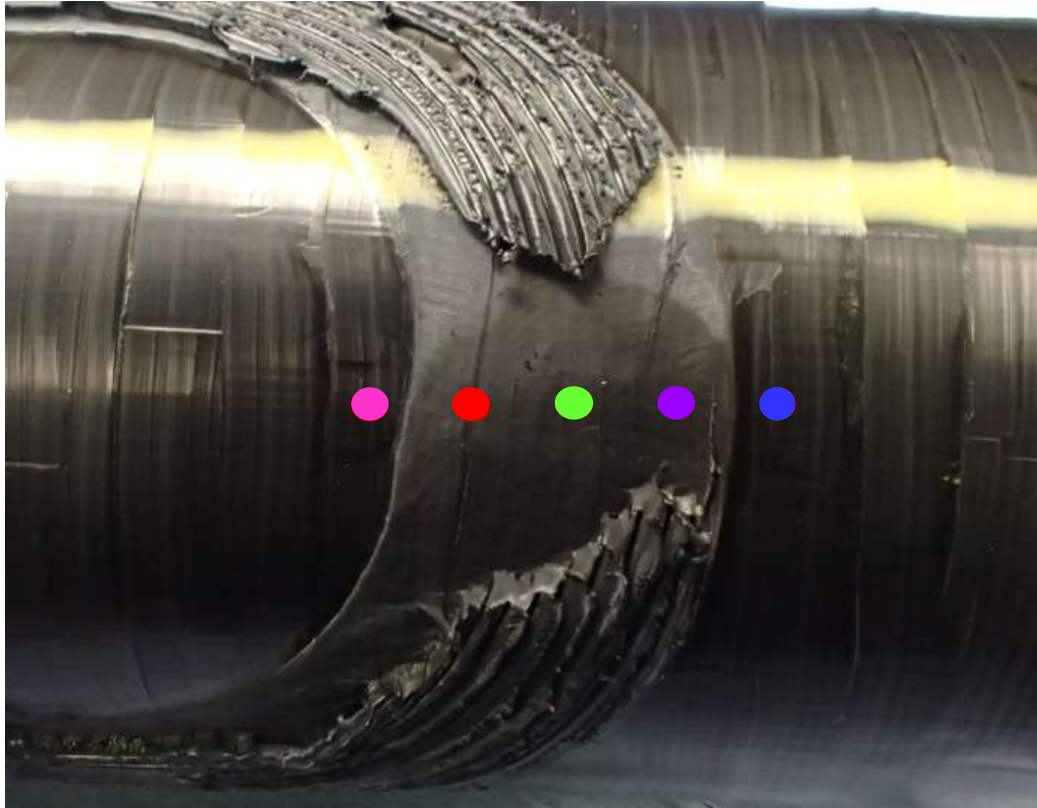
172316-038	172395-018	Talc	91% Isopropanol	Cotton Cloth Rag
------------	------------	------	-----------------	------------------

Figure 153. Sample 172316-038, decohesion test result

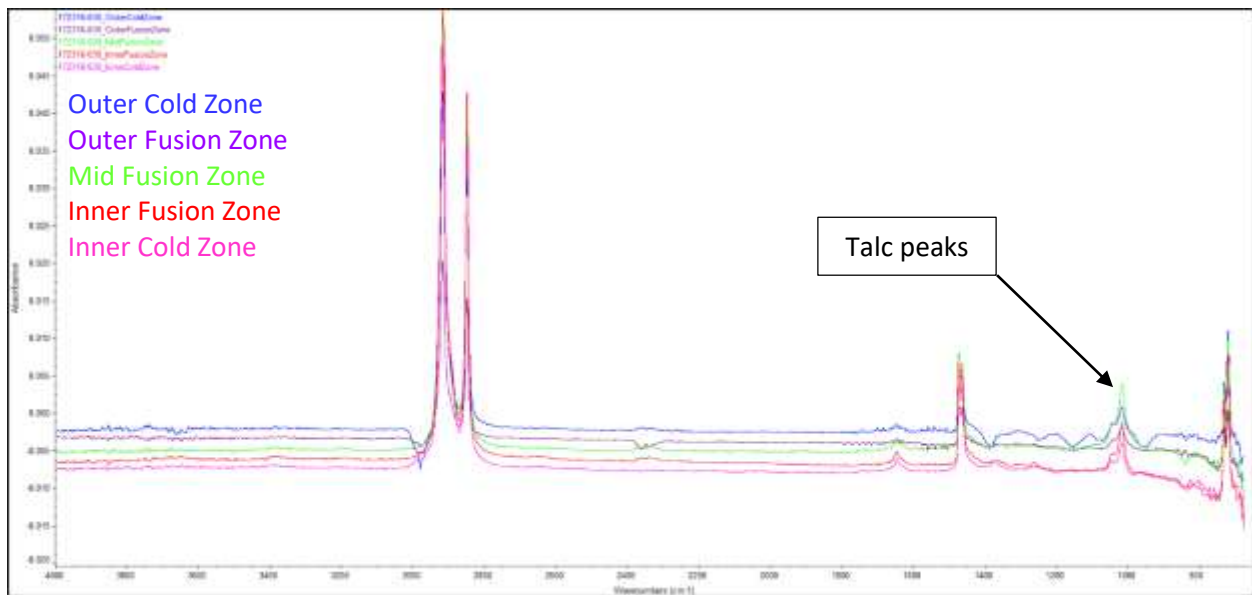
Figure 154. Sample 172316-038, FTIR spectra from decohesion test result

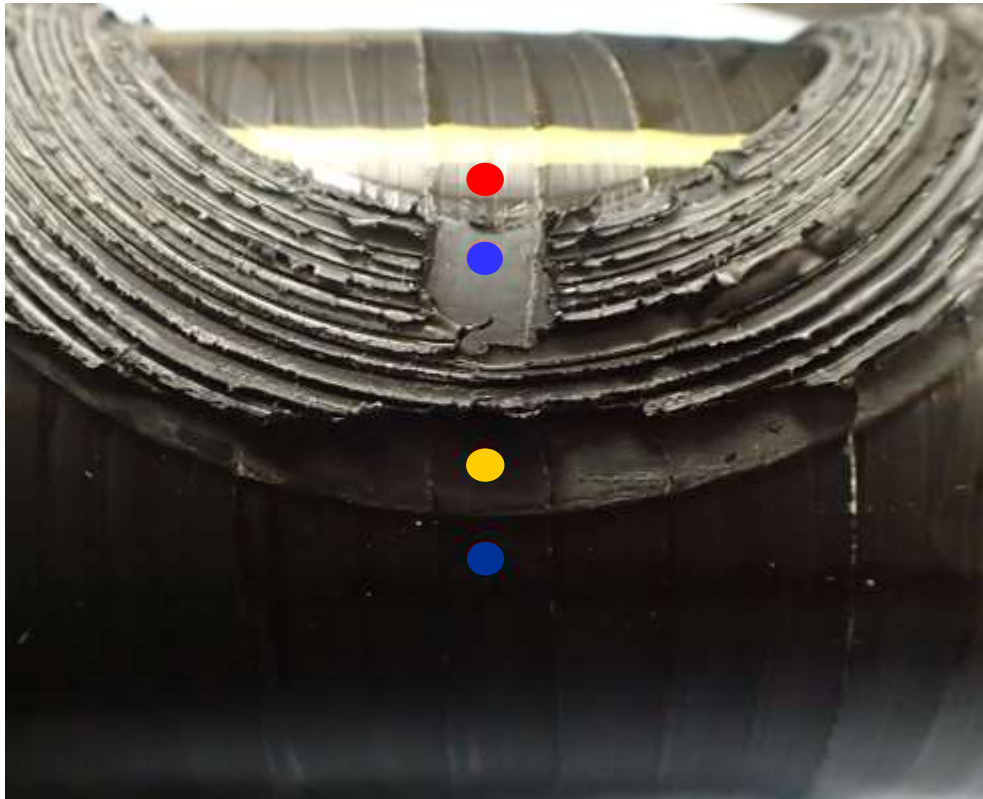
172316-041	172395-021	Talc	91% Isopropanol	Lint-Free Wipe
------------	------------	------	-----------------	----------------

Figure 155. Sample 172316-041, decohesion test result

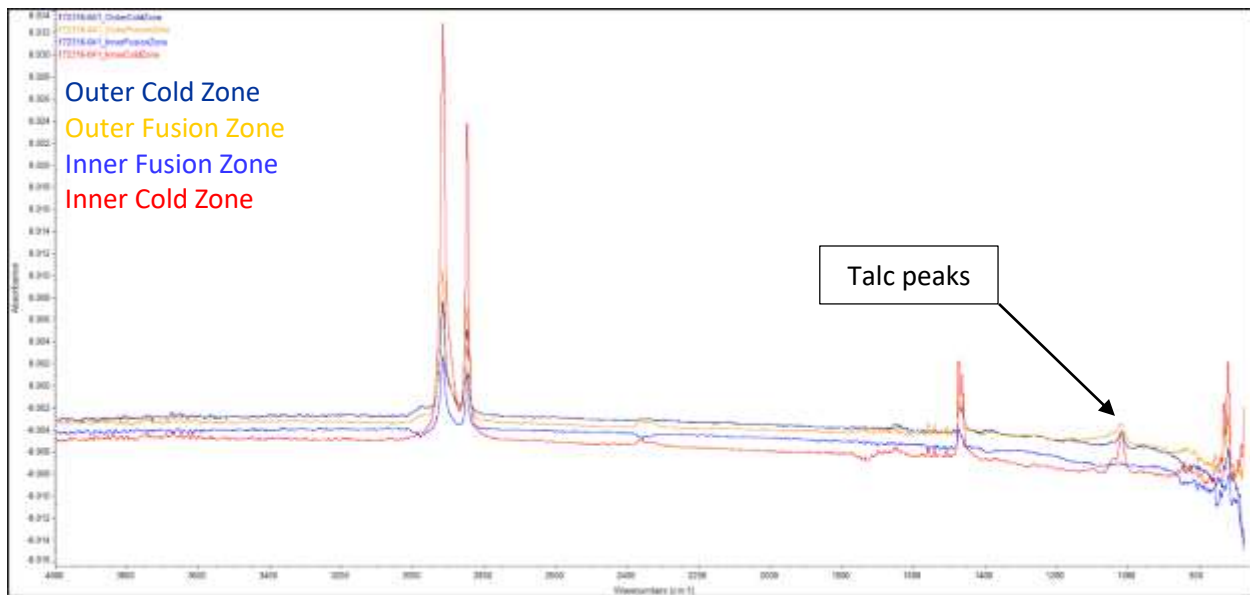
Figure 156. Sample 172316-041, FTIR spectra from decohesion test result

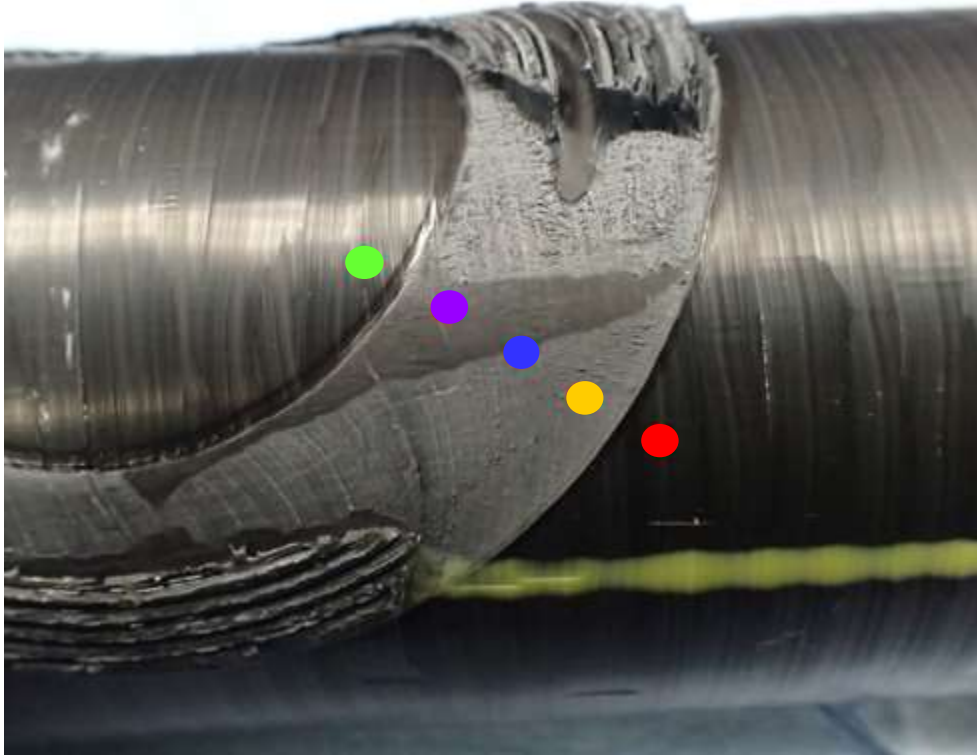
172316-042	172395-023	Talc	91% Isopropanol	Paper Towel
------------	------------	------	-----------------	-------------

Figure 157. Sample 172316-042, decohesion test result

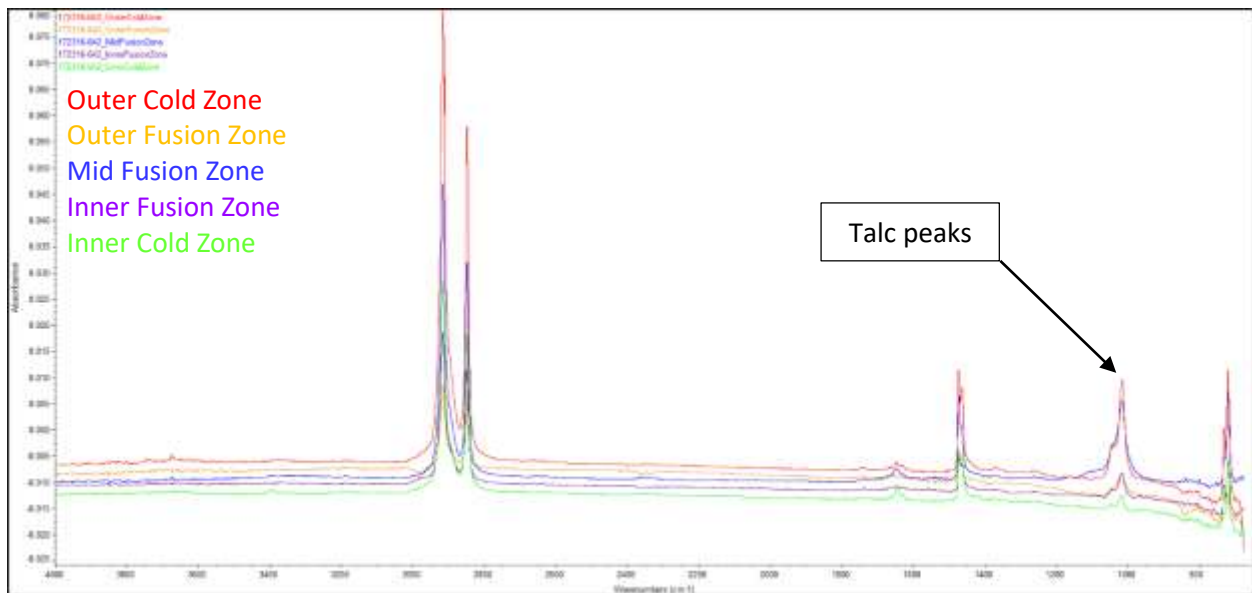
Figure 158. Sample 172316-042, FTIR spectra from decohesion test result

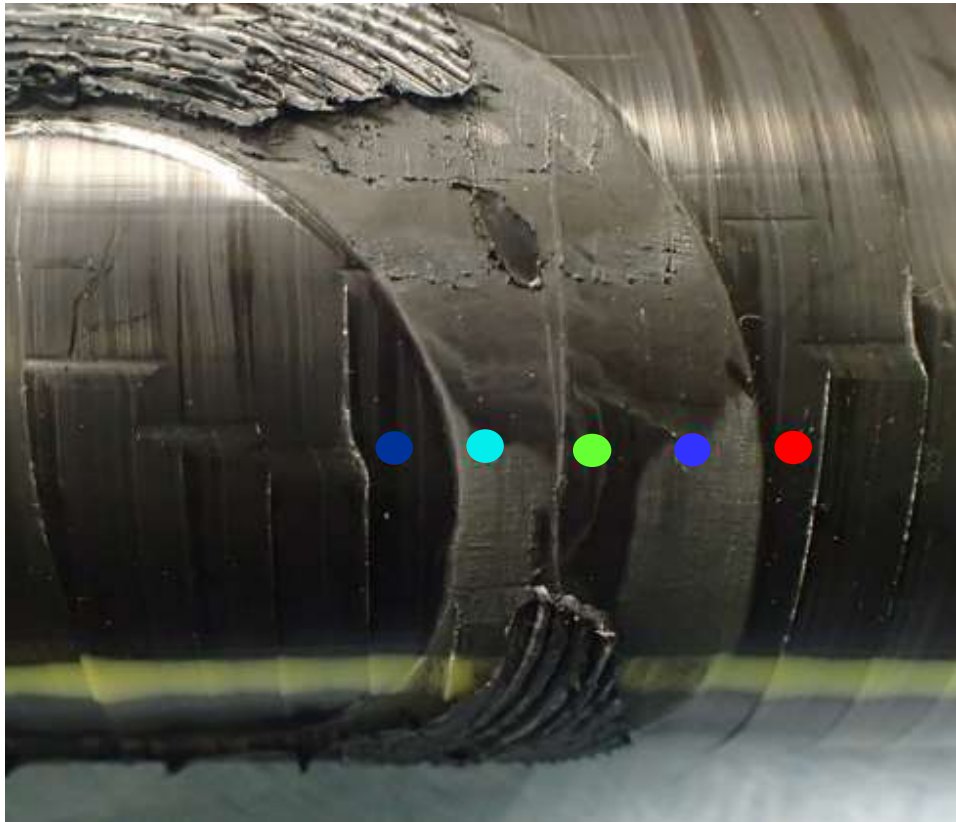
172316-044	172395-027	Talc	Acetone	Lint-Free Wipe
------------	------------	------	---------	----------------

Figure 159. Sample 172316-044, decohesion test result

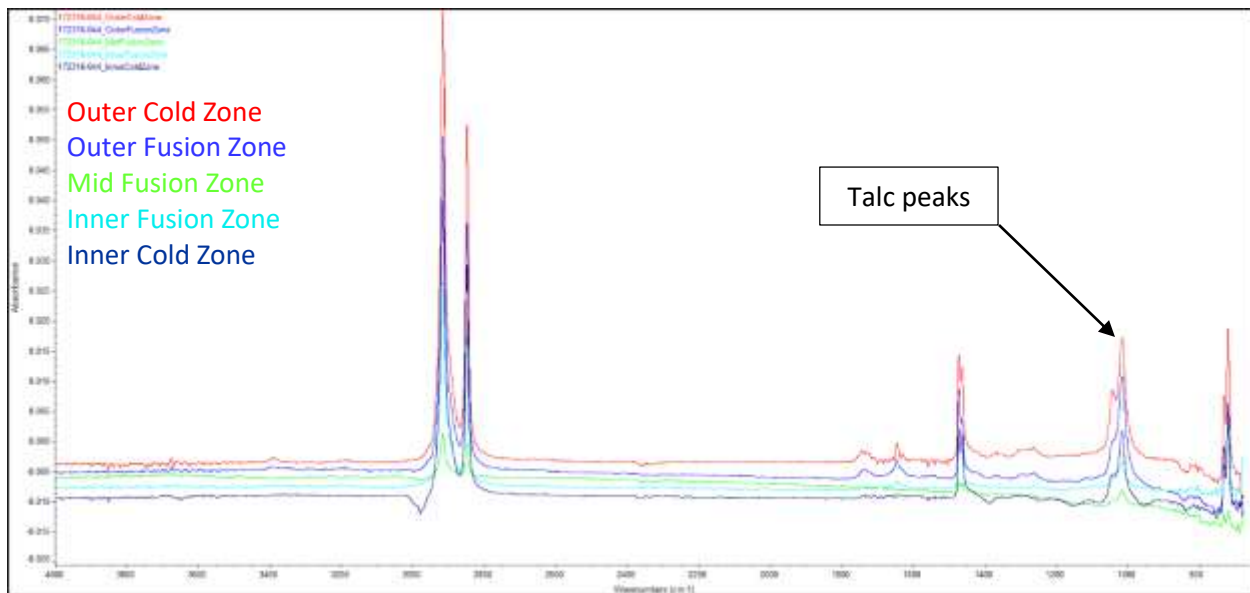
Figure 160. Sample 172316-044, FTIR spectra from decohesion test result

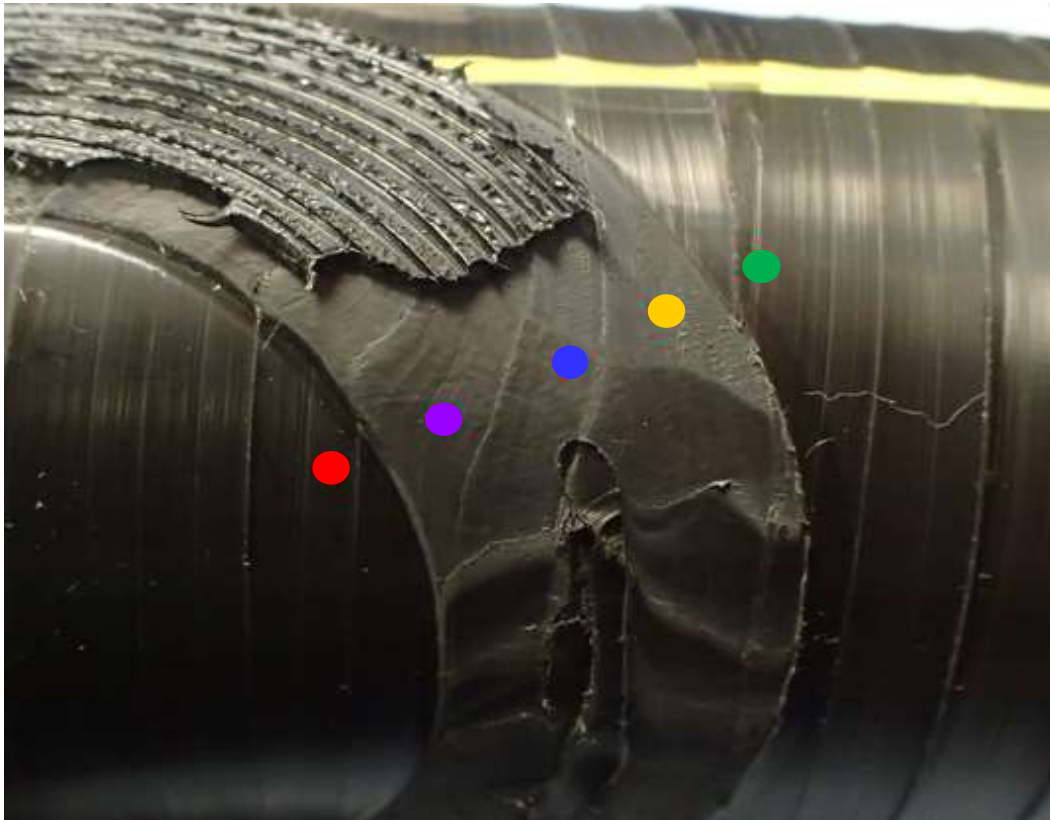
172316-045	172395-028	Talc	Acetone	Lint-Free Wipe
------------	------------	------	---------	----------------

Figure 161. Sample 172316-045, decohesion test result

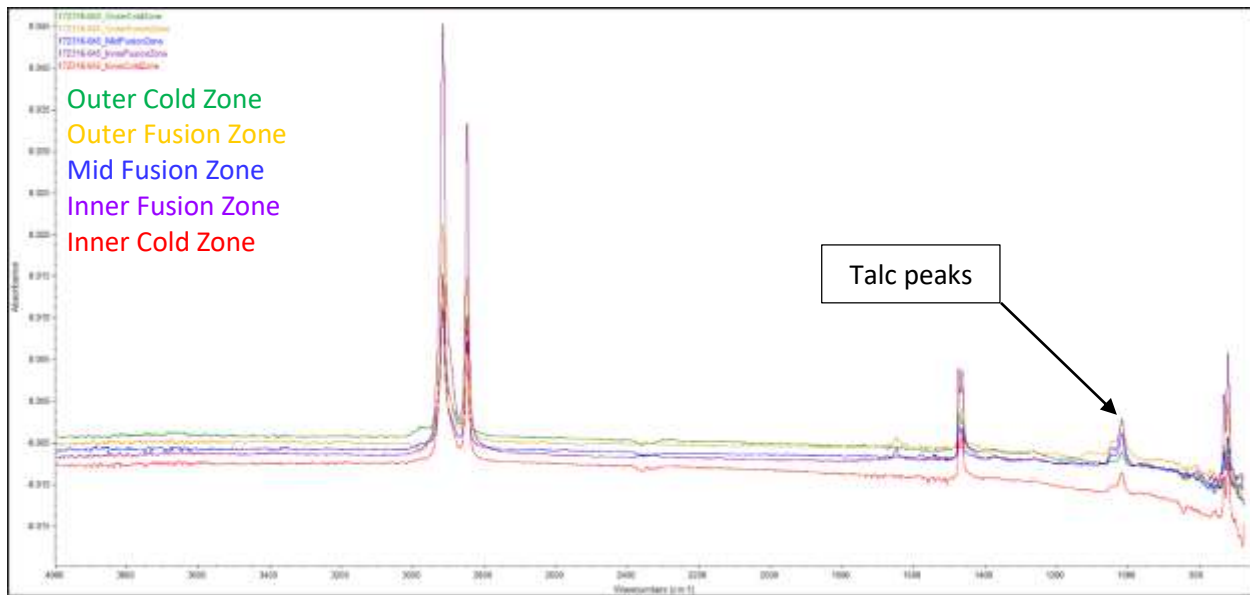
Figure 162. Sample 172316-045, FTIR spectra from decohesion test result

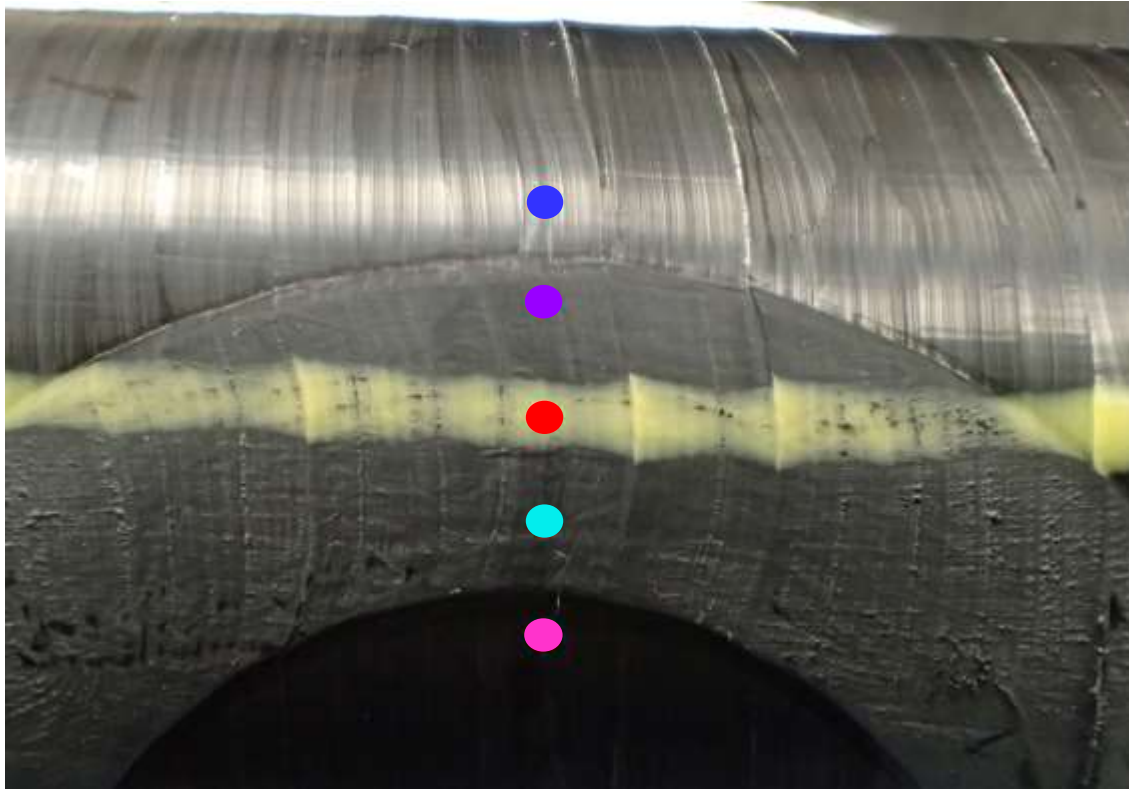
172316-046	172395-031	Talc	Acetone	Cotton Cloth Rag
------------	------------	------	---------	------------------

Figure 163. Sample 172316-046, decohesion test result

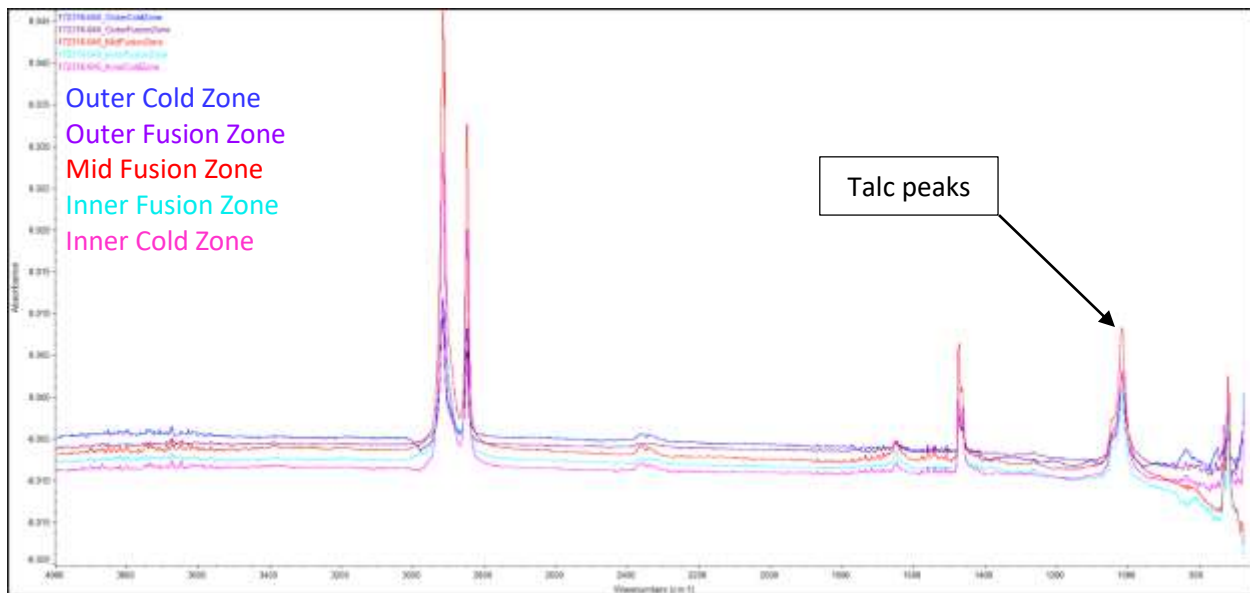
Figure 164. Sample 172316-046, FTIR spectra from decohesion test result

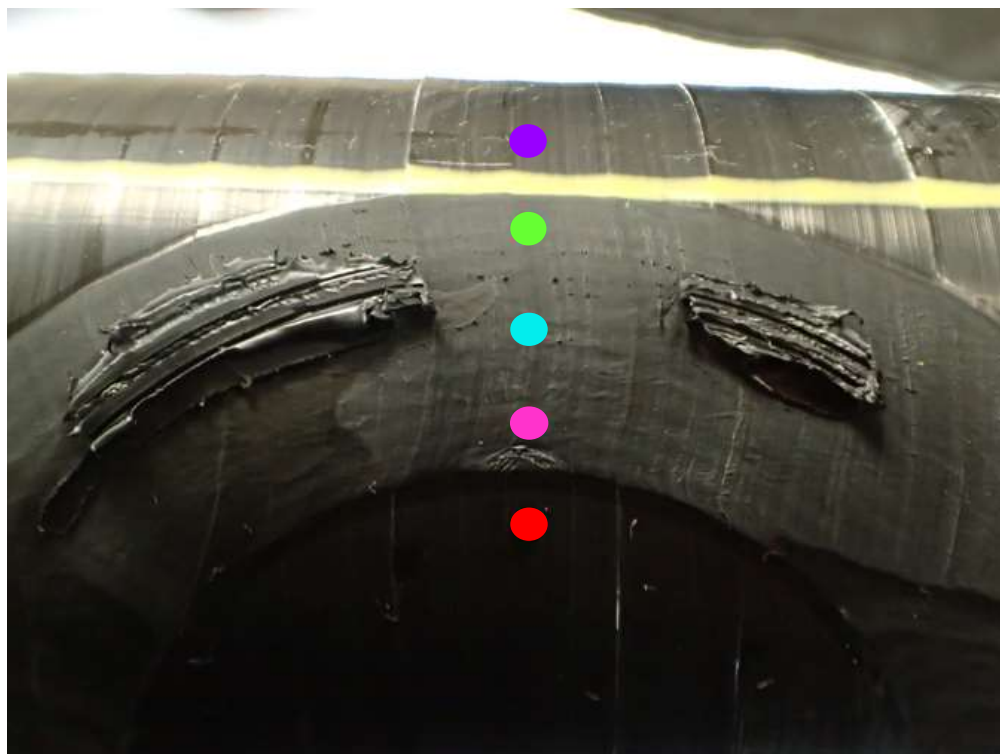
172316-047	172395-032	Talc	Acetone	Cotton Cloth Rag
------------	------------	------	---------	------------------

Figure 165. Sample 172316-047, decohesion test result

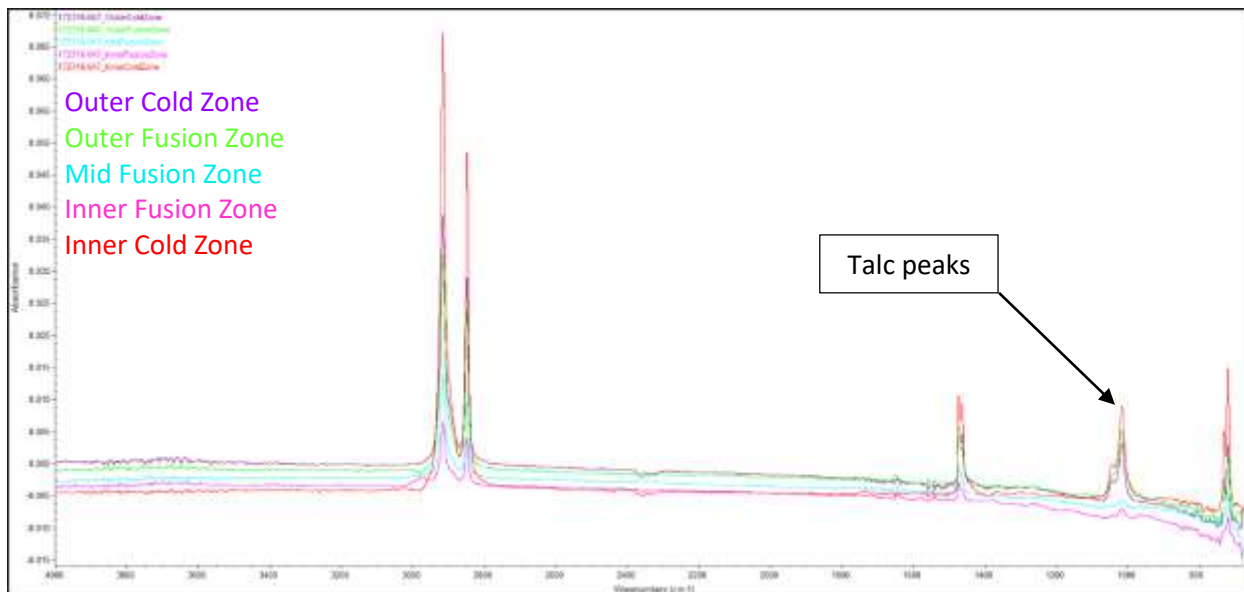
Figure 166. Sample 172316-047, FTIR spectra from decohesion test result

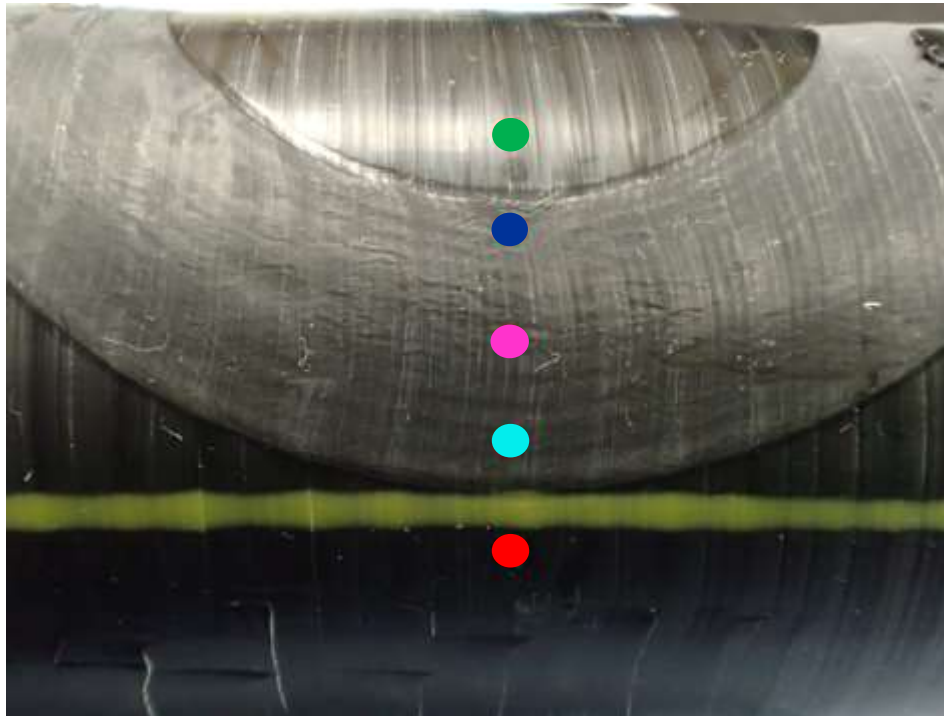
172316-048	172395-035	Talc	Acetone	Paper Towel
------------	------------	------	---------	-------------

Figure 167. Sample 172316-048, decohesion test result

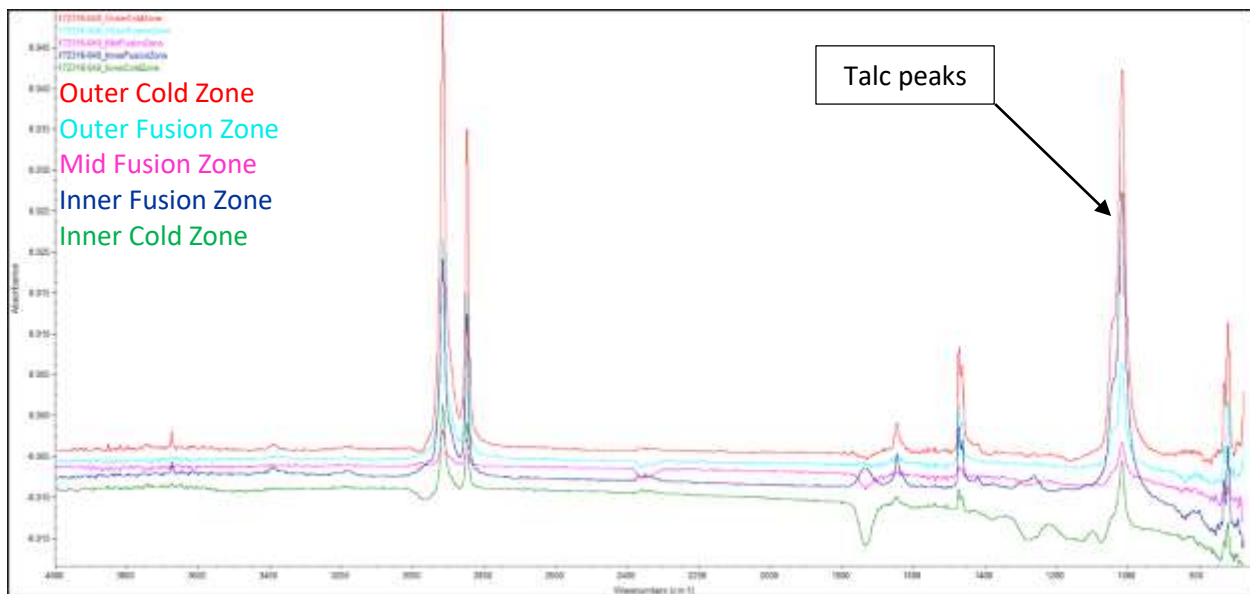
Figure 168. Sample 172316-048, FTIR spectra from decohesion test result

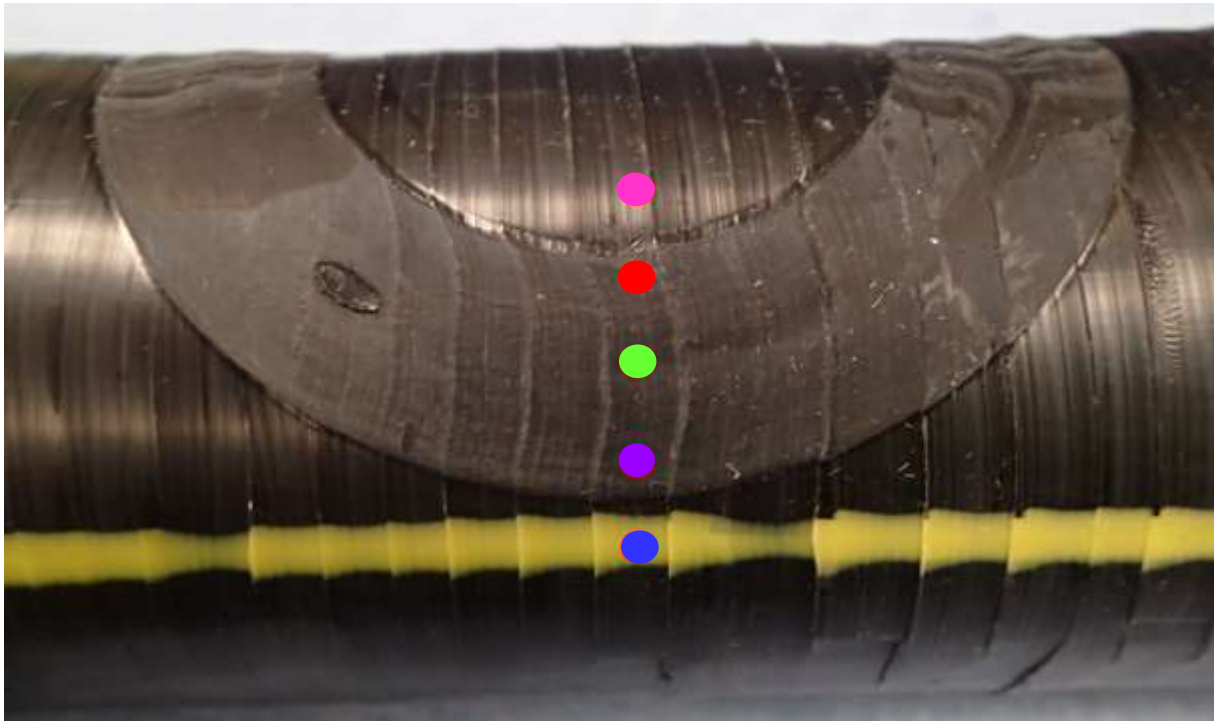
172316-049	172395-036	Talc	Acetone	Paper Towel
------------	------------	------	---------	-------------

Figure 169. Sample 172316-049, decohesion test result

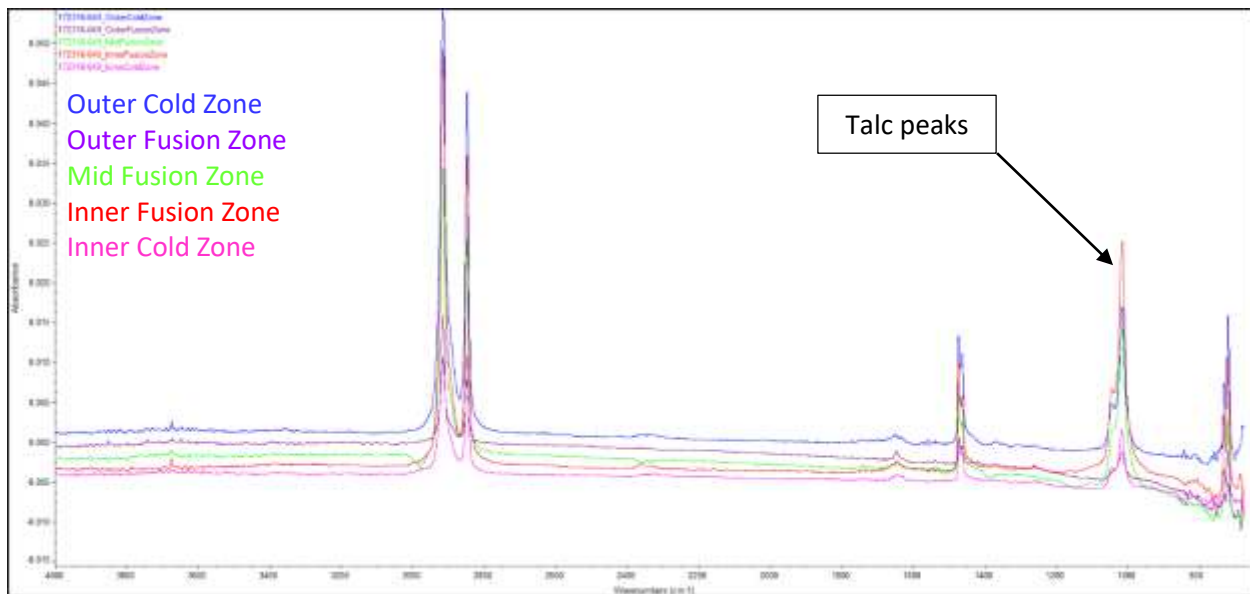
Figure 170. Sample 172316-049, FTIR spectra from decohesion test result

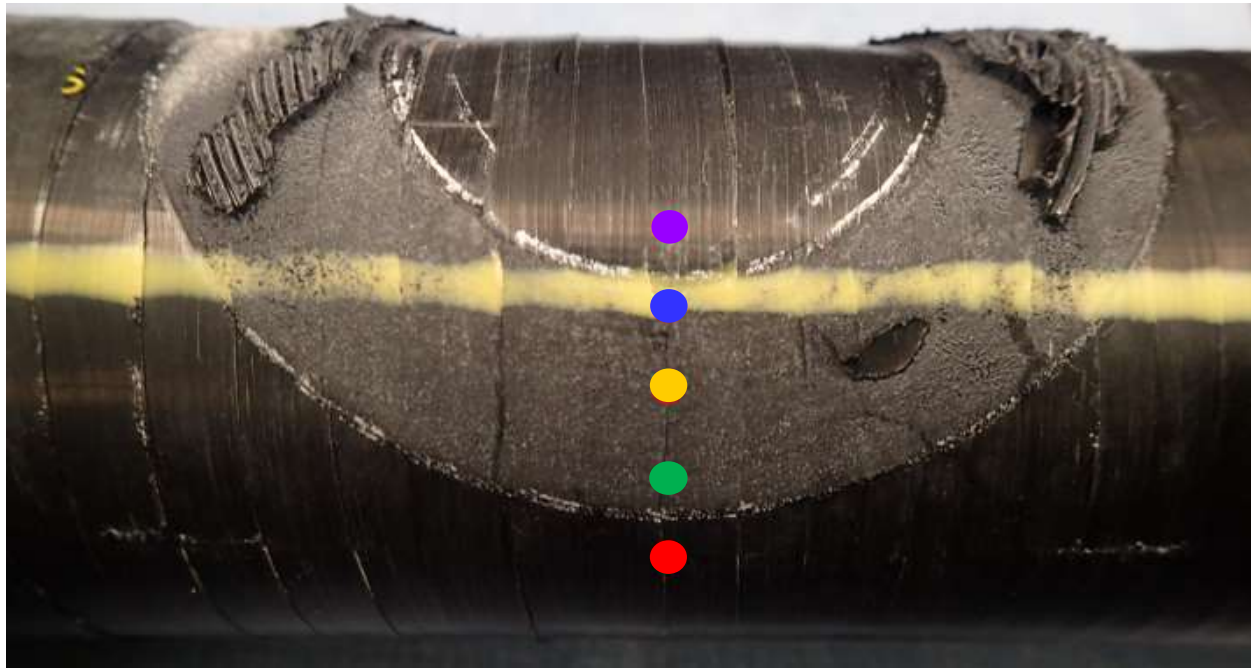
172316-050	172395-039	Talc	None	None
------------	------------	------	------	------

Figure 171. Sample 172316-050, decohesion test result

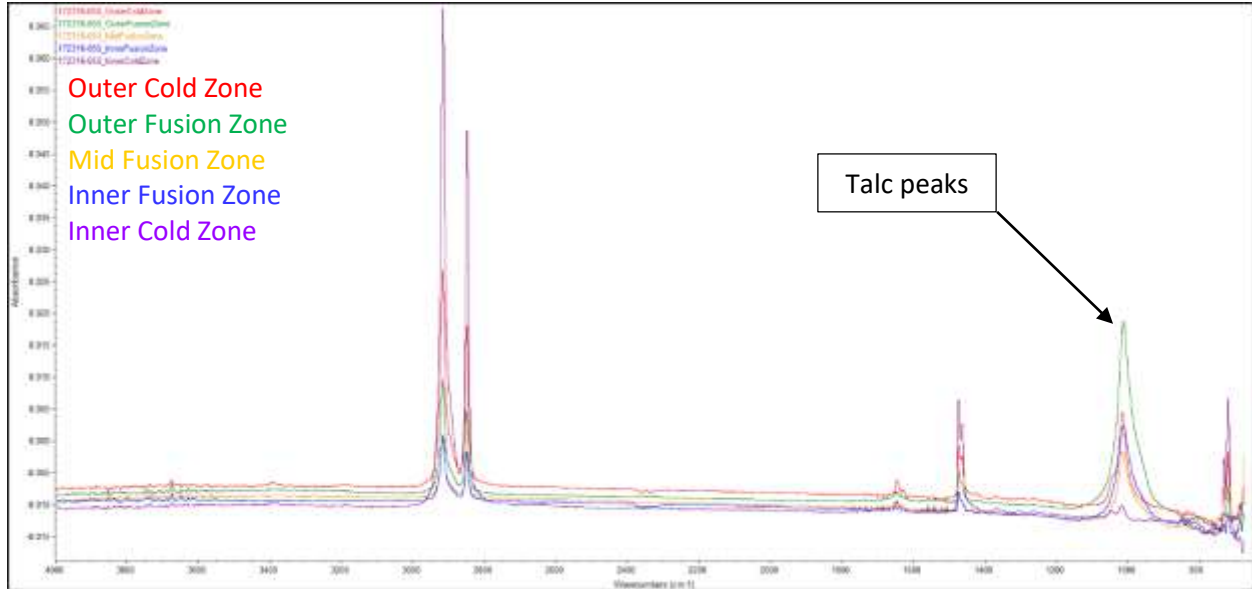
Figure 172. Sample 172316-050, FTIR spectra from decohesion test result

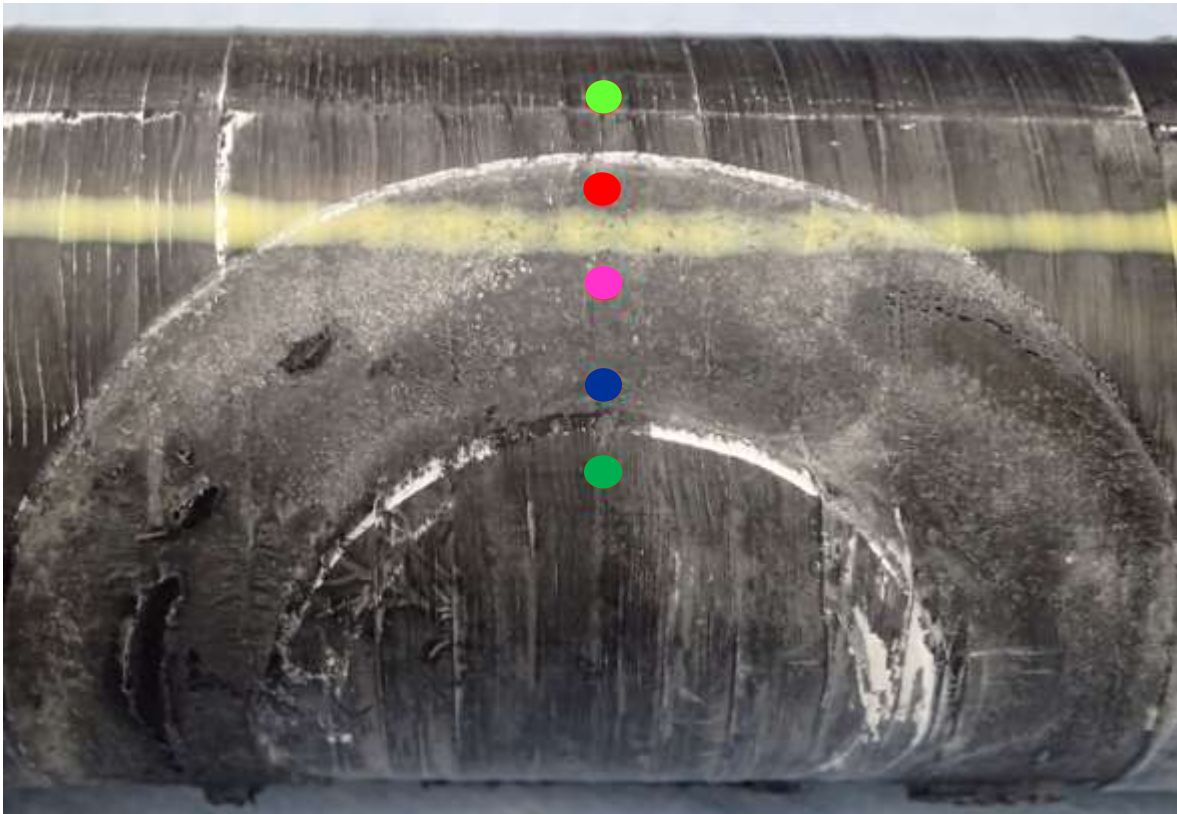
172316-051	172395-040	Talc	None	None
------------	------------	------	------	------

Figure 173. Sample 172316-051, decohesion test result

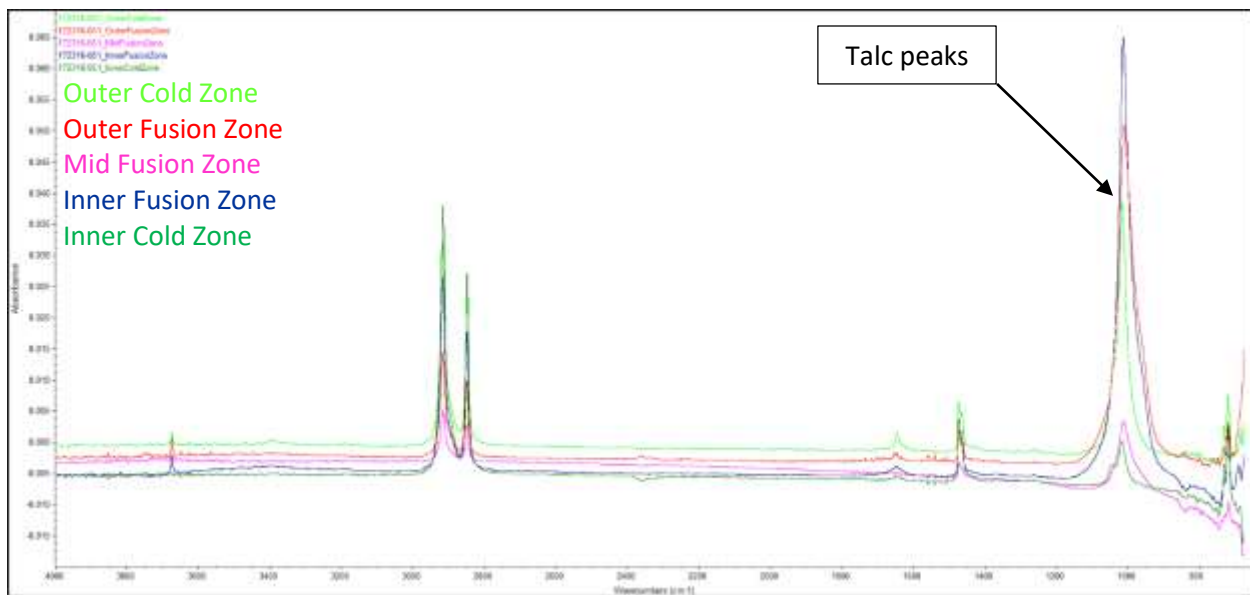
Figure 174. Sample 172316-051, FTIR spectra from decohesion test result

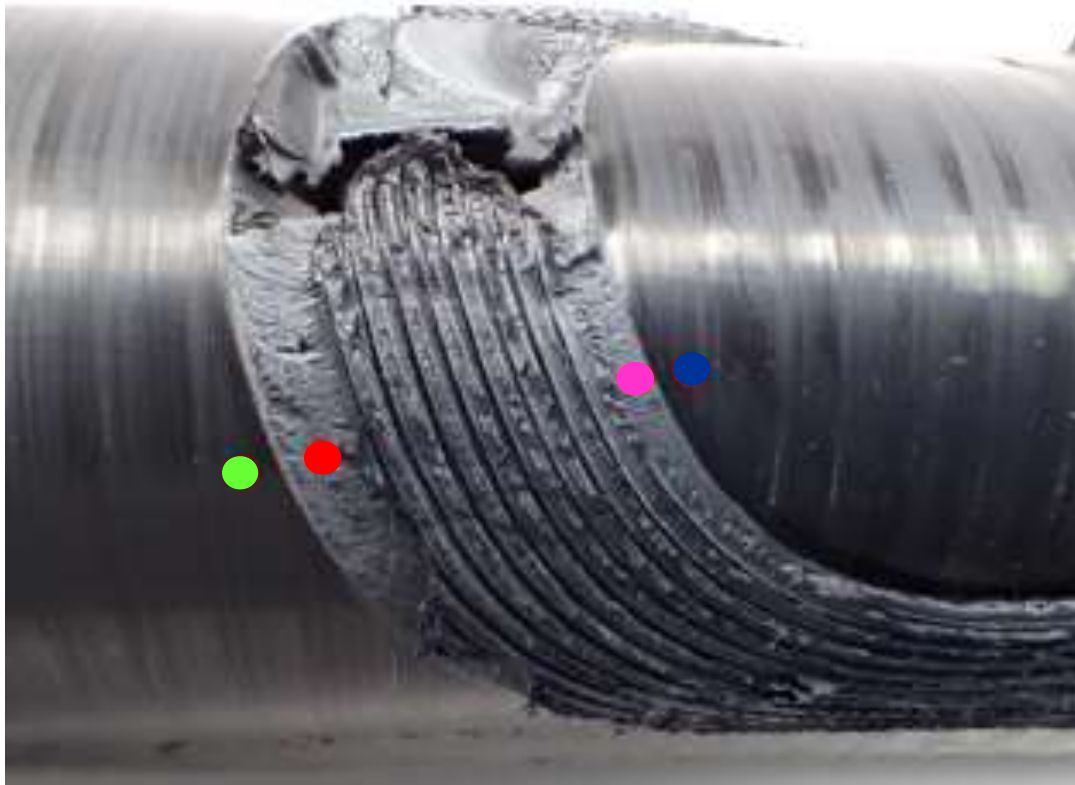
172316-052	172395-043	Bentonite	99% Isopropanol	Lint-Free Wipe
------------	------------	-----------	-----------------	----------------

Figure 175. Sample 172316-052, decohesion test result

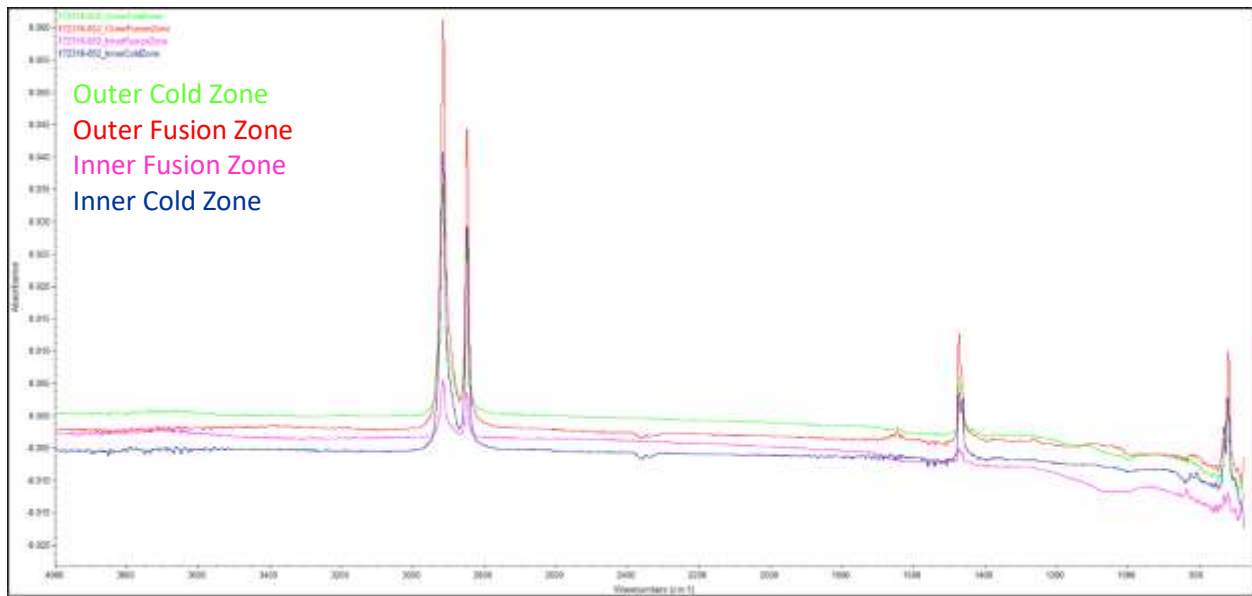
Figure 176. Sample 172316-052, FTIR spectra from decohesion test result

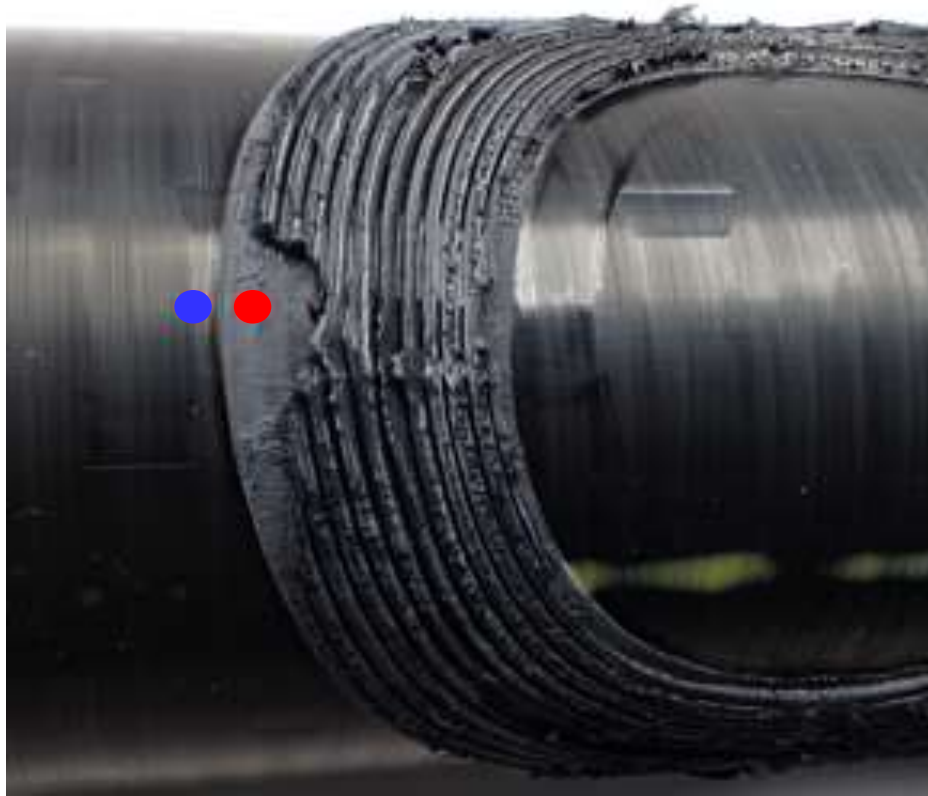
172316-053	172395-044	Bentonite	99% Isopropanol	Lint-Free Wipe
------------	------------	-----------	-----------------	----------------

Figure 177. Sample 172316-053, decohesion test result

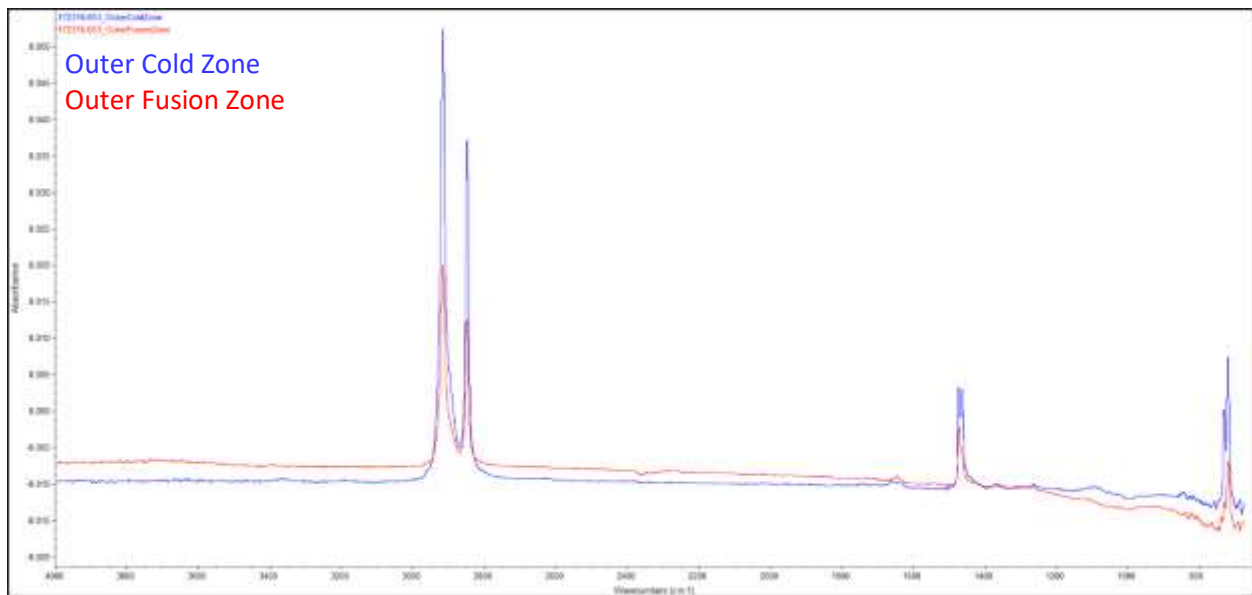
Figure 178. Sample 172316-053, FTIR spectra from decohesion test result

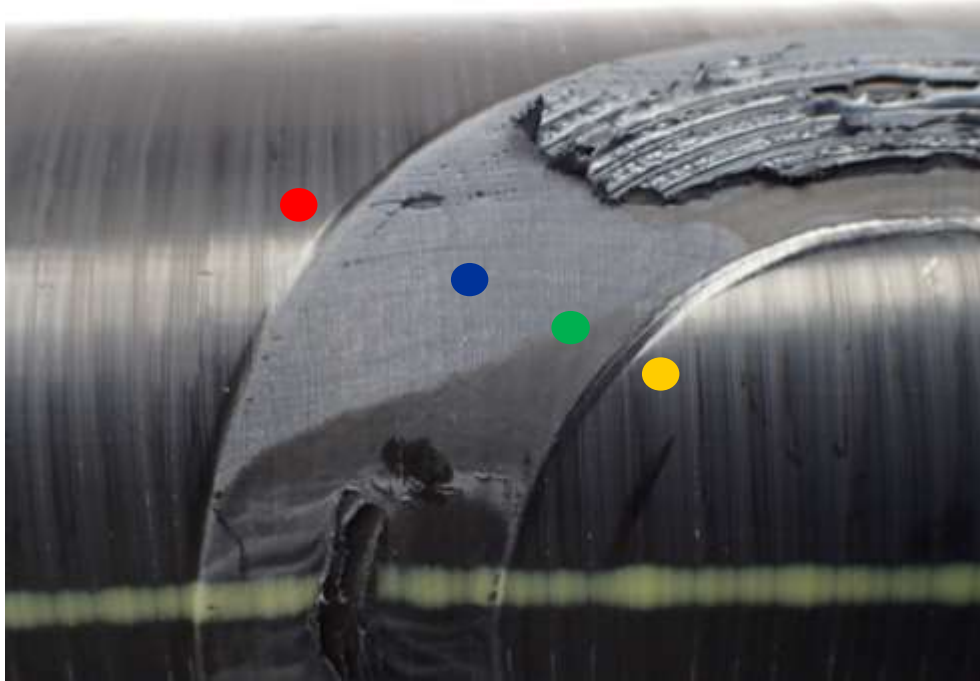
172316-054	172395-047	Bentonite	99% Isopropanol	Cotton Cloth Rag
------------	------------	-----------	-----------------	------------------

Figure 179. Sample 172316-054, decohesion test result
