▼
**Solvent Cleaning and PE
Joining Procedures**

Prepared by:
Gas Technology Institute
Des Plaines, Illinois

GTI-OTD FINAL REPORT

Solvent Cleaning and PE Joining Procedures

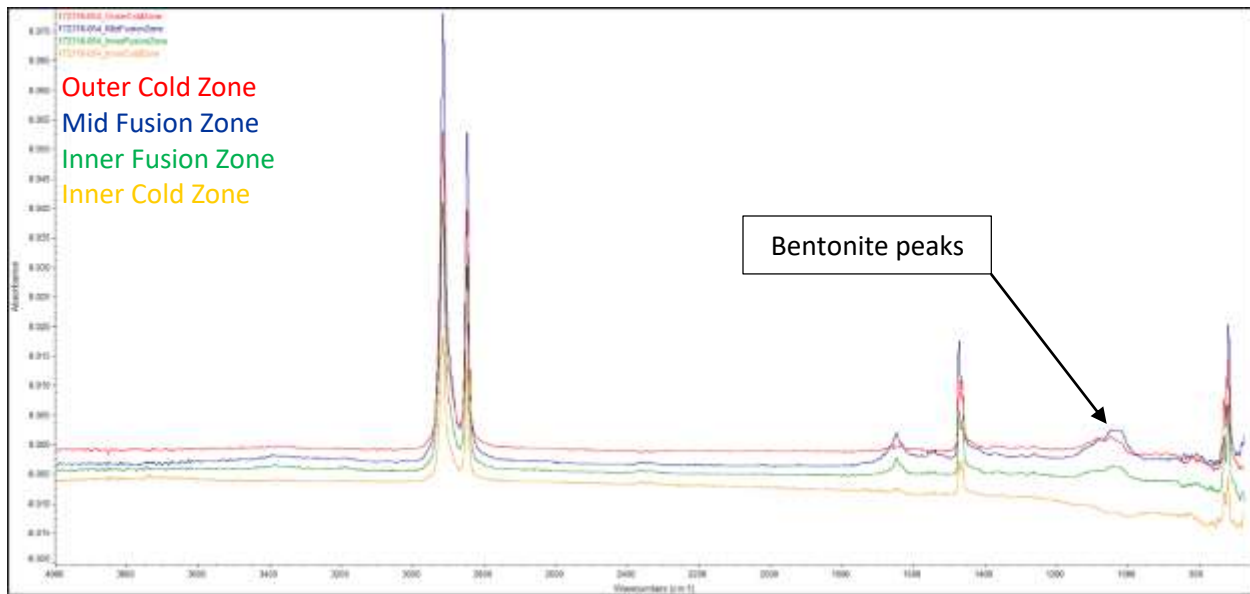
Figure 180. Sample 172316-054, FTIR spectra from decohesion test result

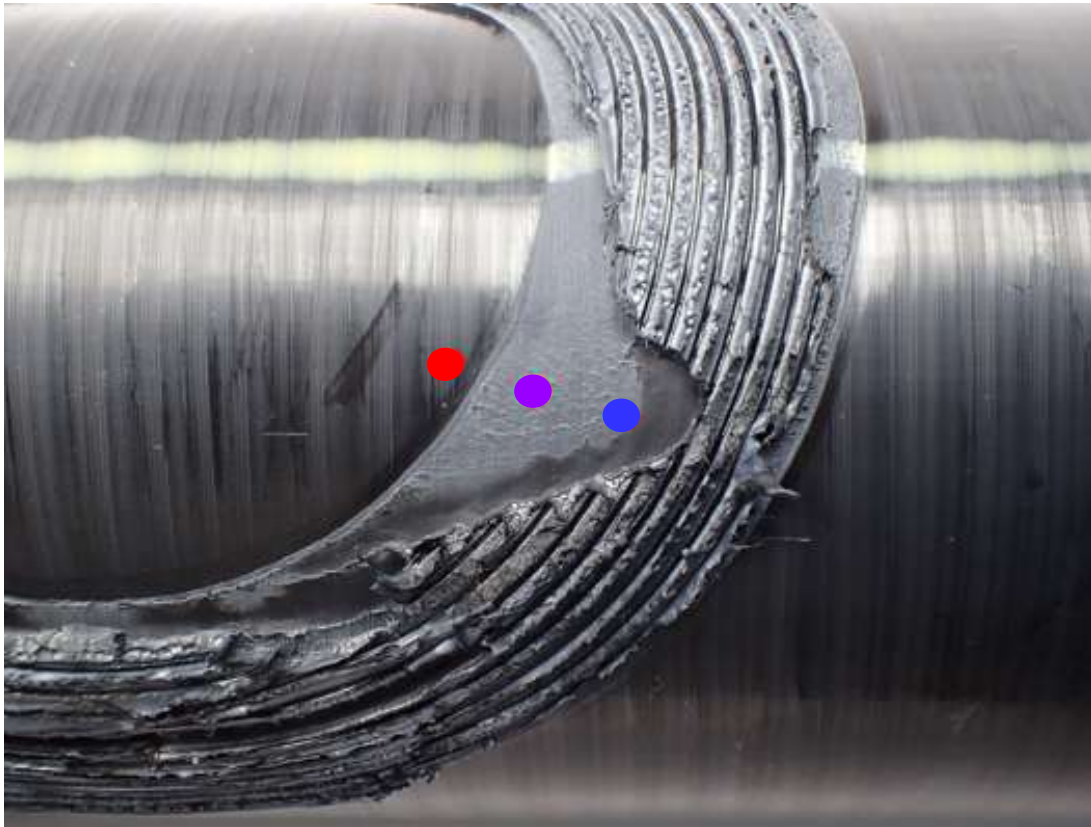
172316-055	172395-048	Bentonite	99% Isopropanol	Cotton Cloth Rag
------------	------------	-----------	-----------------	------------------

Figure 181. Sample 172316-055, decohesion test result

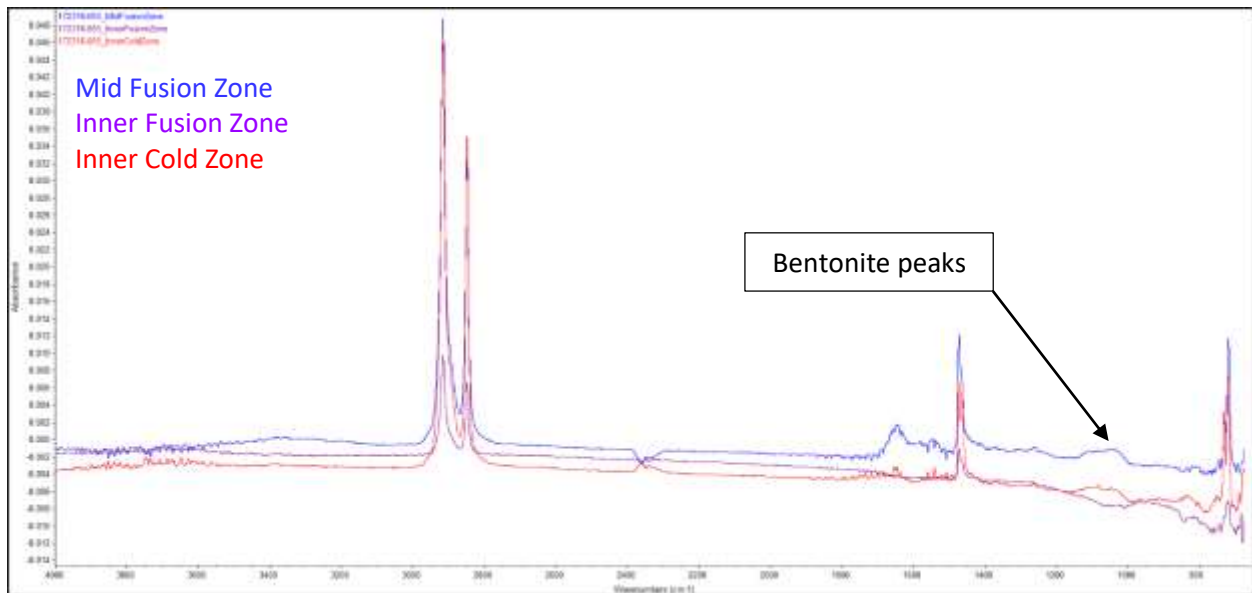
Figure 182. Sample 172316-055, FTIR spectra from decohesion test result

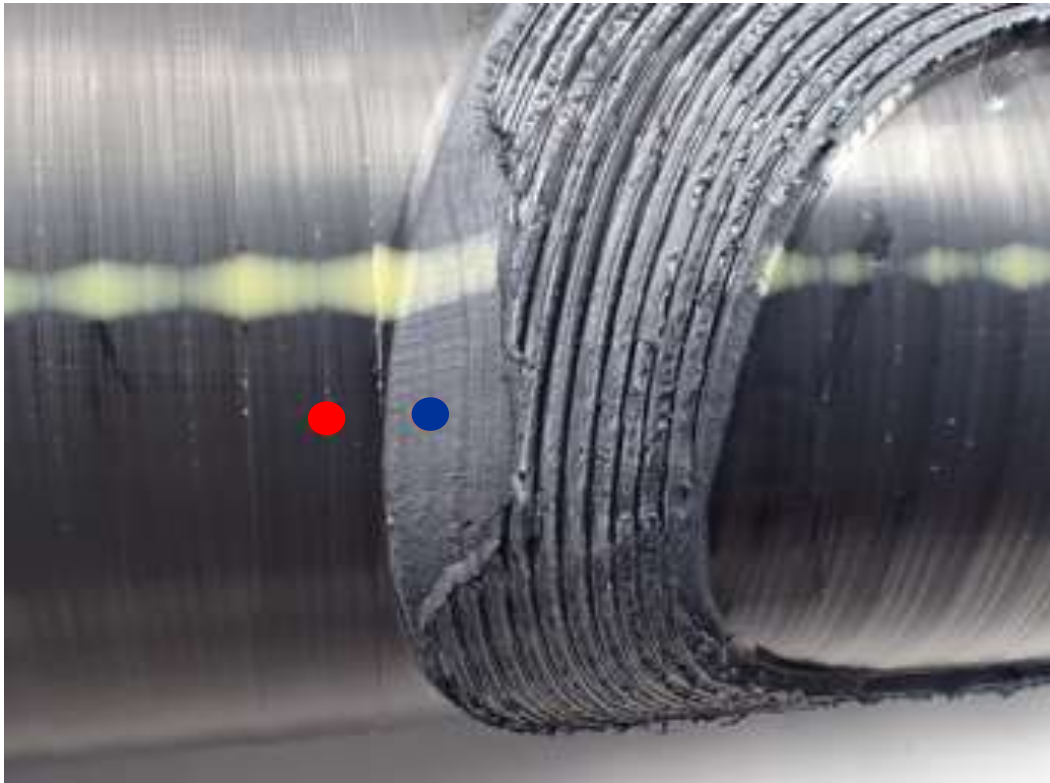
172316-057	172395-052	Bentonite	99% Isopropanol	Paper Towel
------------	------------	-----------	-----------------	-------------

Figure 183. Sample 172316-057, decohesion test result

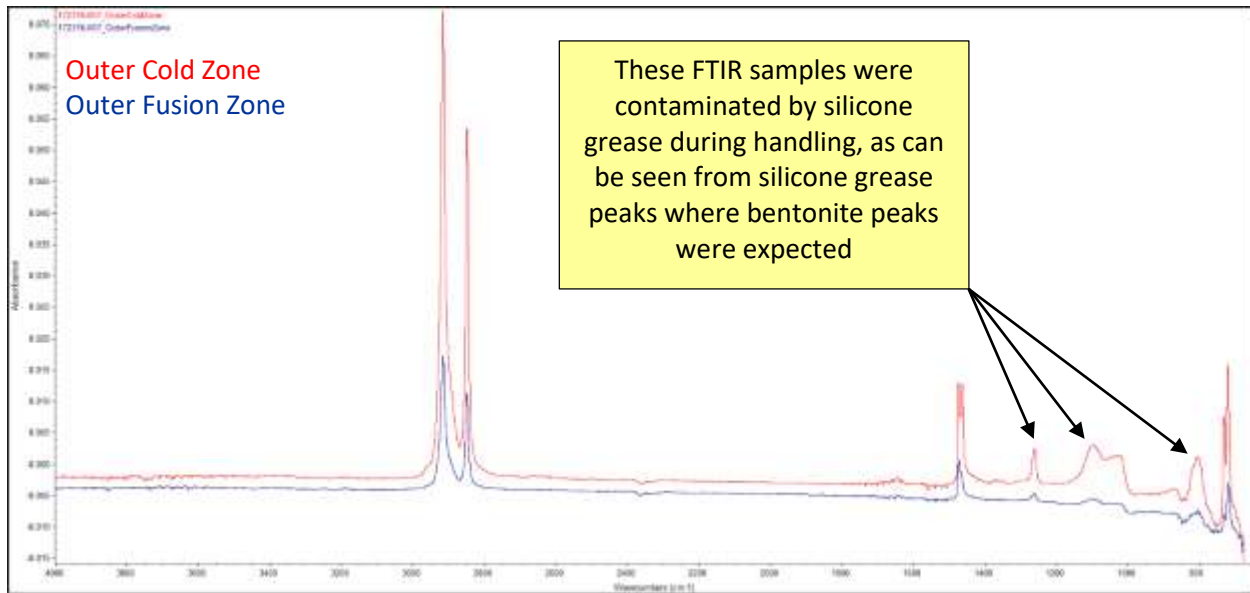
Figure 184. Sample 172316-057, FTIR spectra from decohesion test result

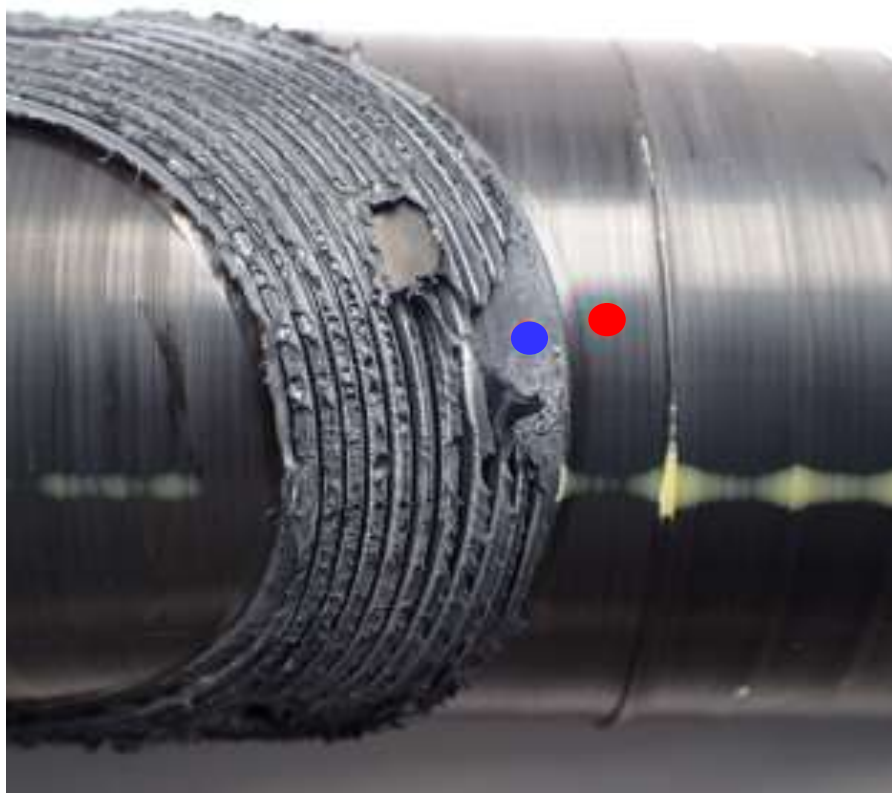
172316-058	172395-055	Bentonite	91% Isopropanol	Lint-Free Wipe
------------	------------	-----------	-----------------	----------------

Figure 185. Sample 172316-058, decohesion test result

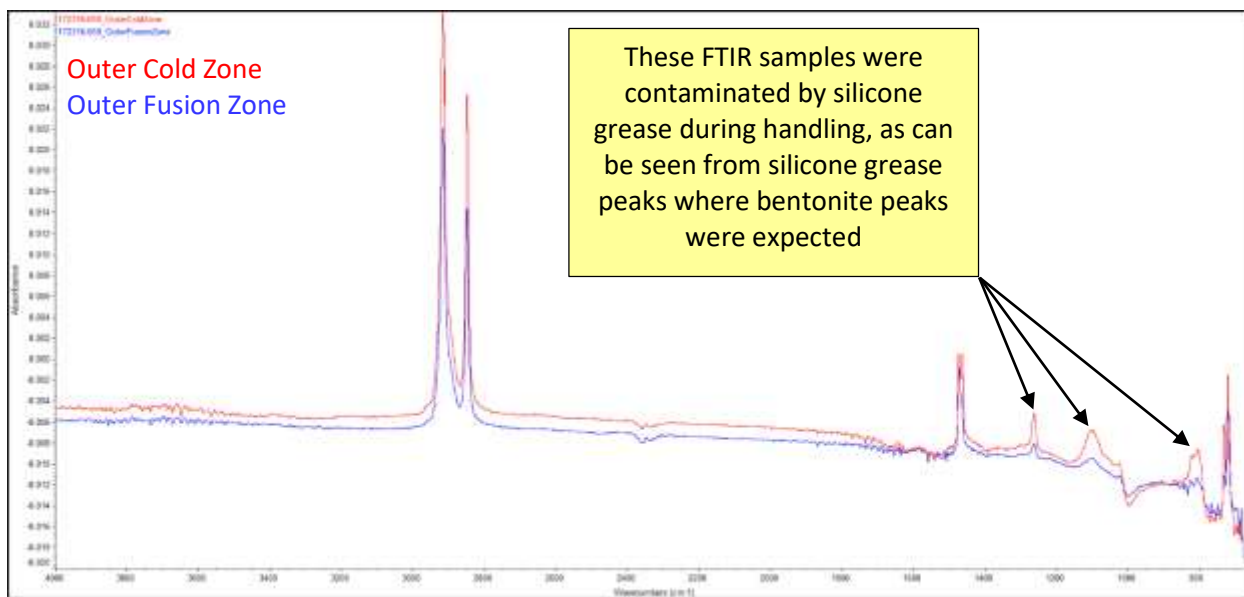
Figure 186. Sample 172316-058, FTIR spectra from decohesion test result

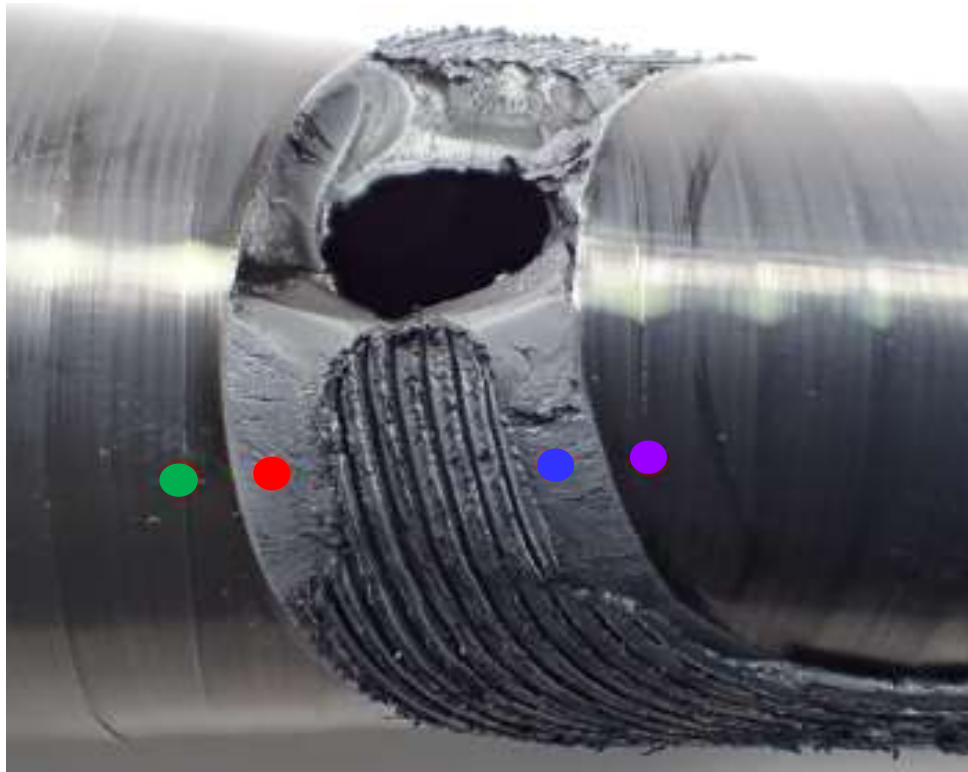
172316-059	172395-056	Bentonite	91% Isopropanol	Lint-Free Wipe
------------	------------	-----------	-----------------	----------------

Figure 187. Sample 172316-059, decohesion test result

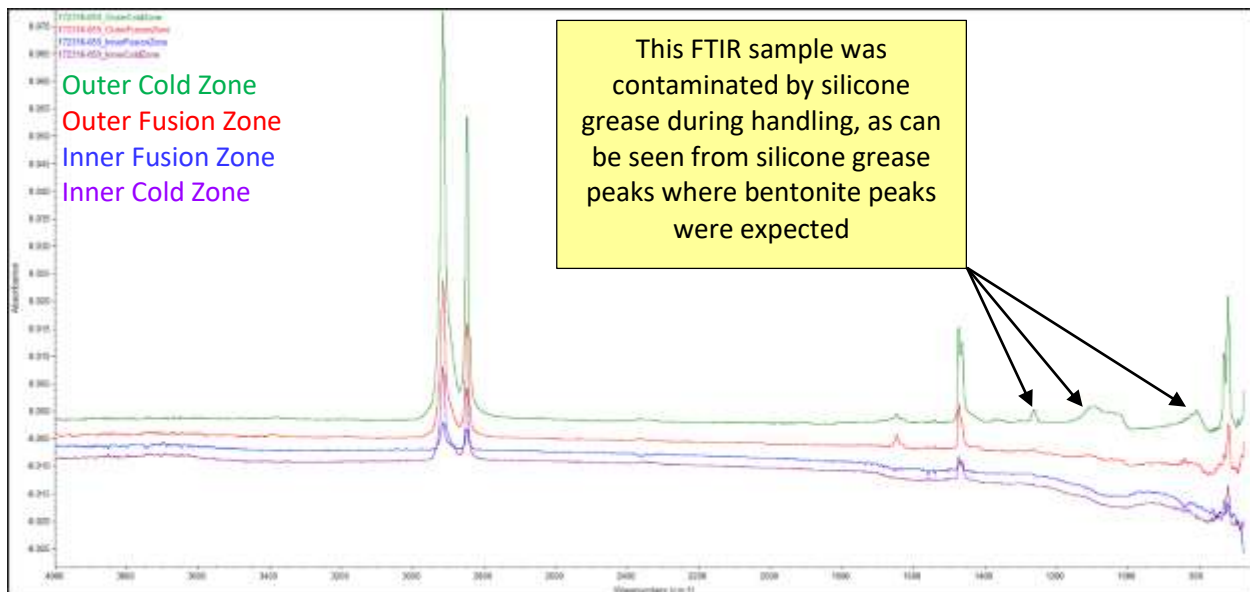
Figure 188. Sample 172316-059, FTIR spectra from decohesion test result

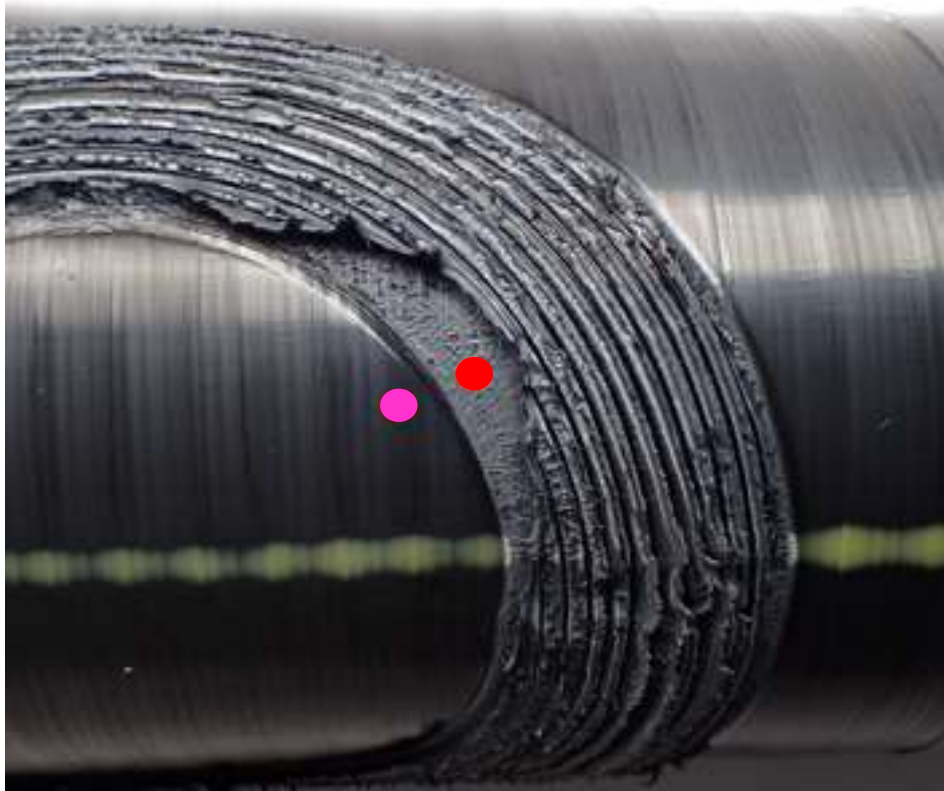
172316-060	172395-059	Bentonite	91% Isopropanol	Cotton Cloth Rag
------------	------------	-----------	-----------------	------------------

Figure 189. Sample 172316-060, decohesion test result

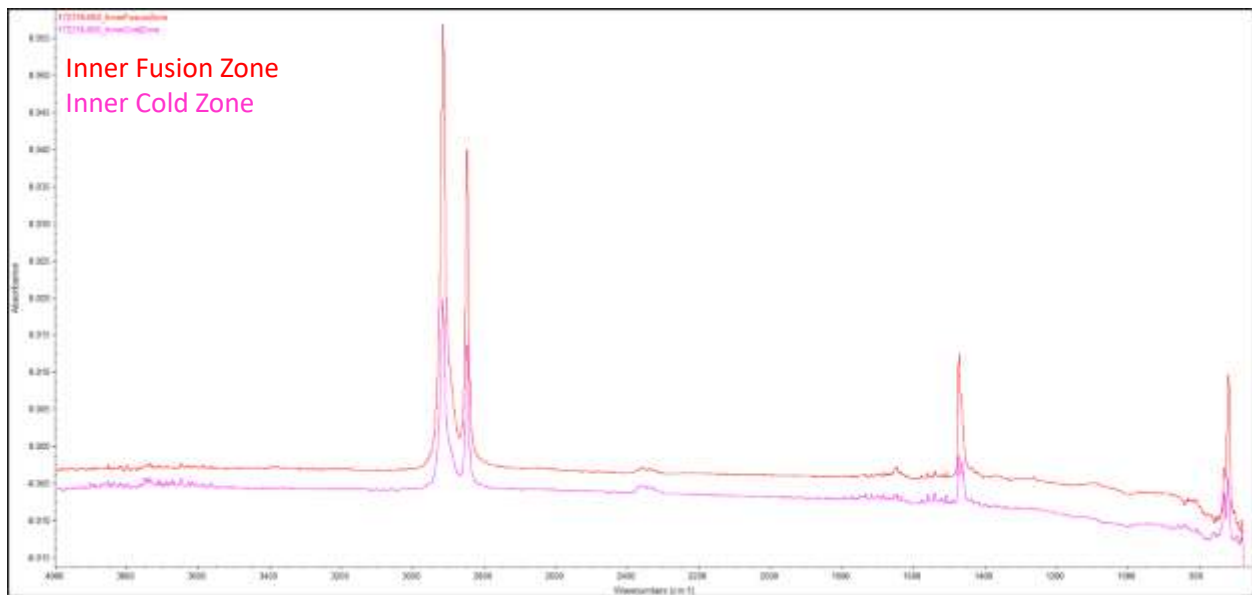
Figure 190. Sample 172316-060, FTIR spectra from decohesion test result

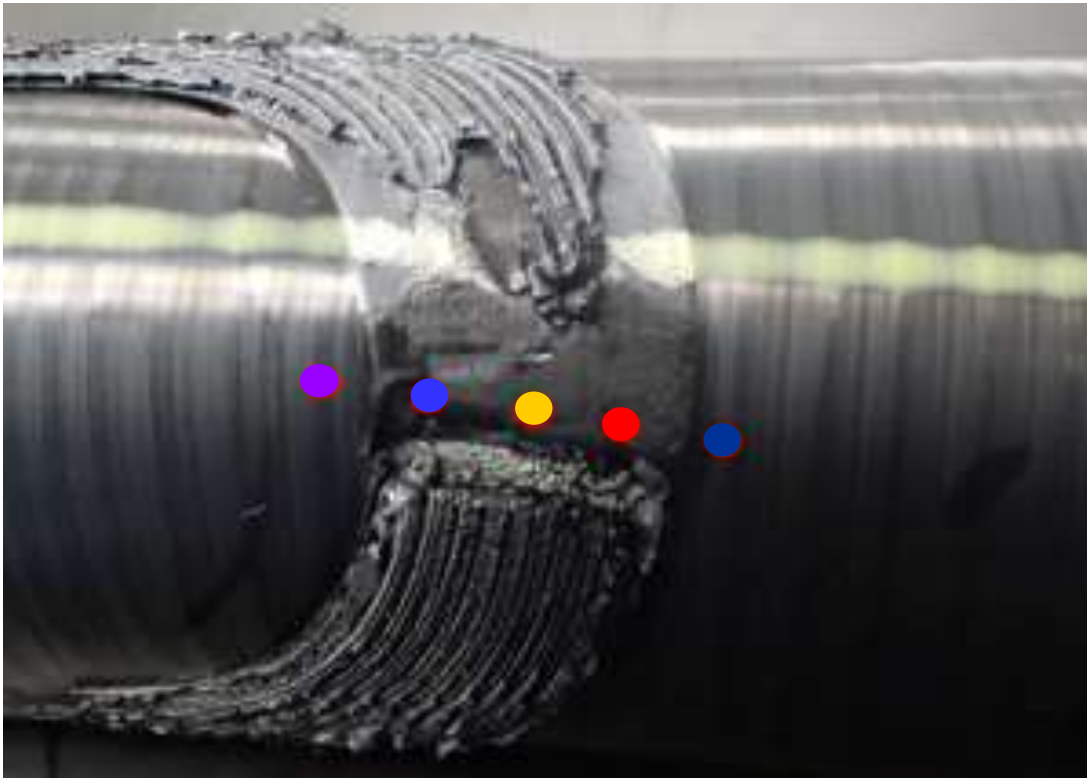
172316-061	172395-060	Bentonite	91% Isopropanol	Cotton Cloth Rag
------------	------------	-----------	-----------------	------------------

Figure 191. Sample 172316-061, decohesion test result

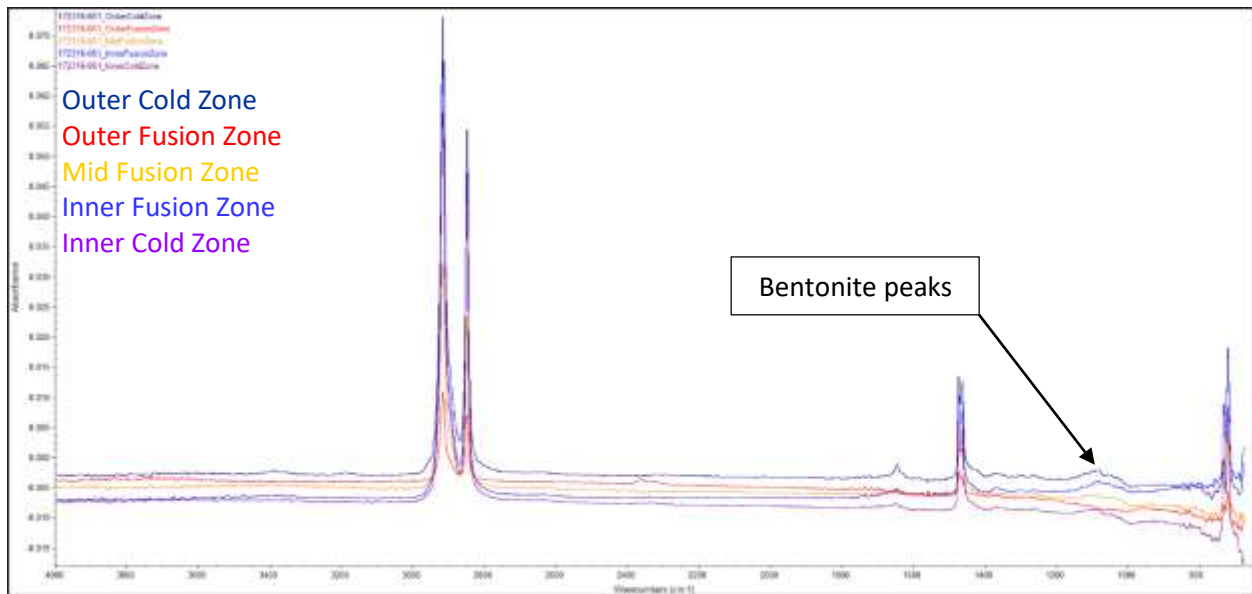
Figure 192. Sample 172316-061, FTIR spectra from decohesion test result

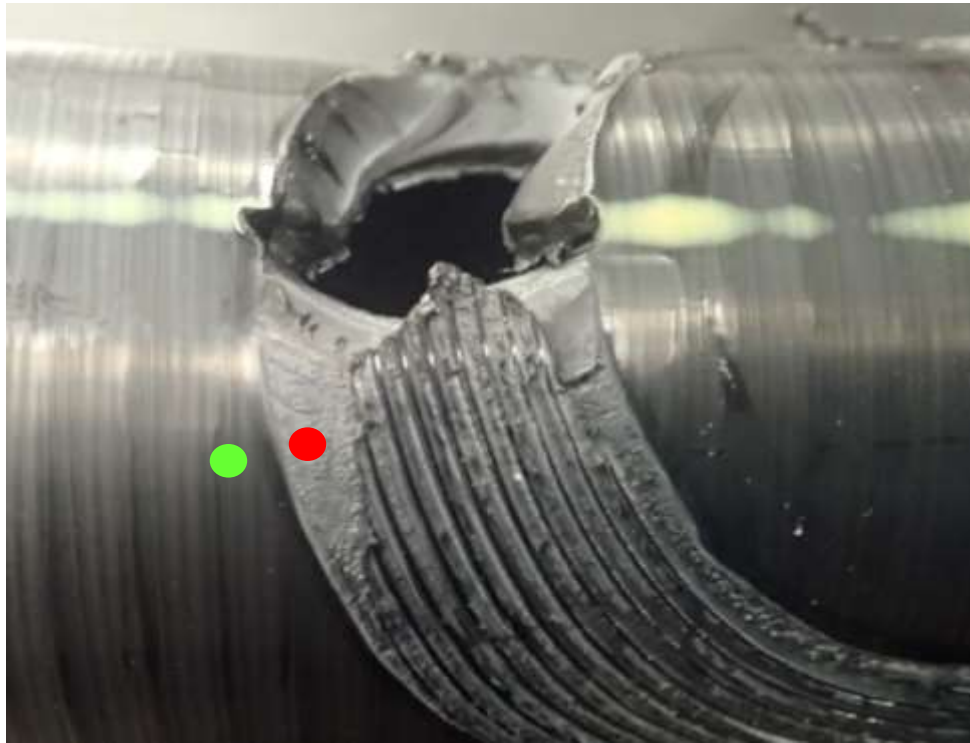
172316-063	172395-064	Bentonite	91% Isopropanol	Paper Towel
------------	------------	-----------	-----------------	-------------

Figure 193. Sample 172316-063, decohesion test result

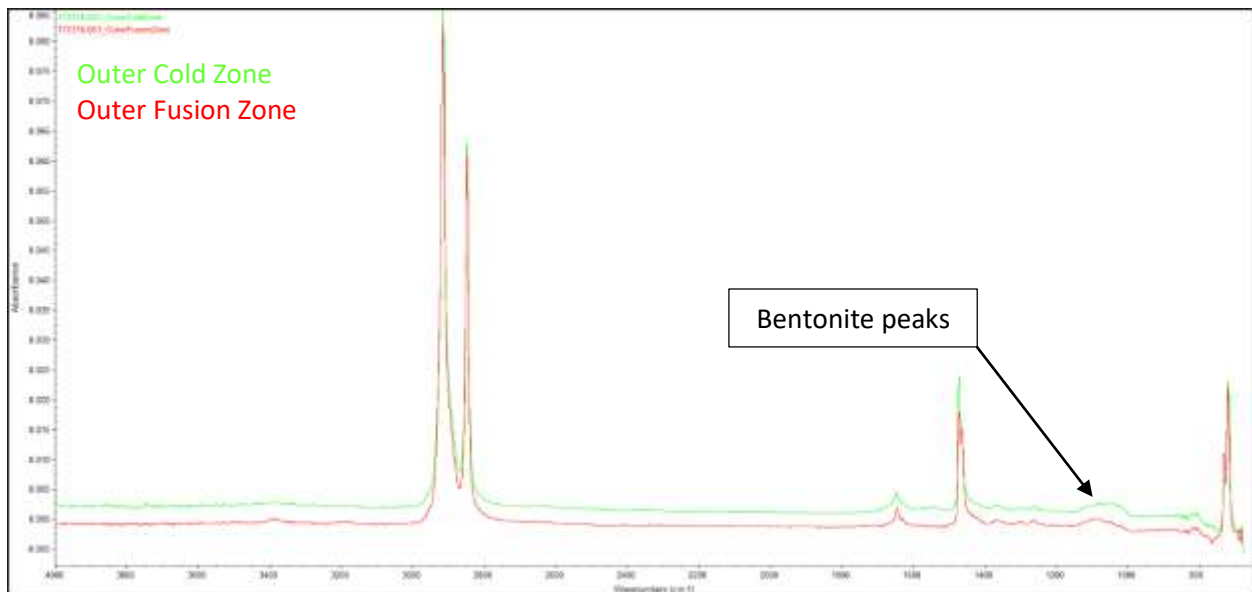
Figure 194. Sample 172316-063, FTIR spectra from decohesion test result

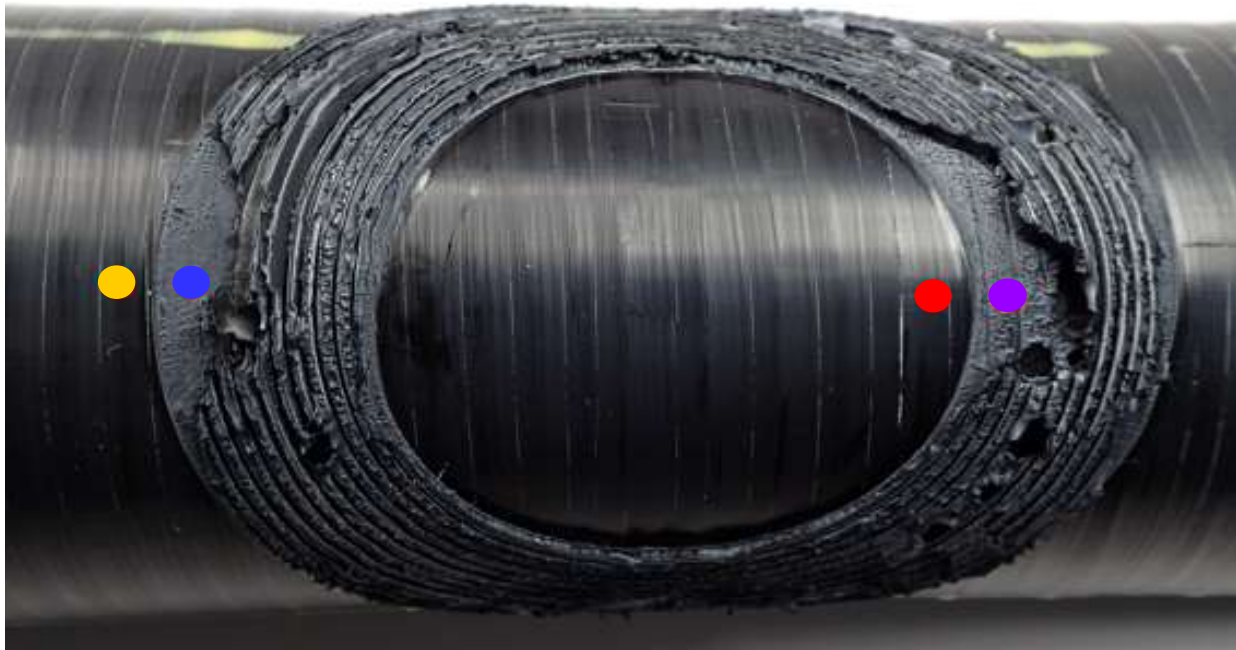
172316-064	172395-067	Bentonite	Acetone	Lint-Free Wipe
------------	------------	-----------	---------	----------------

Figure 195. Sample 172316-064, decohesion test result

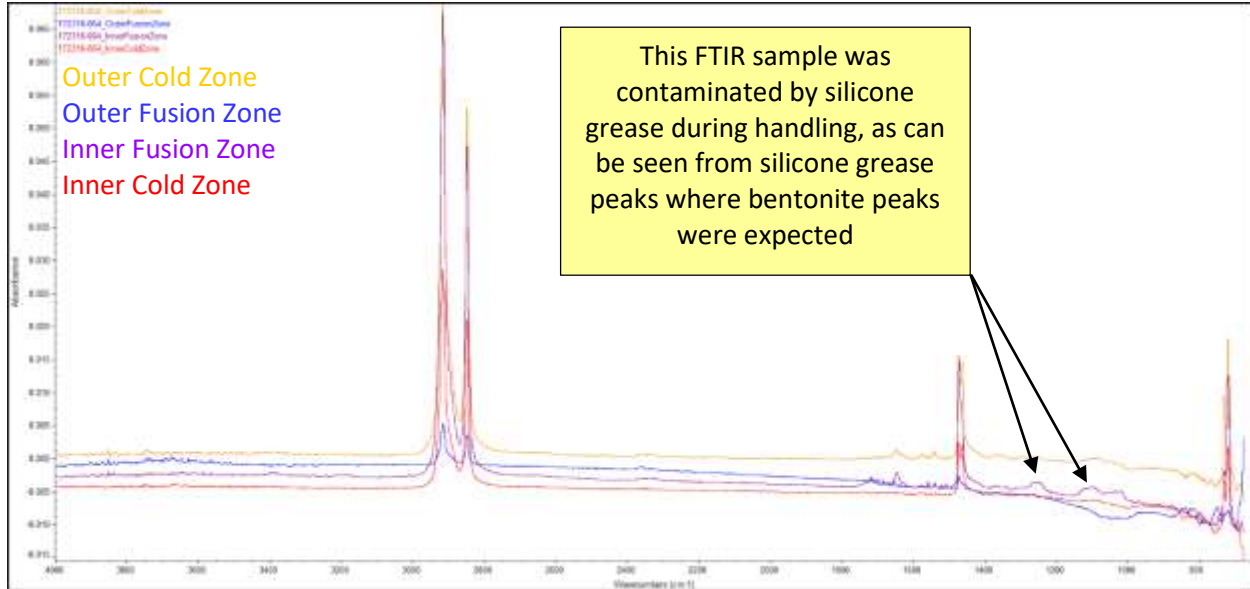
Figure 196. Sample 172316-064, FTIR spectra from decohesion test result

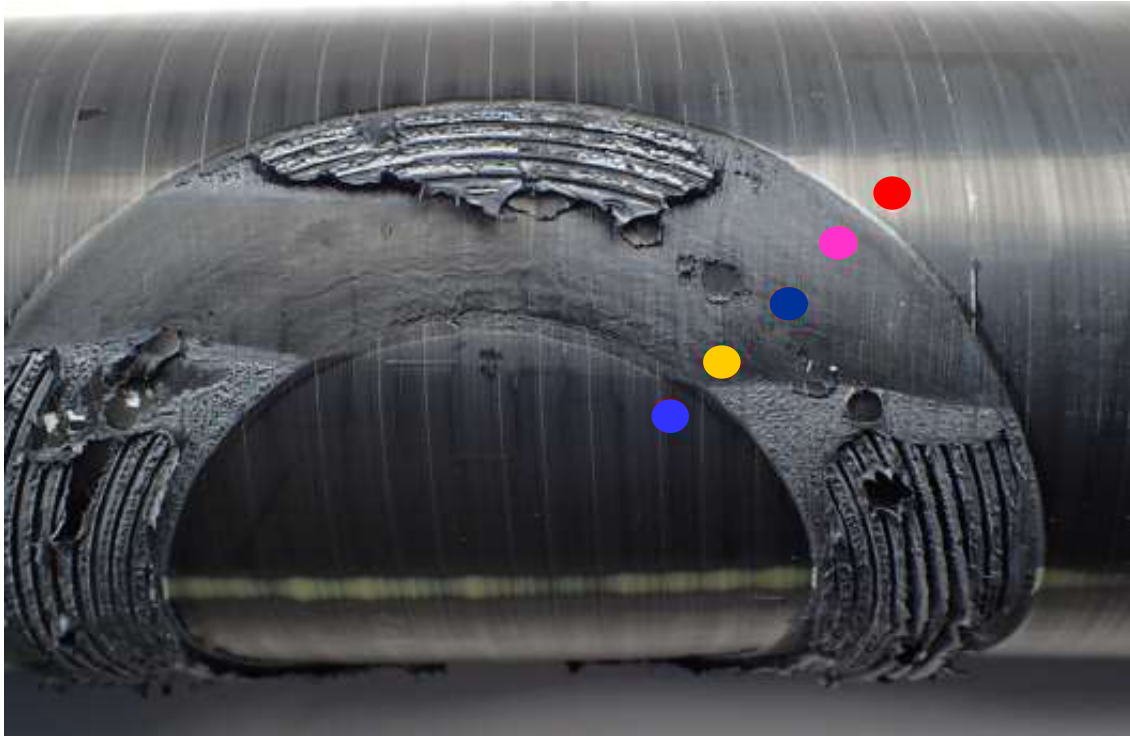
172316-065	172395-068	Bentonite	Acetone	Lint-Free Wipe
------------	------------	-----------	---------	----------------

Figure 197. Sample 172316-065, decohesion test result

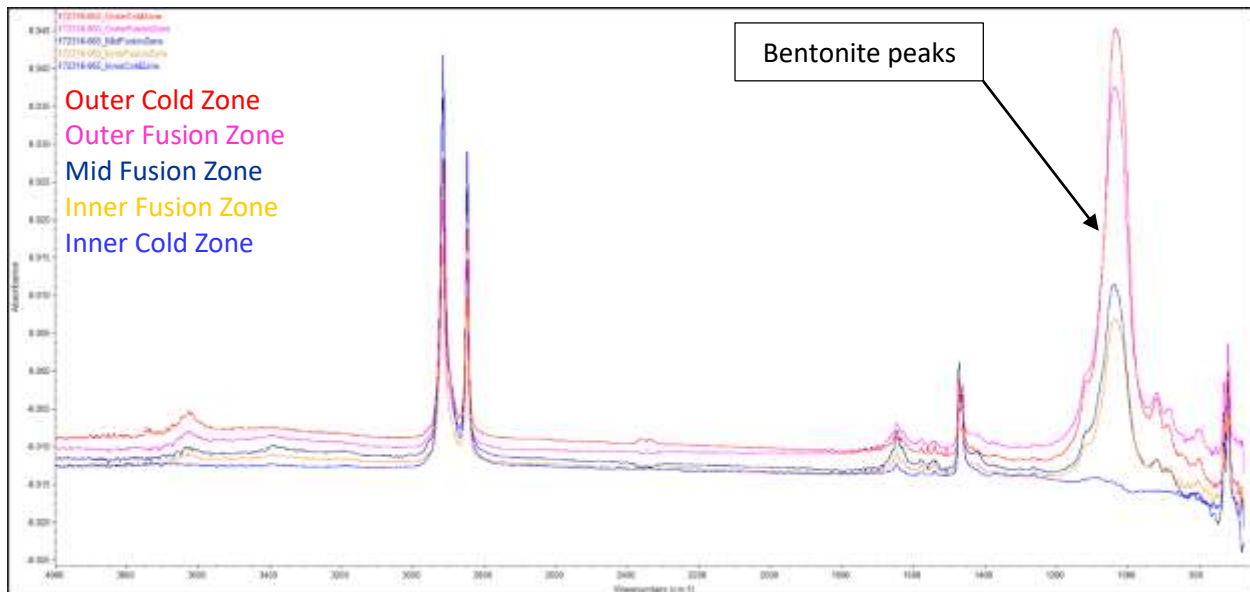
Figure 198. Sample 172316-065, FTIR spectra from decohesion test result

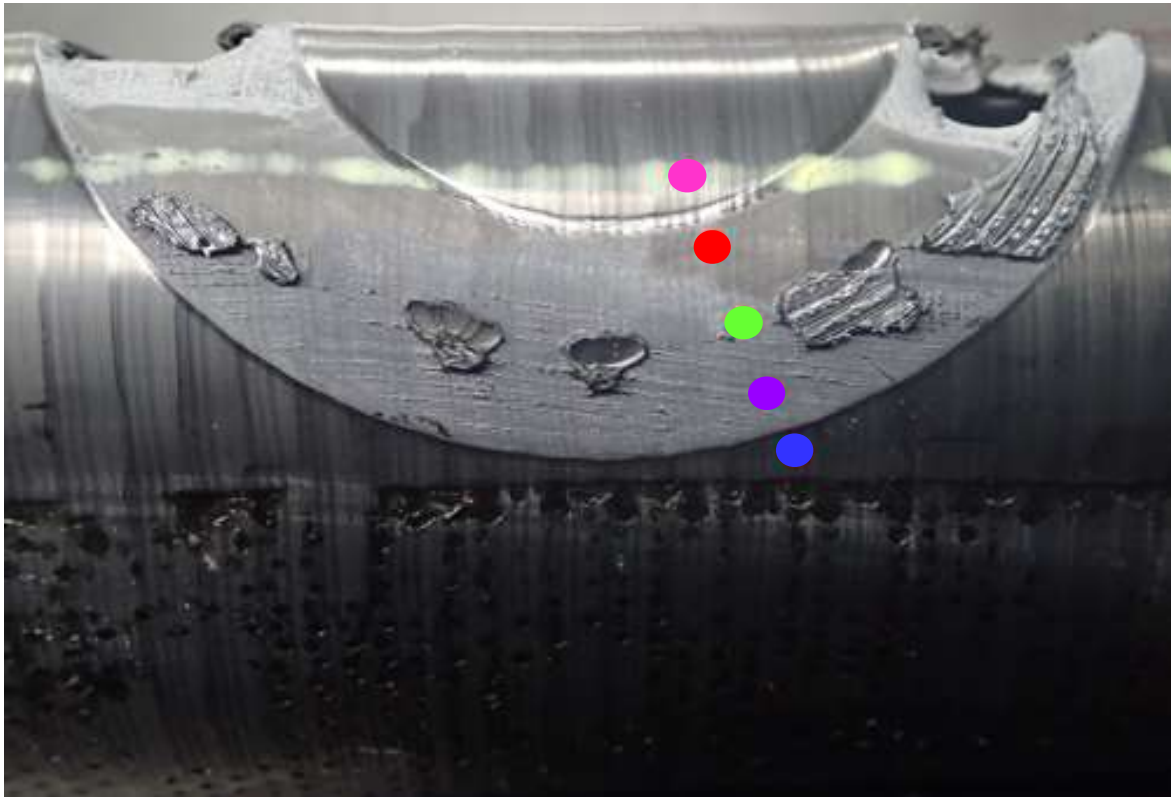
172316-066	172395-071	Bentonite	Acetone	Cotton Cloth Rag
------------	------------	-----------	---------	------------------

Figure 199. Sample 172316-066, decohesion test result

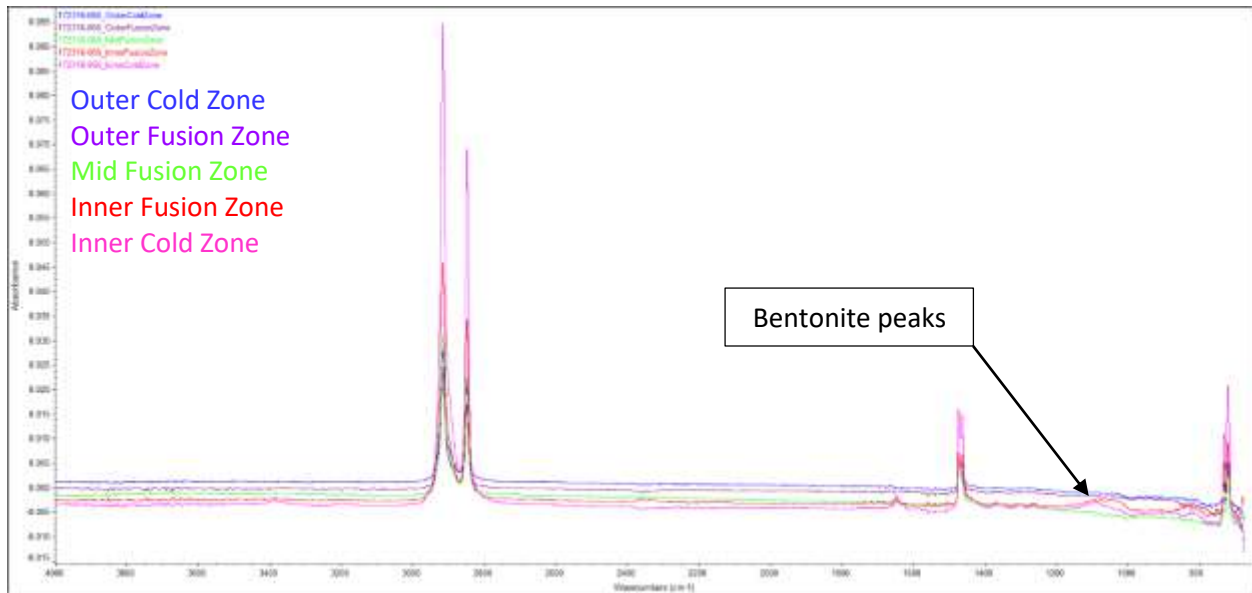
Figure 200. Sample 172316-066, FTIR spectra from decohesion test result

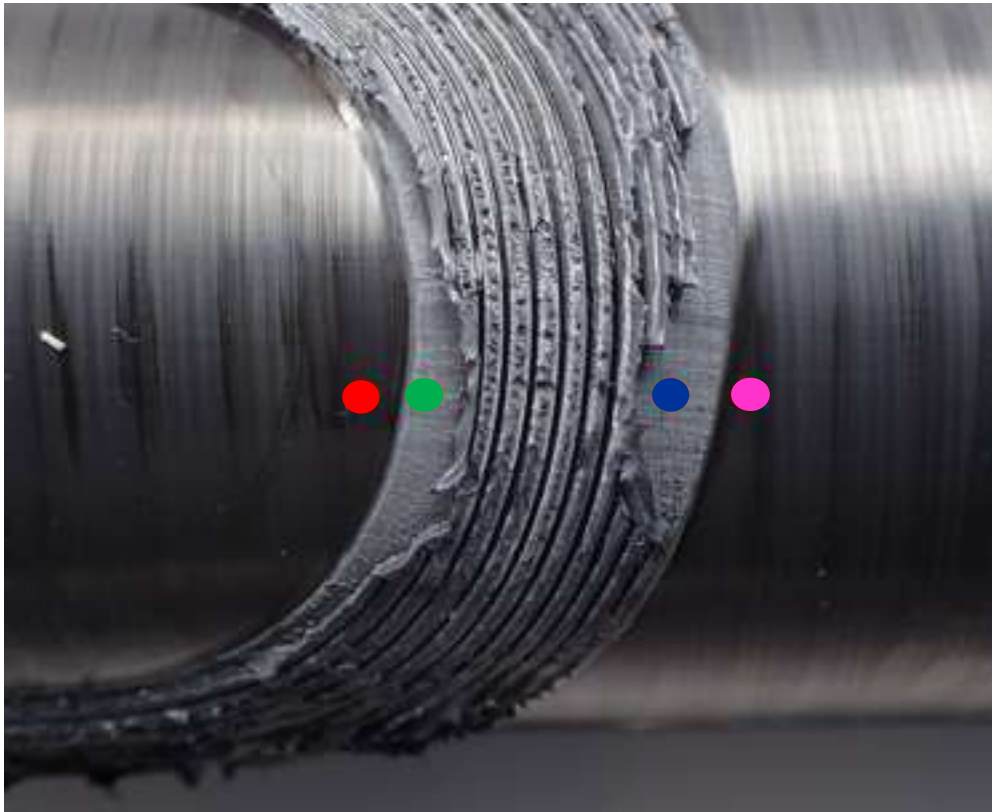
172316-067	172395-072	Bentonite	Acetone	Cotton Cloth Rag
------------	------------	-----------	---------	------------------

Figure 201. Sample 172316-067, decohesion test result

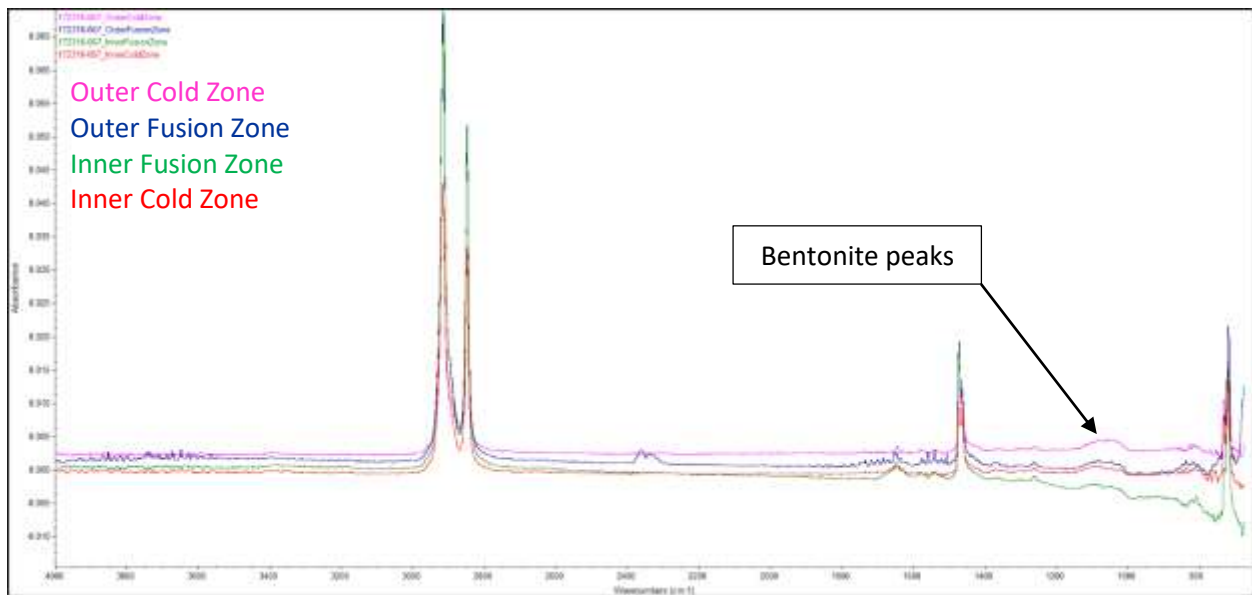
Figure 202. Sample 172316-067, FTIR spectra from decohesion test result

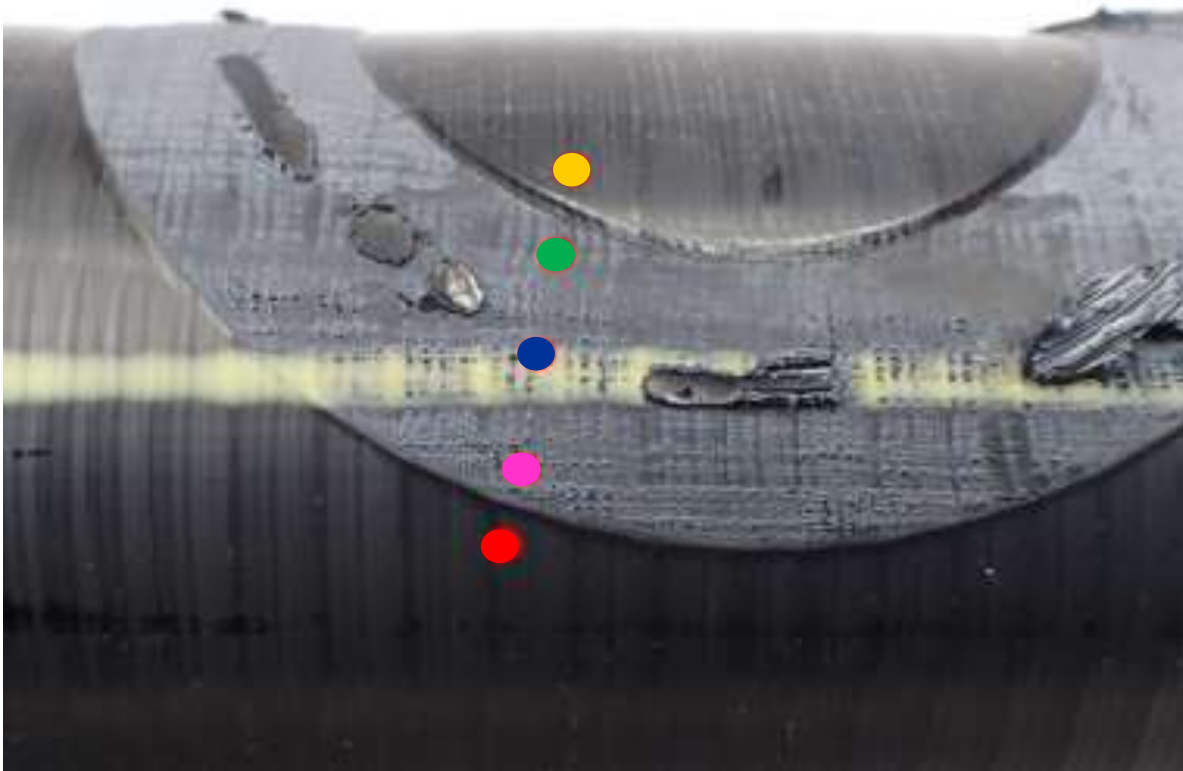
172316-068	172395-075	Bentonite	Acetone	Paper Towel
------------	------------	-----------	---------	-------------

Figure 203. Sample 172316-068, decohesion test result

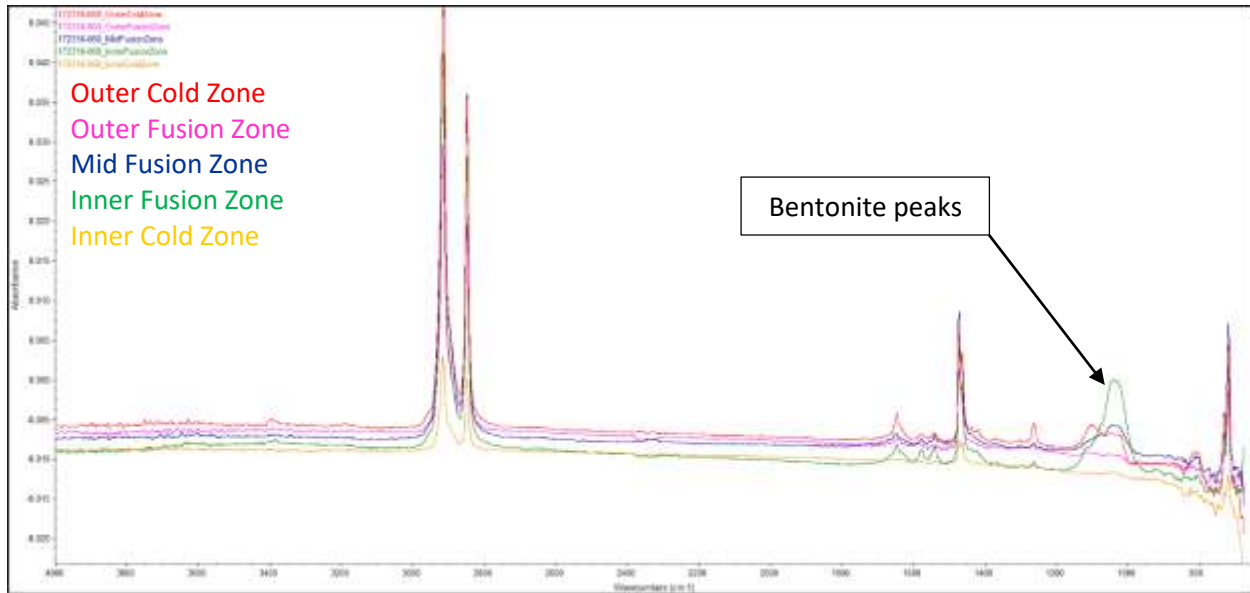
Figure 204. Sample 172316-068, FTIR spectra from decohesion test result

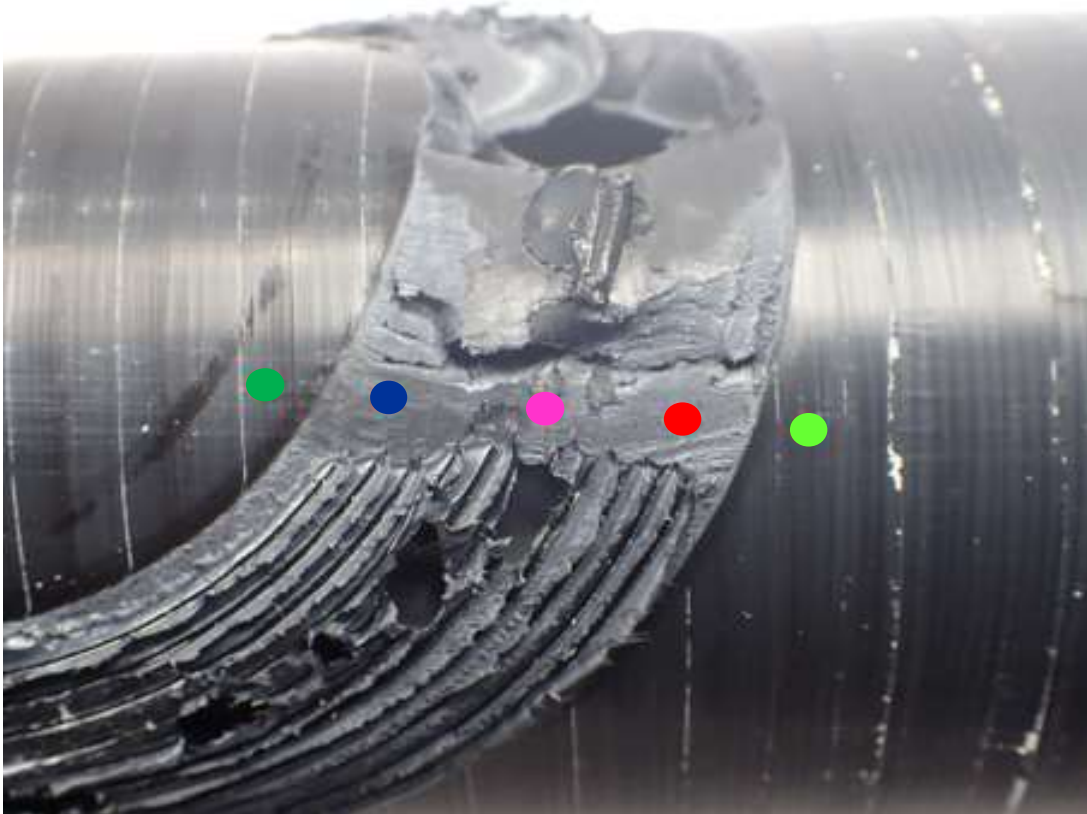
172316-069	172395-076	Bentonite	Acetone	Paper Towel
------------	------------	-----------	---------	-------------

Figure 205. Sample 172316-069, decohesion test result

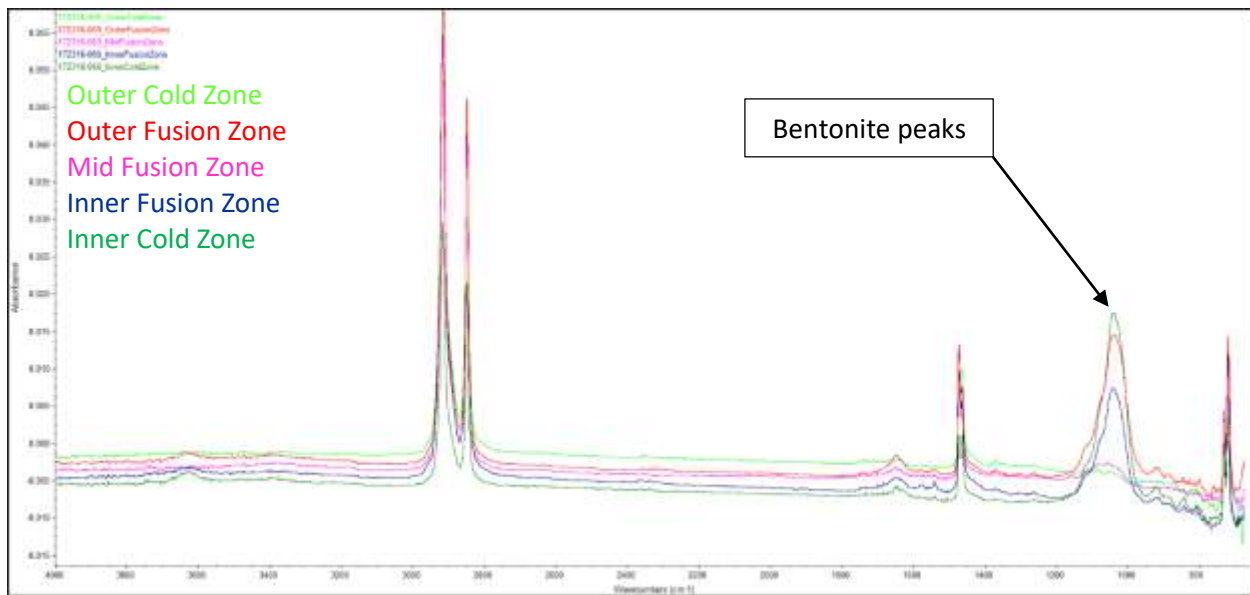
Figure 206. Sample 172316-069, FTIR spectra from decohesion test result

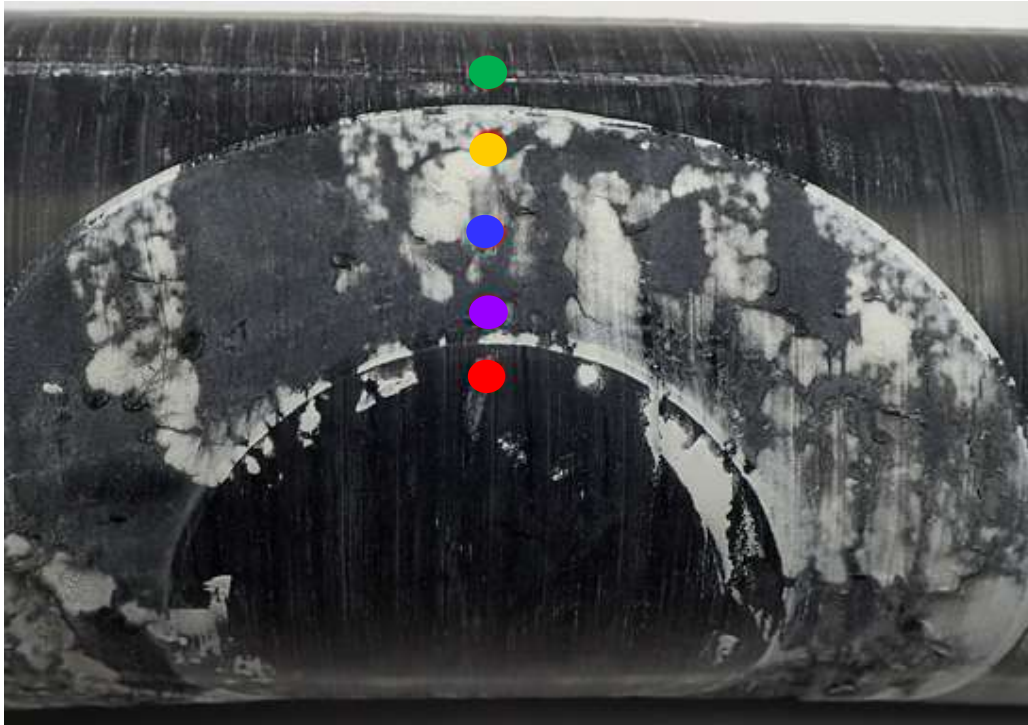
172316-070	172395-079	Bentonite	None	None
------------	------------	-----------	------	------

Figure 207. Sample 172316-070, decohesion test result
