▼
**Solvent Cleaning and PE
Joining Procedures**

Prepared by:
Gas Technology Institute
Des Plaines, Illinois

GTI-OTD FINAL REPORT

Solvent Cleaning and PE Joining Procedures

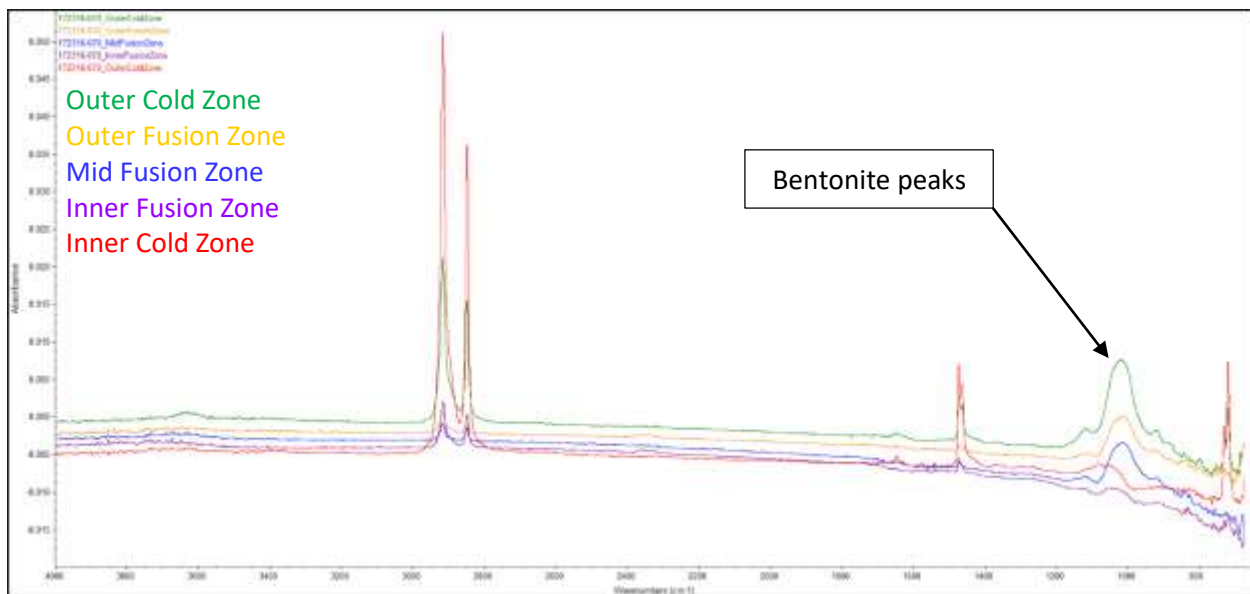
Figure 208. Sample 172316-070, FTIR spectra from decohesion test result

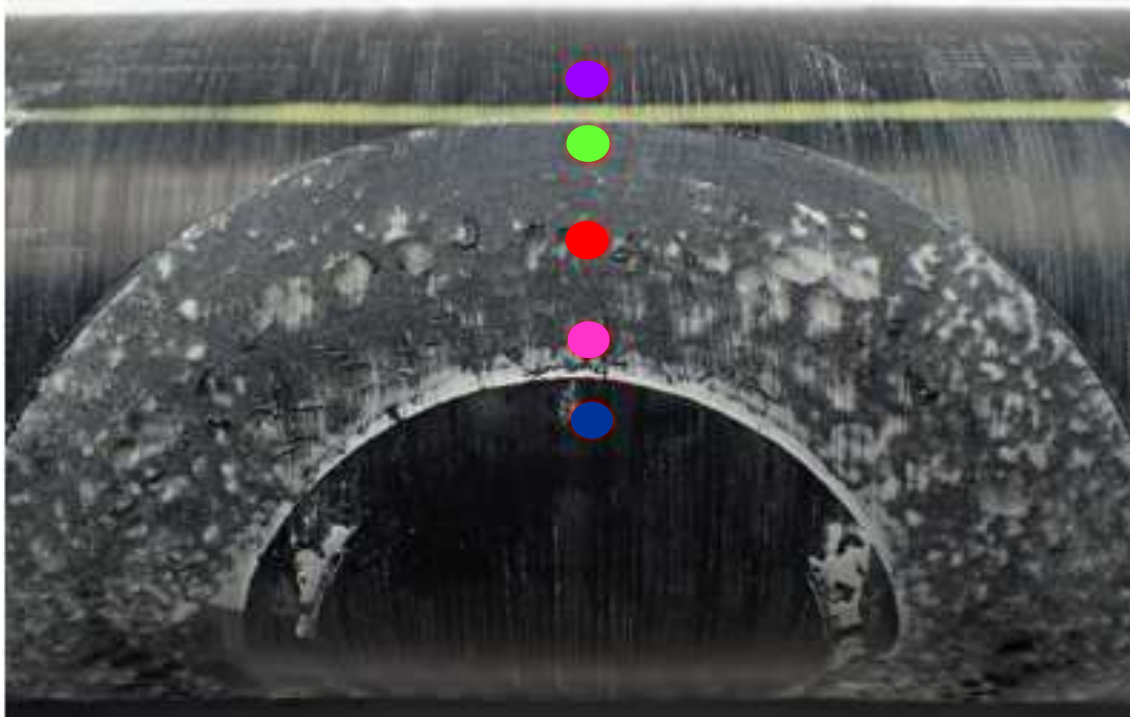
172316-071	172395-080	Bentonite	None	None
------------	------------	-----------	------	------

Figure 209. Sample 172316-071, decohesion test result

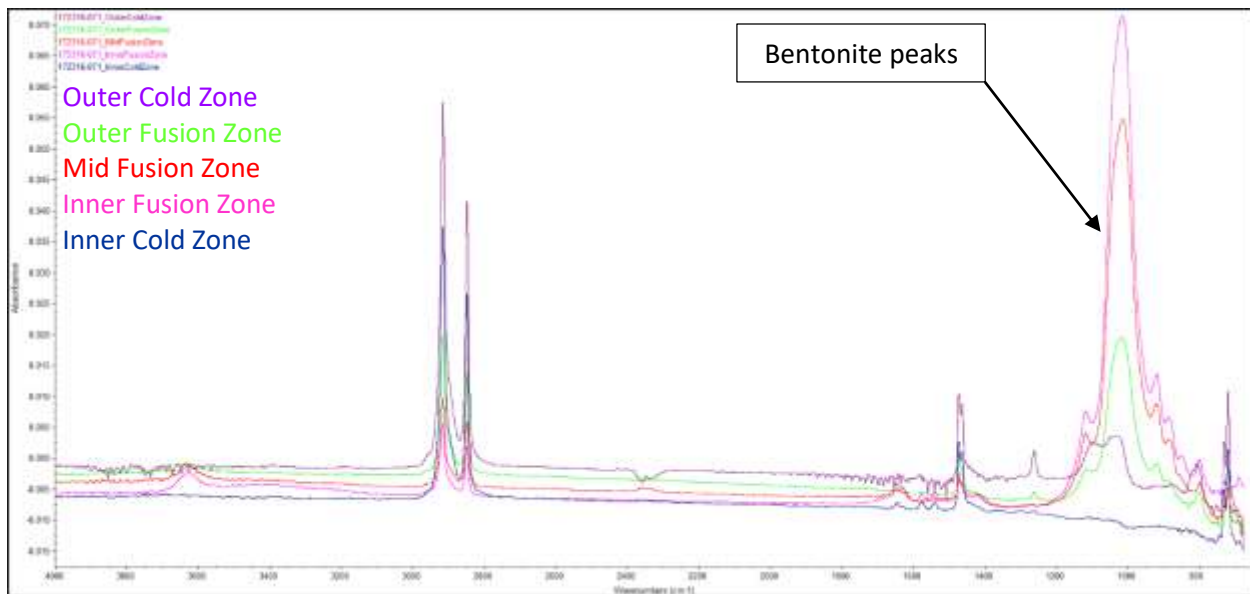
Figure 210. Sample 172316-071, FTIR spectra from decohesion test result

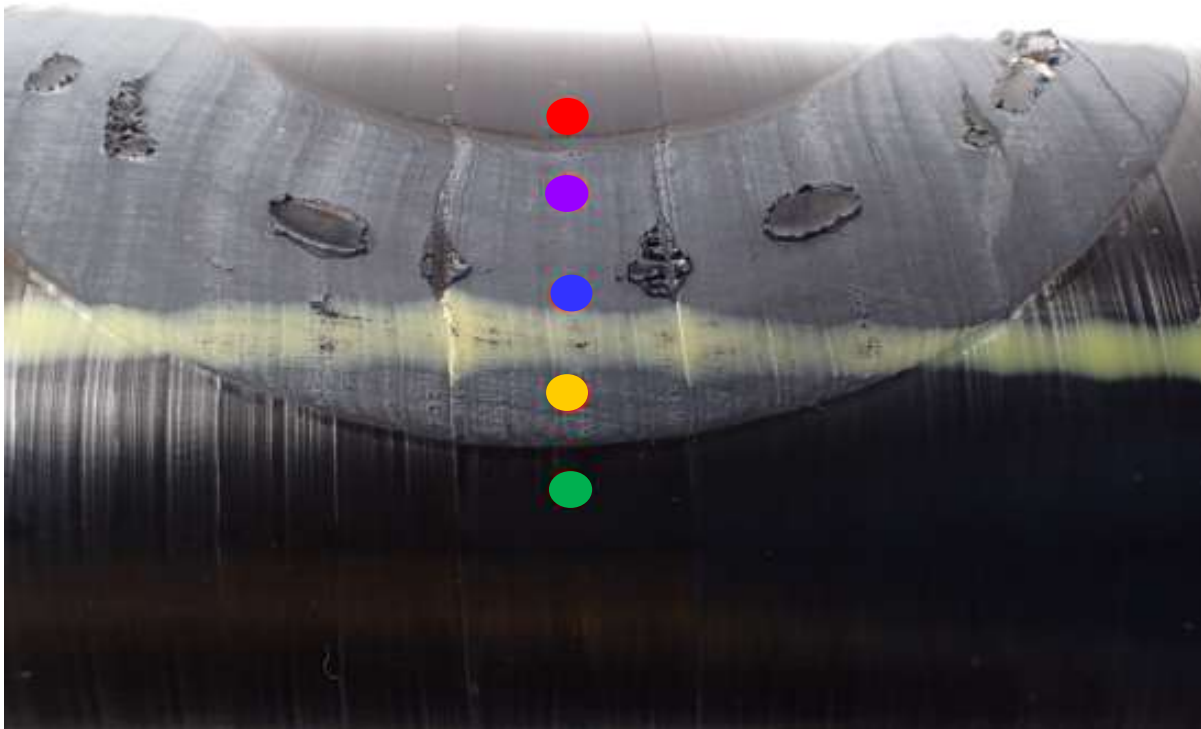
172316-072	172395-083	Silicon Grease	99% Isopropanol	Lint-Free Wipe
------------	------------	----------------	-----------------	----------------

Figure 211. Sample 172316-072, decohesion test result

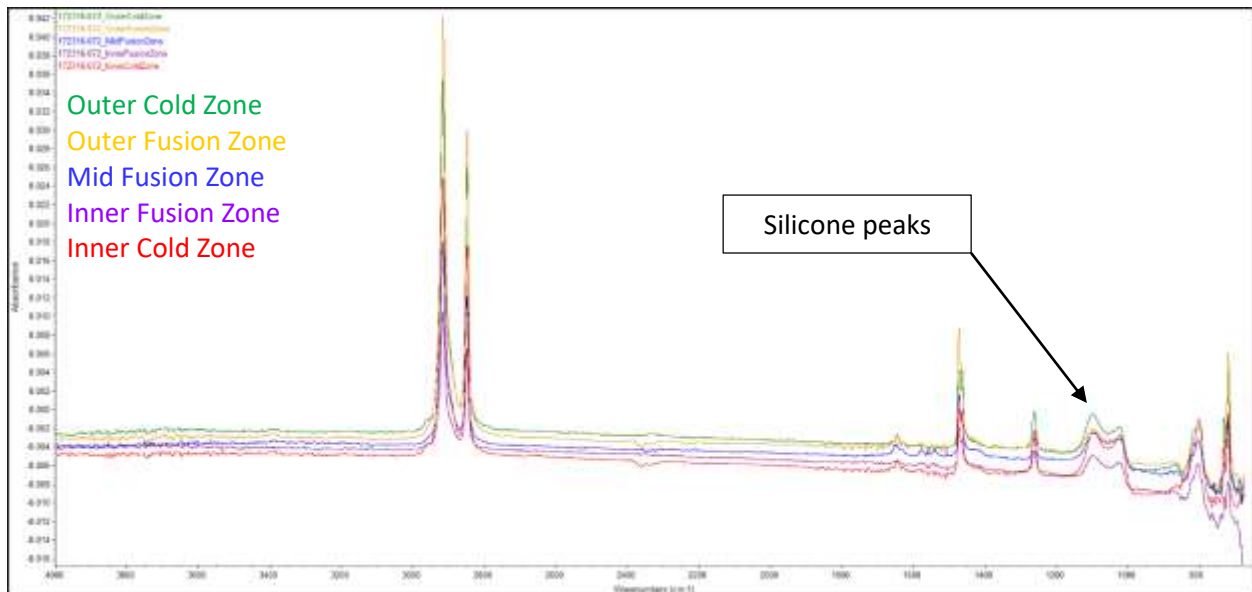
Figure 212. Sample 172316-072, FTIR spectra from decohesion test result

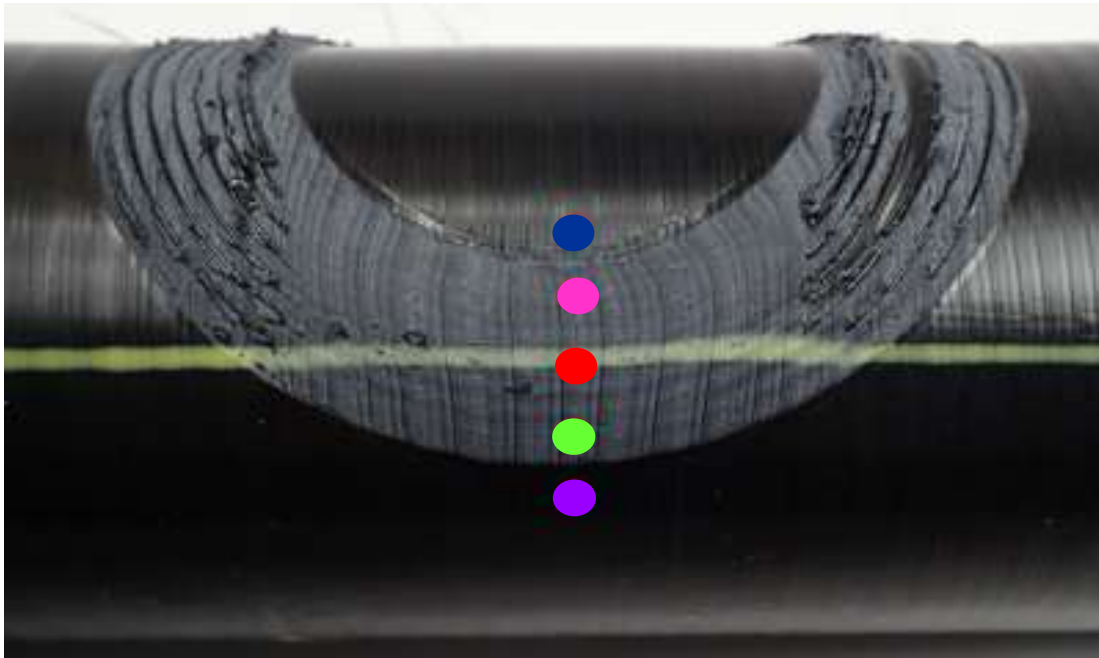
172316-073	172395-084	Silicon Grease	99% Isopropanol	Lint-Free Wipe
------------	------------	----------------	-----------------	----------------

Figure 213. Sample 172316-073, decohesion test result

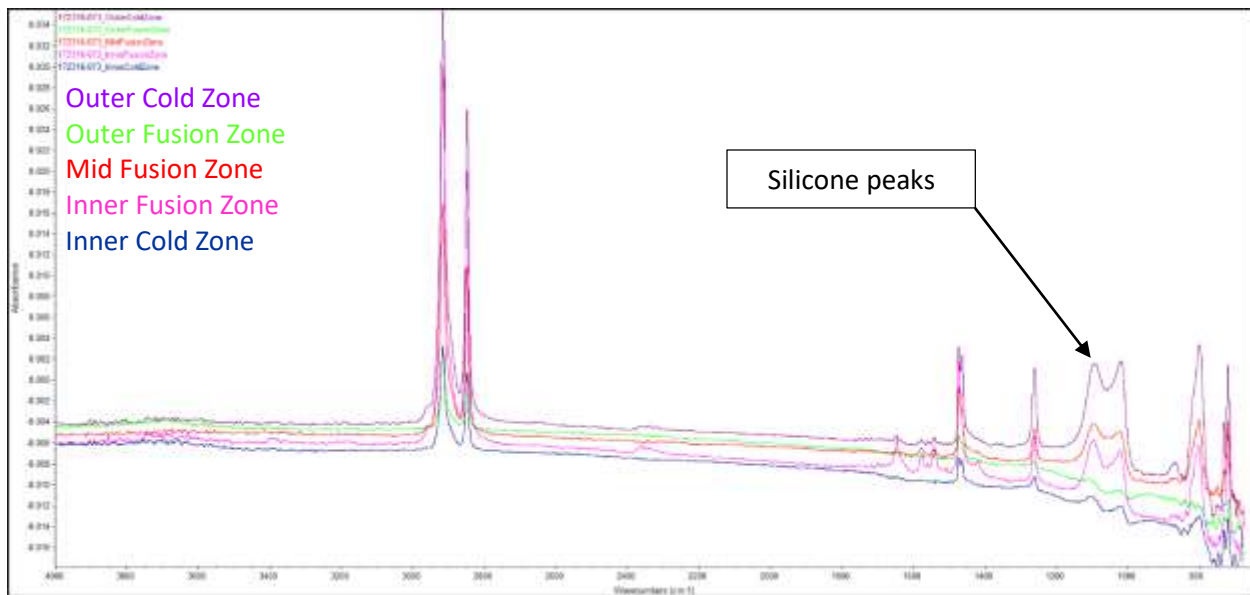
Figure 214. Sample 172316-073, FTIR spectra from decohesion test result

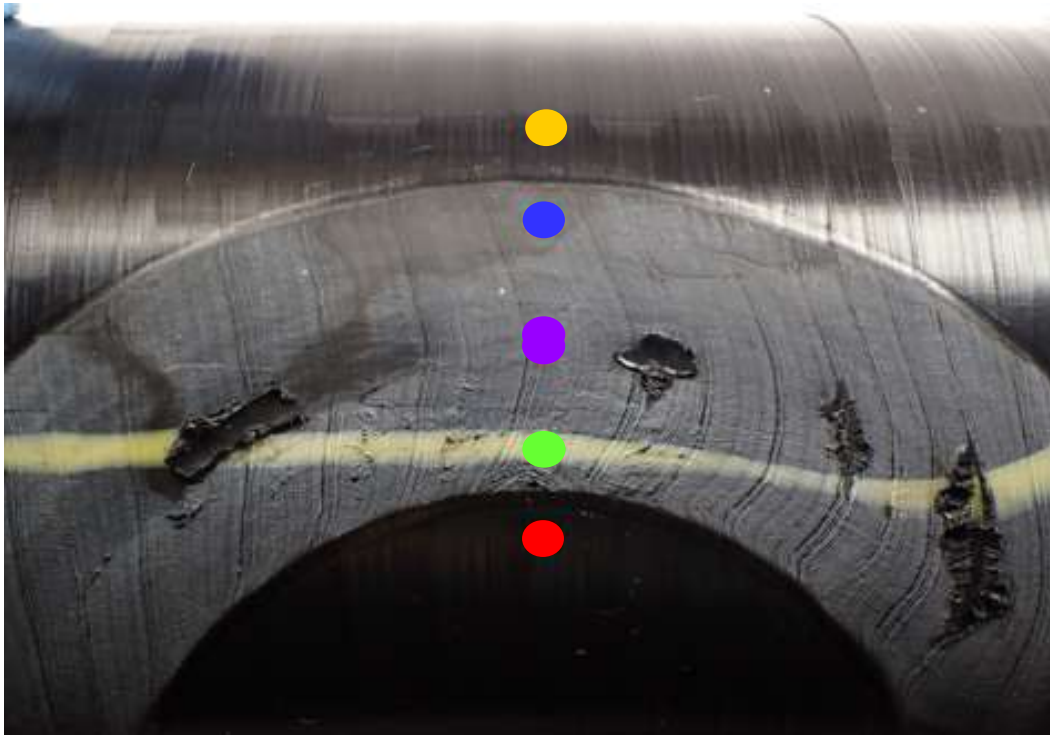
172316-074	172395-088	Silicon Grease	Acetone	Lint-Free Wipe
------------	------------	----------------	---------	----------------

Figure 215. Sample 172316-074, decohesion test result

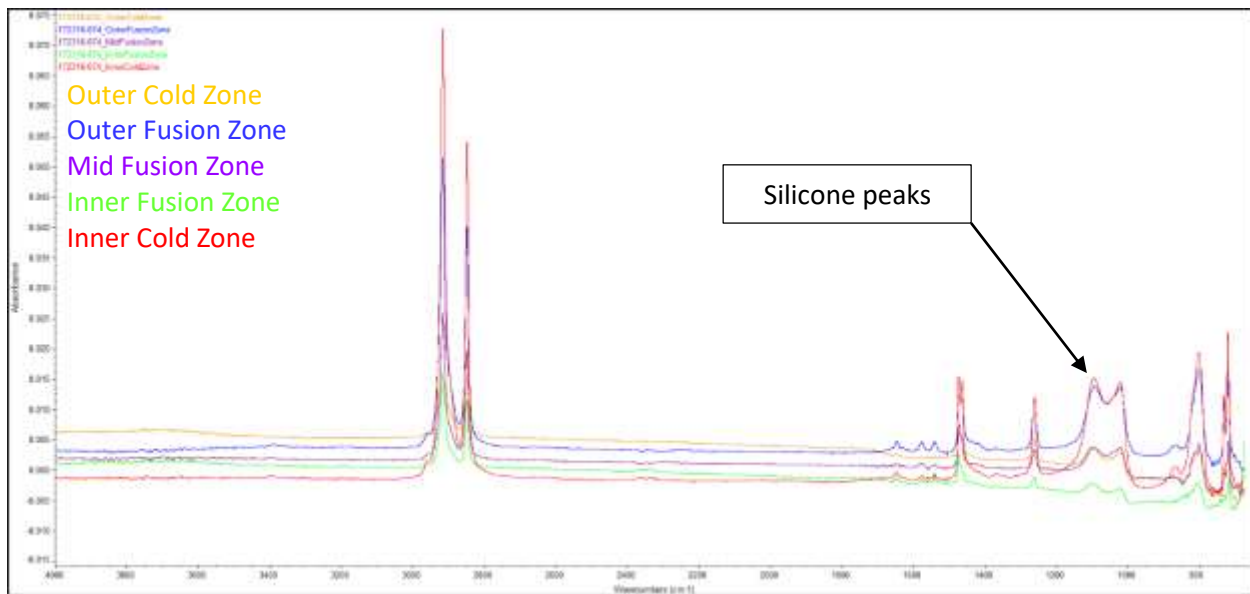
Figure 216. Sample 172316-074, FTIR spectra from decohesion test result

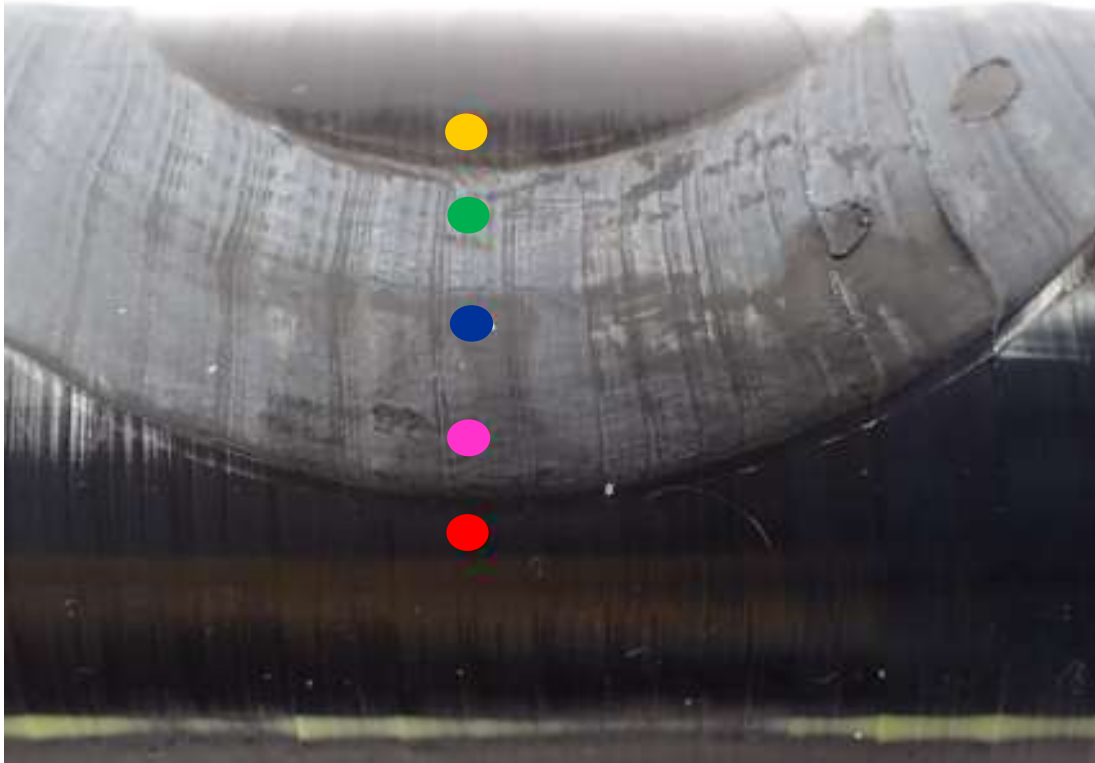
172316-075	172395-089	Silicon Grease	Acetone	Lint-Free Wipe
------------	------------	----------------	---------	----------------

Figure 217. Sample 172316-075, decohesion test result

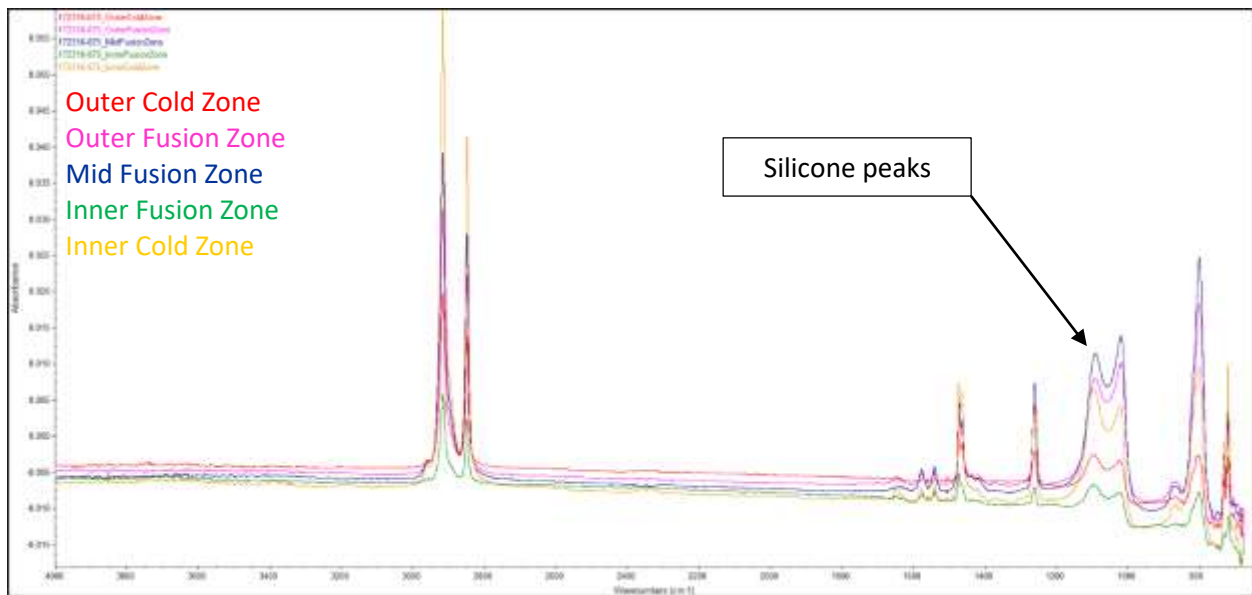
Figure 218. Sample 172316-075, FTIR spectra from decohesion test result

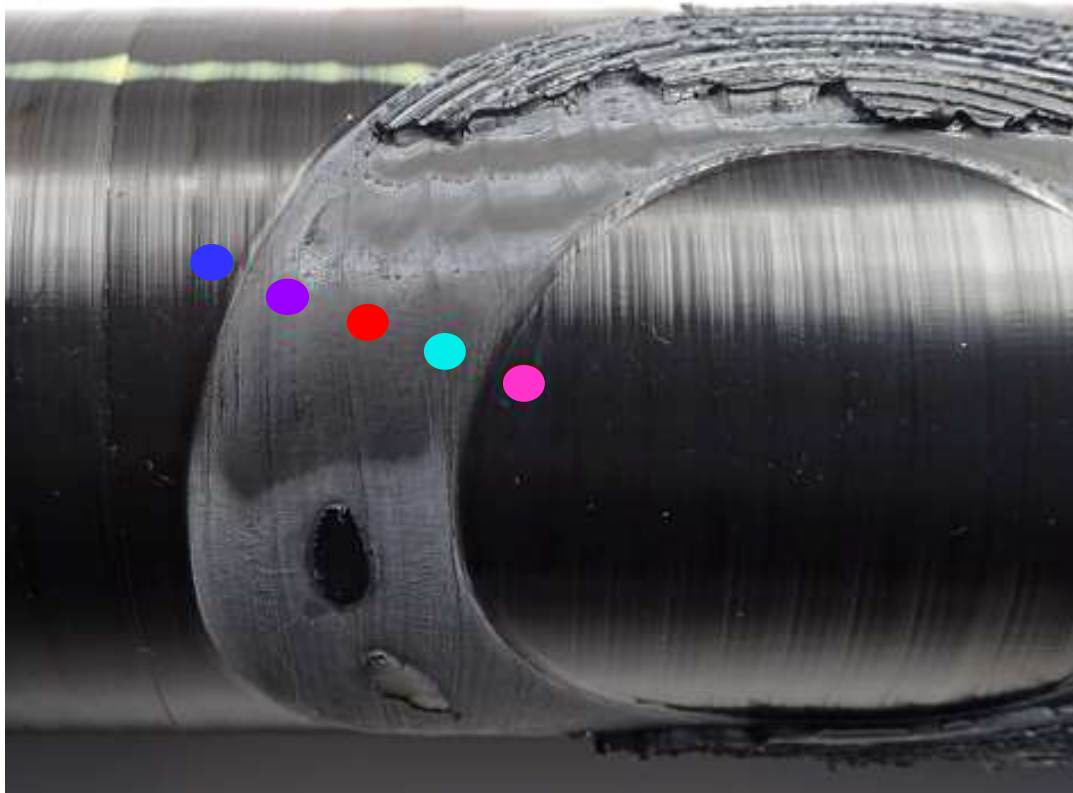
172316-076	172395-092	Silicon Grease	Acetone	Cotton Cloth Rag
------------	------------	----------------	---------	------------------

Figure 219. Sample 172316-076, decohesion test result

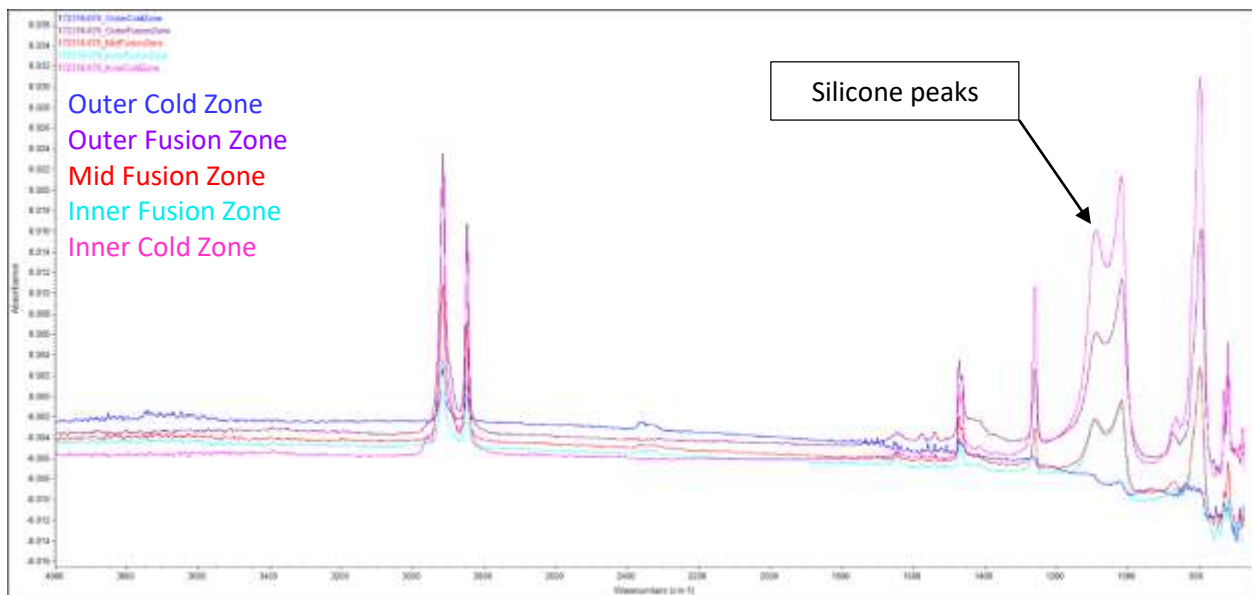
Figure 220. Sample 172316-076, FTIR spectra from decohesion test result

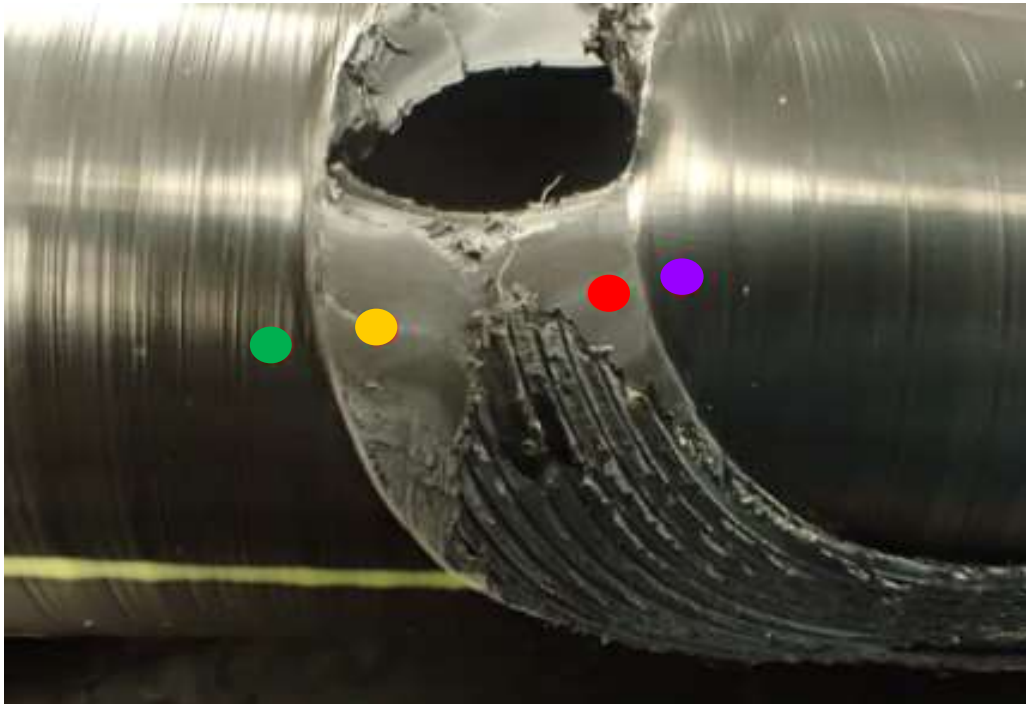
172316-077	172395-093	Silicon Grease	Acetone	Cotton Cloth Rag
------------	------------	----------------	---------	------------------

Figure 221. Sample 172316-077, decohesion test result

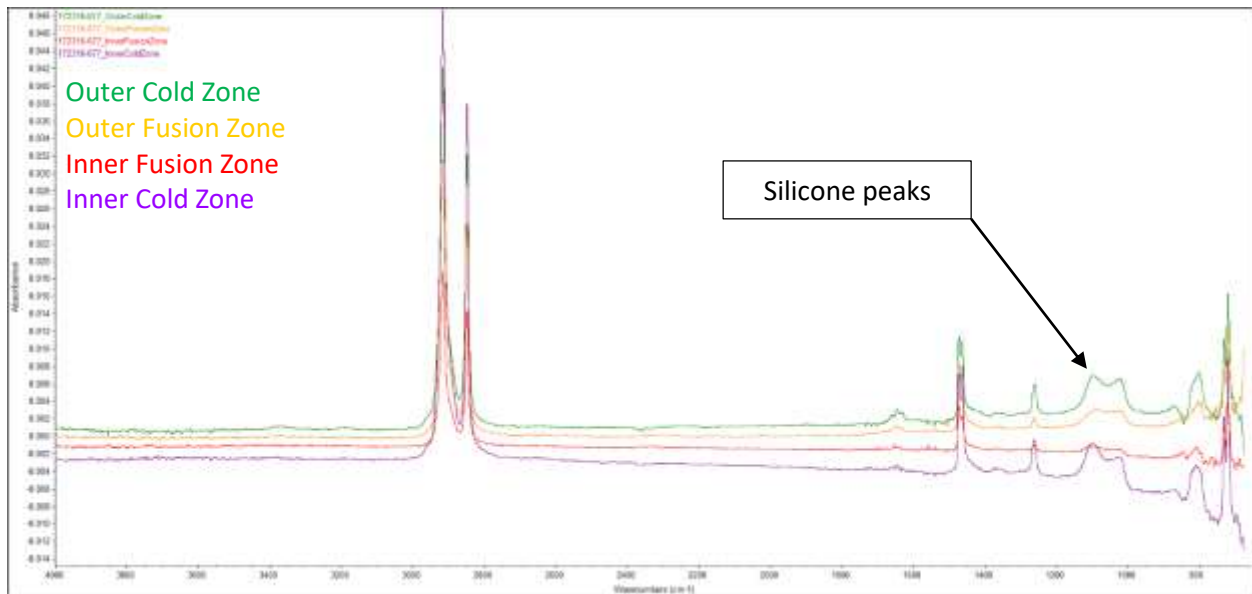
Figure 222. Sample 172316-077, FTIR spectra from decohesion test result

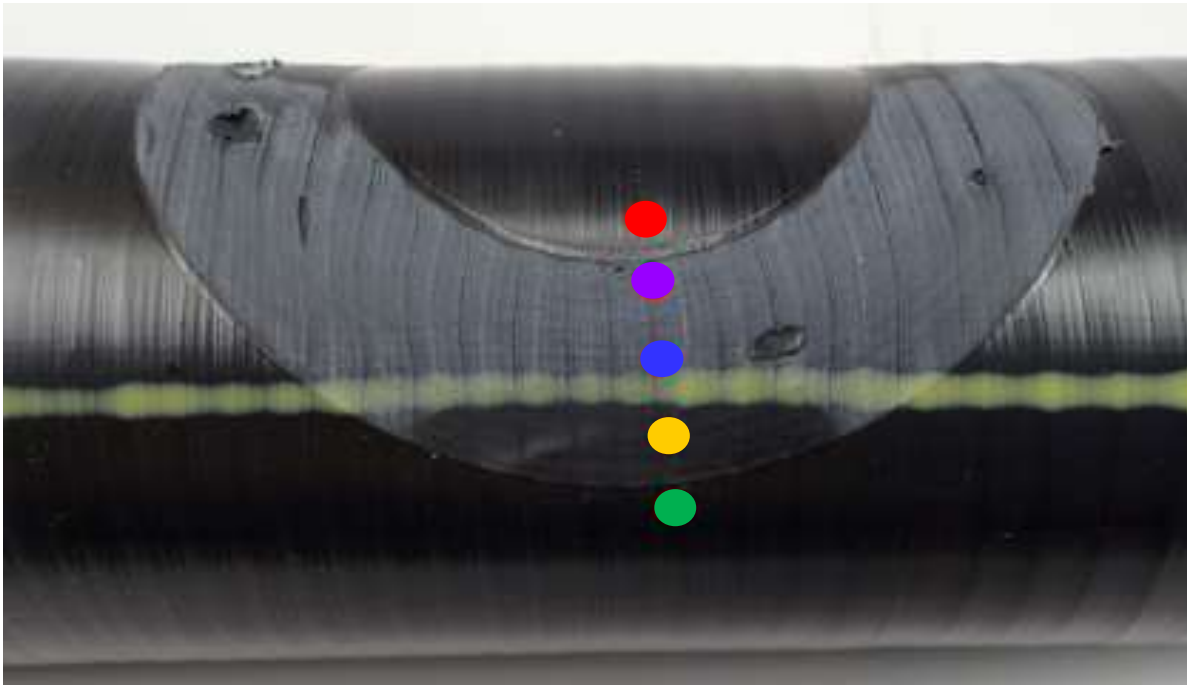
172316-078	172395-096	Silicon Grease	Acetone	Paper Towel
------------	------------	----------------	---------	-------------

Figure 223. Sample 172316-078, decohesion test result

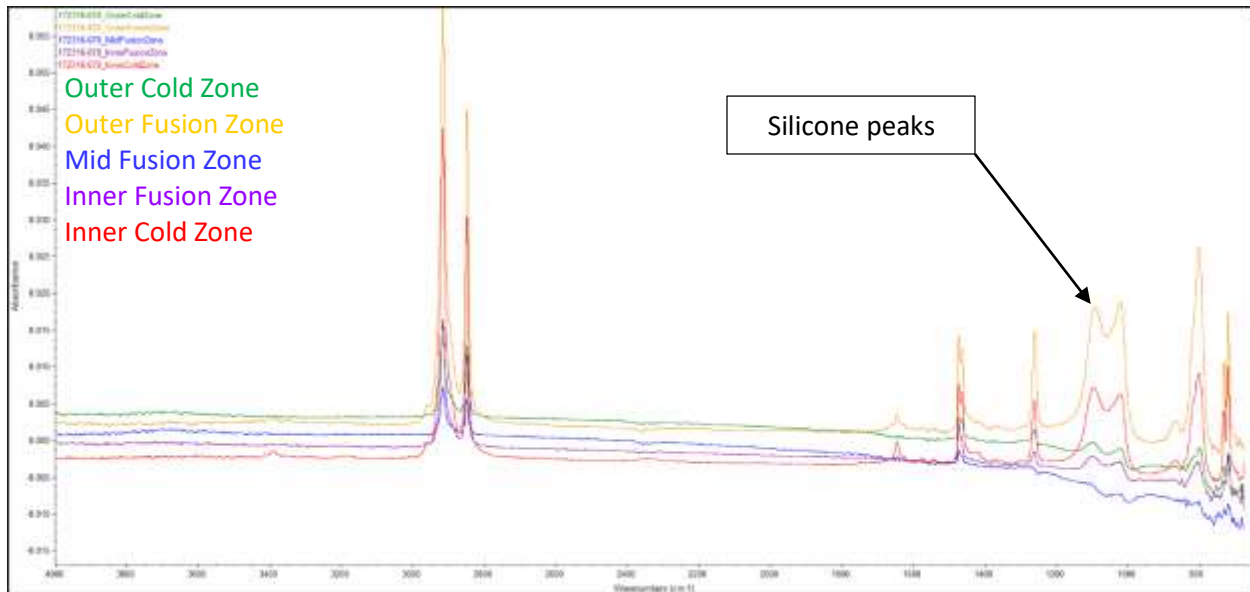
Figure 224. Sample 172316-078, FTIR spectra from decohesion test result

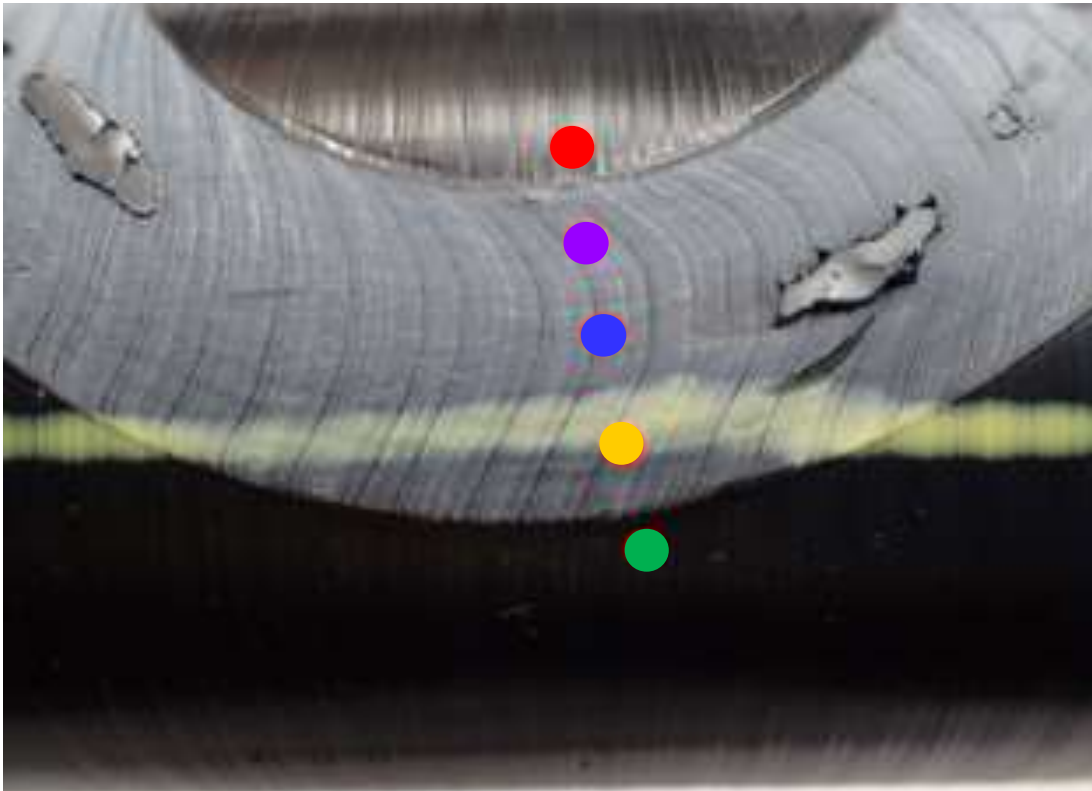
172316-079	172395-097	Silicon Grease	Acetone	Paper Towel
------------	------------	----------------	---------	-------------

Figure 225. Sample 172316-079, decohesion test result

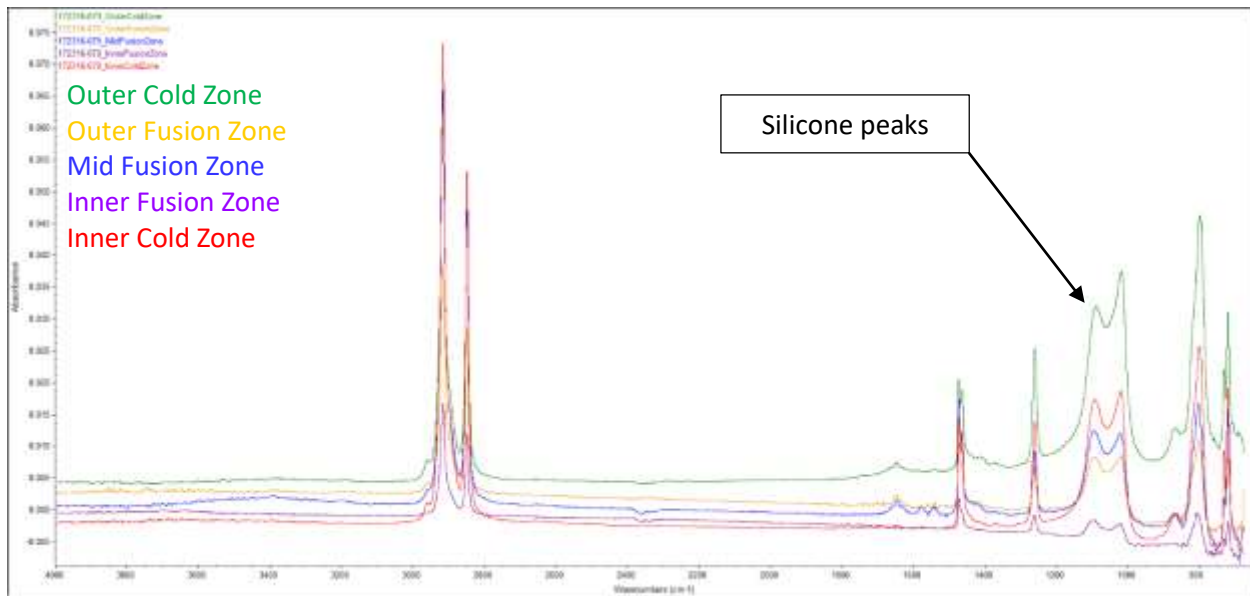
Figure 226. Sample 172316-079, FTIR spectra from decohesion test result
